ReBuilding Center

3625 N Mississippi Avenue
Portland, Oregon

PROJECT SUMMARY	
------------------------	--

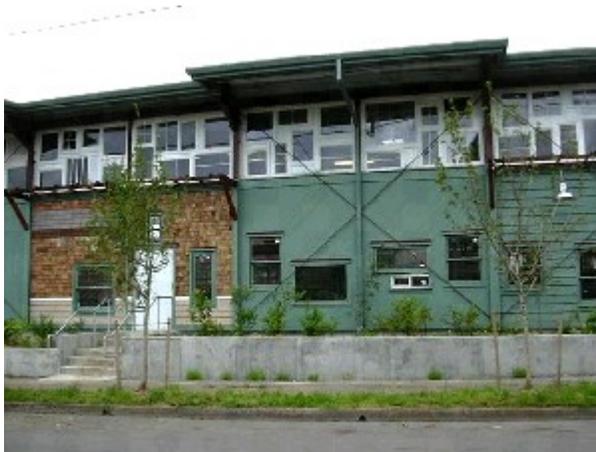
Infiltration planters along the Michigan canopy structure

- The ReBuilding Center is a non-profit community enhancement organization dedicated to the reuse of discarded building materials. It is a popular destination for people interested in building with affordable, environmentally low-impact materials. When the center built two new warehouse-type canopy structures adjacent to an existing warehouse, the design included onsite stormwater management for the new buildings and parking lot.
- Roof runoff from the new Michigan Canopy warehouse is directed into two landscaped infiltration planters facing N Michigan Avenue. The infiltration planters have open bottoms, so the stormwater filters through plants, soil, and gravel into the ground.

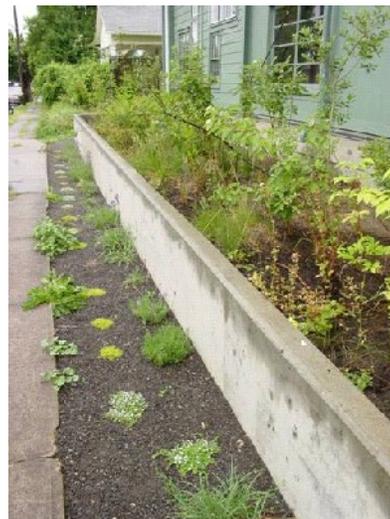
Infiltration planter

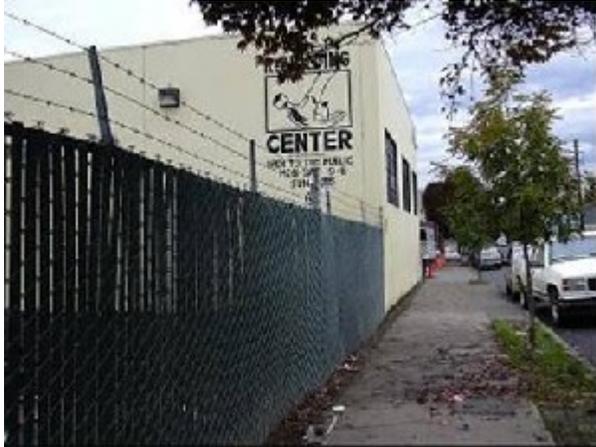
The ReBuilding Center's existing warehouse before the addition of the Mississippi canopy structure

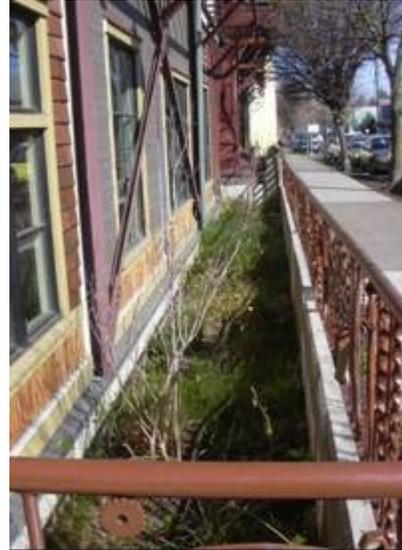
The flow-through planters in front of the new Mississippi Canopy with existing warehouse in the background

- Roof runoff from the new Mississippi Canopy is directed into two flow-through landscaped planters facing N Mississippi Avenue and one flow-through planter facing the back alley. The flow-through planters have solid bottoms. After stormwater filters through plants, soils,

and rock sub-base, a perforated pipe at the bottom carries excess water to two drywells buried below the parking lot.

Modified design: Monitoring by the landscape architect showed that the flow-through planters along N Mississippi Avenue were not infiltrating at the minimum two inches per hour rate requested by the engineer. Discussions followed about whether this was caused by clogged filter fabric, undersized facilities for the catchment drainage (approximately 75% of capacity)*, too many fines in the soil mix, or only six to eight inches of storage capacity on top of the soil (freeboard). It was also possible that, given time, infiltration may have improved with plant establishment.

The landscape architect concluded it was a combination of several of these issues. Because the facility sizing could not be modified, the following modifications were implemented to restore the function of the flow-through planters:

- The plants, soil, and filter fabric were removed, and the rock subbase was reduced from 18 inches to 12 inches (in accordance with the construction specifications and *Stormwater Management Manual* requirements).

- Freeboard was increased to 12 inches.
- The clogged filter fabric was replaced with a non-woven fabric, which was layered between the gravel subbase and six inches of washed pea gravel; this is expected to serve as an additional filter for settling fines. The fabric extends from edge to edge rather than up the sides of the planter wall.

- The soil was replaced with a mix of approximately 70% sandy loam, 20% digested paper fiber, and 10% organic compost and installed in six-inch lifts to ensure uniform soil matrix distribution.

- The downspouts were taken off-line temporarily (approximately three months) and diverted to the bottom perforated pipe to allow the soil to settle and bind before heavy storm events occurred.

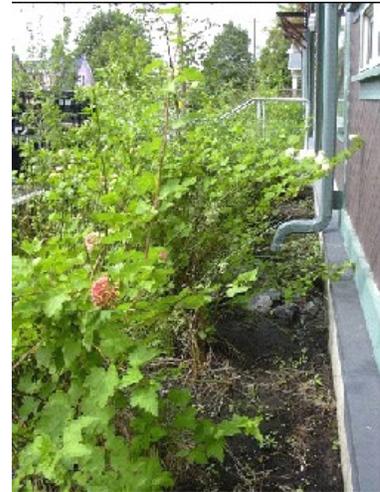
A downspout disconnected into the infiltration planters on Michigan Street

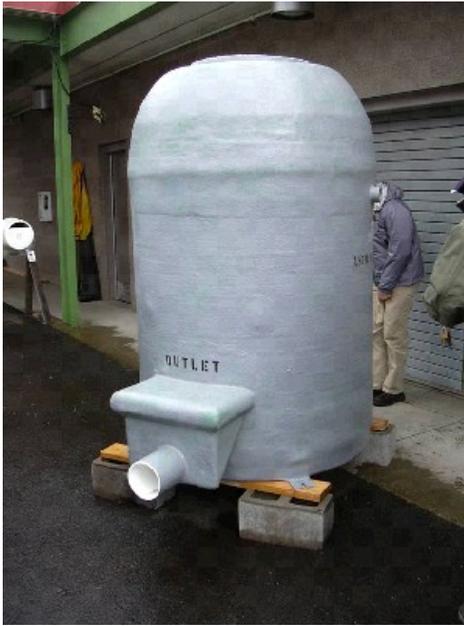
Manhole for accessing monitoring equipment

The Bureau of Environmental Services (BES) will monitor the flow-through planters facing N Mississippi Avenue to determine their effectiveness. Flow monitoring equipment will record the amount of water that flows through to the perforated pipe at the bottom of the planters, indicating the volume of stormwater runoff that is not absorbed by the plants and soil. Data will be downloaded and recorded monthly. A manhole unit will house the equipment and allow BES staff to access and record the data.

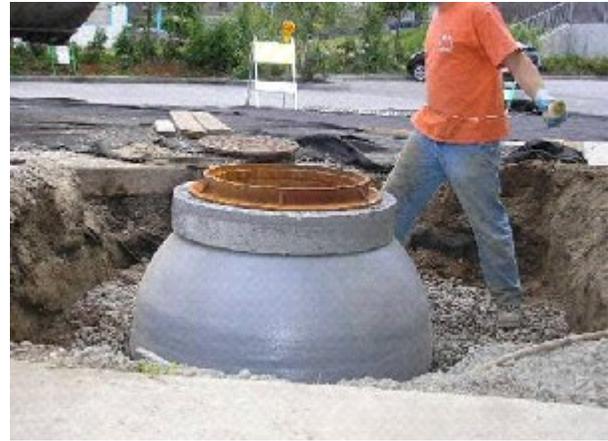
Burying the manhole in landscaping area adjacent to the flow-through planters on Mississippi Street
