George Middle School

10000 N Burr, Portland, Oregon

Project Type:	Public school planter box stormwater retrofit – demonstration project
Technologies:	Flow-through and infiltration stormwater planter cells
Major Benefits:	<ul style="list-style-type: none"> • Runoff from 1,260 square feet of rooftop was rerouted from the combined sewer system to an onsite stormwater planter. • Monitoring equipment was installed to assess how effectively the flow-through planter cell reduces stormwater flow and removes pollutants.
Cost:	\$26,426 total, with \$25,226 paid by EPA funds
Constructed:	August 2004 through February 2006

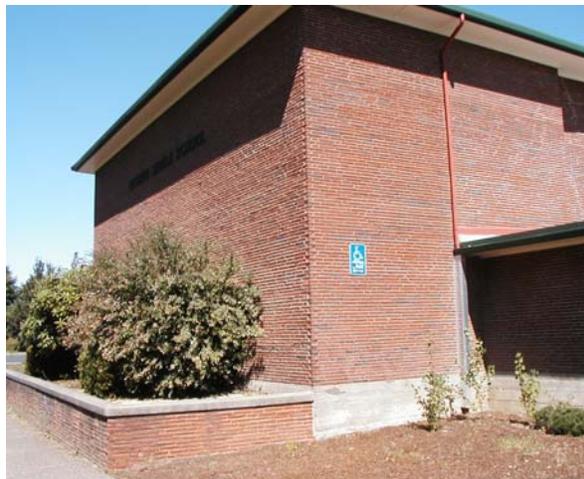
Figure 2: Original Landscape Planter

- An existing brick landscape planter was excavated to a depth of 44 inches. New concrete walls were added to divide the planter into three cells: an infiltration cell, a flow-through cell, and a monitoring cell (Figures 3 and 4).

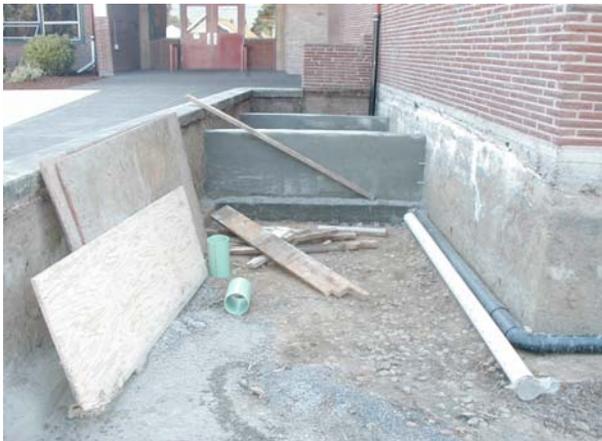
Figure 3: Monitoring, flow-through, and infiltration cells of stormwater planter retrofit (from back to front of photo)

- A waterproof liner was installed against the building foundation in the infiltration cell. The infiltration cell was backfilled with topsoil and planted with native vegetation. An existing downspout that drains approximately 1,260 square feet of rooftop was rehung and disconnected into the infiltration cell.

- The flow-through cell was completely lined with a waterproof liner. A perforated pipe was installed from the bottom of the flow-through cell through the wall of the monitoring cell to the monitoring equipment. The flow-through cell was filled with topsoil and planted with native vegetation.

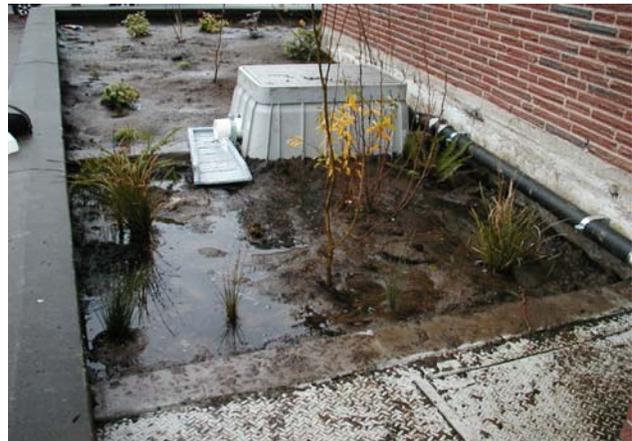
Figure 4: Installed monitoring equipment

- Water quality and quantity monitoring equipment was securely installed in the monitoring cell.

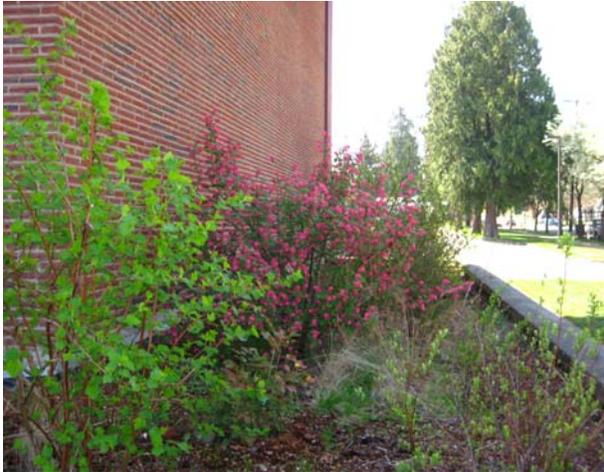
Figure 4: Stormwater planter with native plants in bloom

- Once the planter was excavated and backfilled with topsoil, it was planted with native vegetation. George Middle School students designed the overall planting plan and installed the vegetation. No irrigation was installed for the vegetation.
- The vegetation for the infiltration cell includes 2 vine maples, 2 western serviceberry, 2 mock-orange, 10 salal, 4 tall Oregon grape, 3 red flowering currant, 3 common snowberry, 10 brome grass, 10 western red fescue, 5 tufted hair grass, and 15 Oregon iris.
- The vegetation for the flow-through cell includes 1 Sitka willow, 1 Douglas spirea, 2 Pacific ninebark, 2 lady fern, 2 slough sedge, 2 slender rush, 2 spreading rush, and 2 western sword fern.

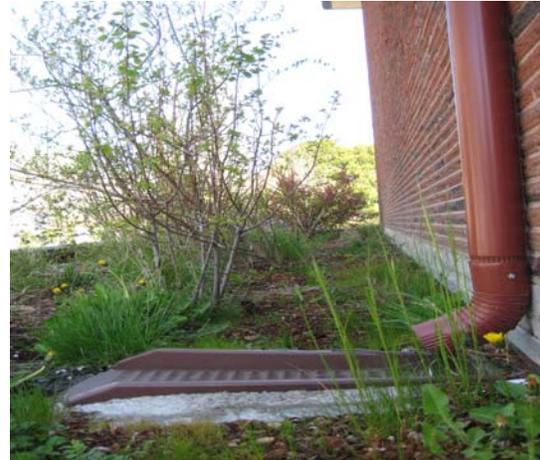
Figure 5: Disconnected downspouts in stormwater planter
