# Tryon Creek Restoration Monitoring Project

## *FY 2005-2007 Annual Report*

J.M. Hudson, C. Luzier, J.R. Cook, G. Silver, and J. Johnson

*U.S. Fish and Wildlife Service – Columbia River Fisheries Program Office  
1211 SE Cardinal Ct – Ste 100  
Vancouver, WA*

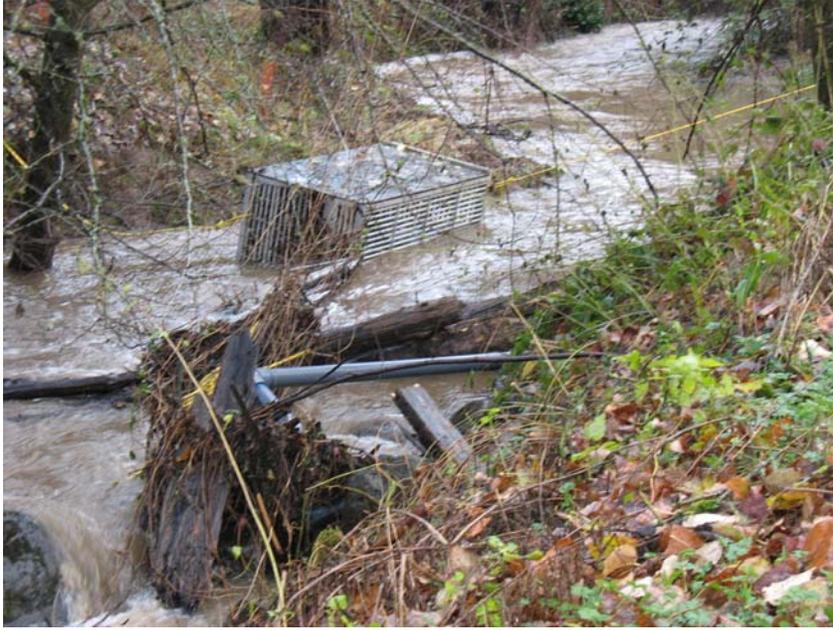
The adult picket weir fish trap was installed in November 2006. Record precipitation in November and December prevented effective operation of the trap until January 2007 (Figure 3).

Figure 3. Adult picket weir fish trap on Tryon Creek following record precipitation events in November 2006.

The initial year that the adult picket weir fish trap was operated provided much insight into successfully sampling using this method in the future. Tryon Creek is an extremely flashy system due to the urban development throughout the watershed. This development has resulted in impervious surfaces over more than 23% of the drainage (WMSWCD 2001). These impervious surfaces allow rapid runoff during precipitation events and result in flow spikes in the hydrograph (see Figure 6). The record rainfall in November and December 2006 that resulted in failure of the picket weir allowed a learning experience to better reconfigure the picket weir to hold against large precipitation events. We have more confidence that the trap will operate more effectively in future years.
