Liberty Centre Parking Garage

633 NE Liberty Place (650 NE Holladay Street)

Project Summary

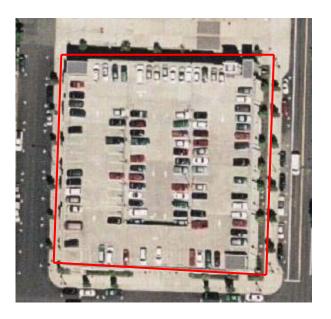
Aerial view of Liberty Centre parking garage, after project construction, 2002.
