# SE Ankeny Green Street Project

## SE Ankeny between SE 56th and SE 57th avenues Portland, Oregon

### PROJECT SUMMARY

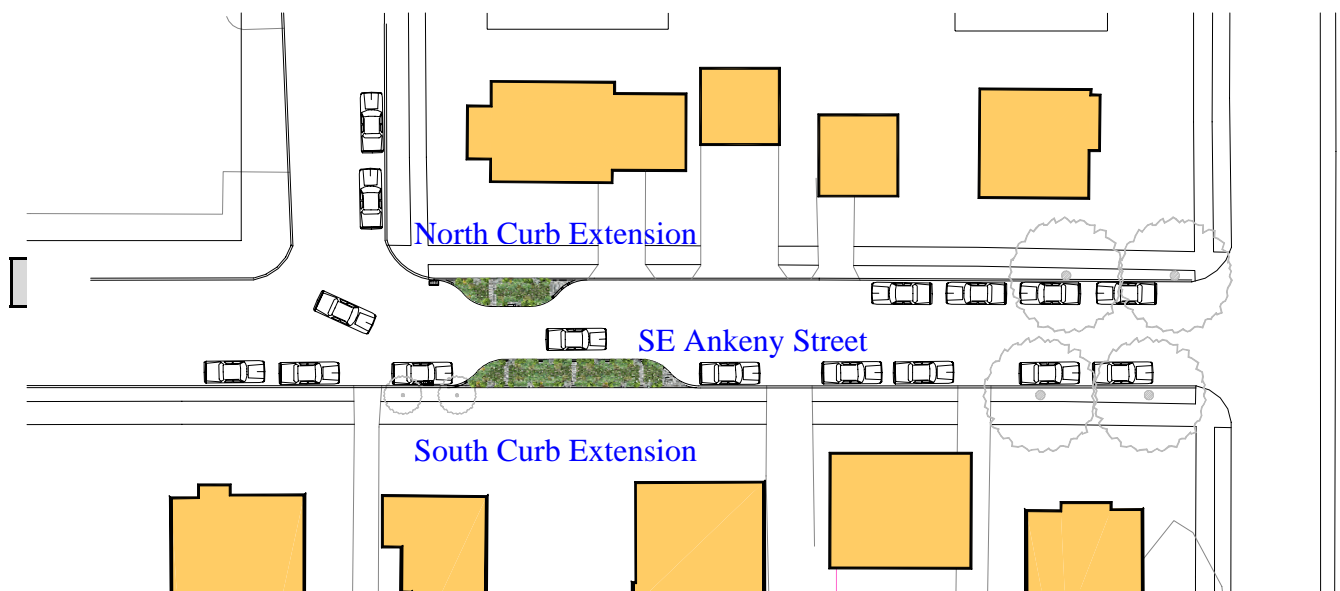
SE Ankeny Green Street Plan View

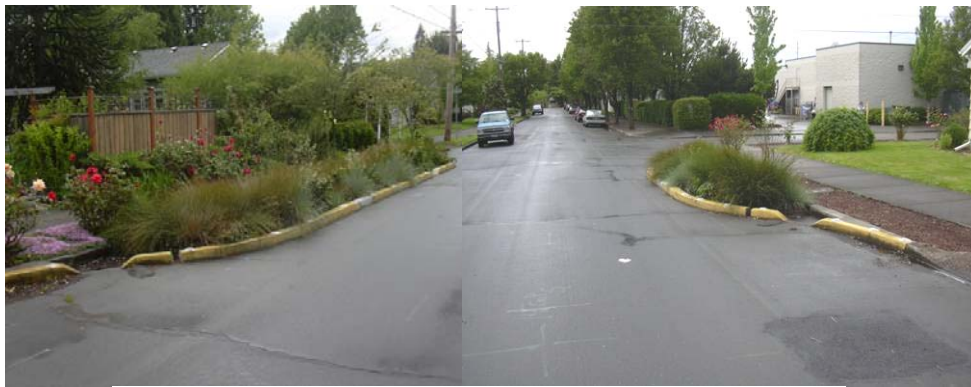
Compilation photo of Ankeny Green Street looking west.

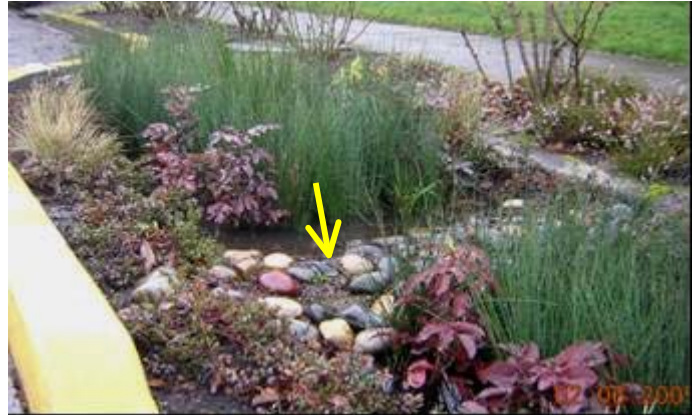
Earthen check dam in South facility

- Originally, three check dams created four separate compartments for retaining and infiltrating runoff. The design was subsequently modified to include only one check dam, with two compartments. (See “Successes and Lessons Learned” below.)

- **Check dams:** Given the minimal longitudinal slope of the street and results of the flow test, it was determined that the south curb extension needs only one check dam to retain runoff. Rather than adding to the effectiveness of the facility, the other two check dams were essentially minimizing storage capacity. The slope of the street determines the number of check dams needed.

Grade is very important when leveling check dams. If check dams are too high, runoff spills over the side of the facility into the street; if they are too low, stormwater is not sufficiently detained for infiltration.

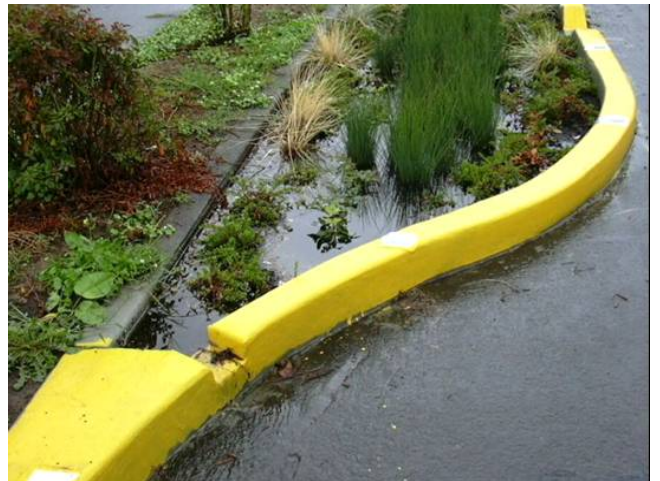
Stormwater retained in North curb extension facility

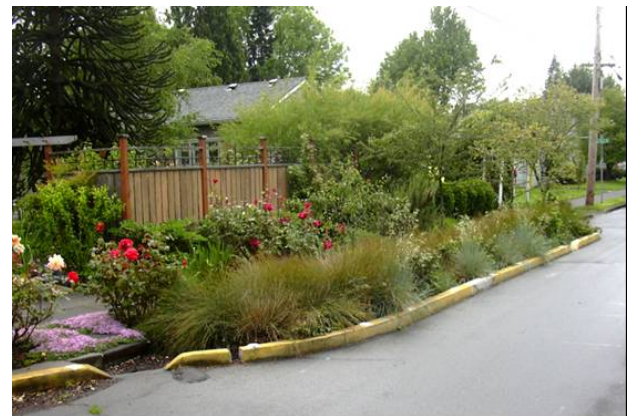
Plants were selected for their drought tolerance, evergreen foliage, and typical short stature. These characteristics help minimize maintenance and safety concerns. The most common plants are native to the Pacific Northwest, including rushes and broadleaf evergreen shrubs. Rushes are the dominant plant in the bottom of the facilities because they thrive in the variable moisture conditions and their stiff structure helps slow the passage of water. Some non-native plants were included, primarily to provide seasonal color accents.

The plants were installed approximately 8 inches apart, a density greater than required by the city’s Stormwater Management Manual. This was done to reduce maintenance requirements (weeding and watering) and to create an aesthetically appealing landscape quickly.

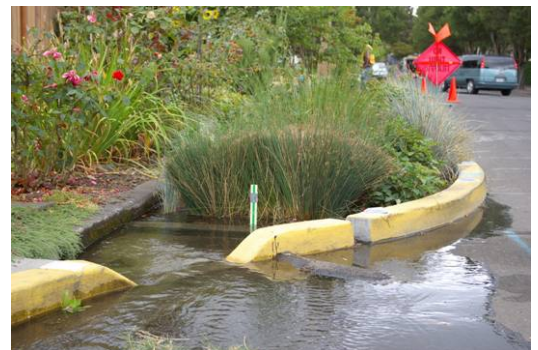
Water entering the south facility during a flow test.

BES conducted a flow test in early 2006 to assess the hydraulic performance of the facilities. Results indicated an infiltration rate of 1.8 inches per hour. Monitoring results were instrumental in identifying necessary design modifications to improve the facilities' function. (See "Successes and Lessons Learned" below.)

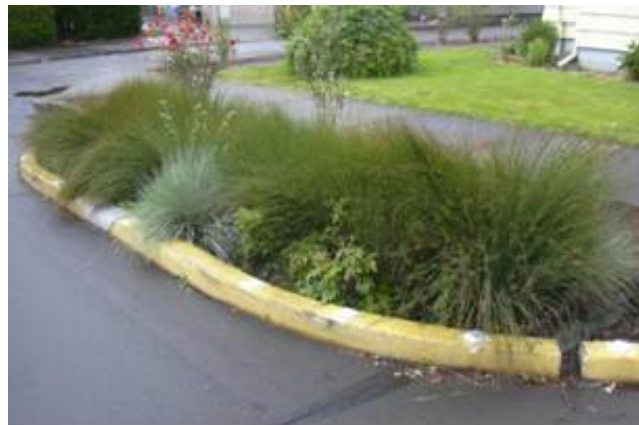
Vigorous growing *Juncus patens* (dark green plant).

- **Landscaping:** Planting the *Juncus patens* 8 inches apart proved to be too dense. This species tends to grow vigorously in this environment, reaching 24 inches or more and requiring trimming so it does not inhibit the growth of other plants and obscure the curb. This density did, however, minimize weeding during the first year. Cost savings could be obtained with less density and fewer plants. The city is researching alternative lower-growing *Juncus* species.
