### Mold in Vented Wood-Frame Roofs in the Coastal Pacific Northwest

By Lorne Ricketts, MASc, EIT

Graham Finch, Dipl.T, MASc, P.Eng.

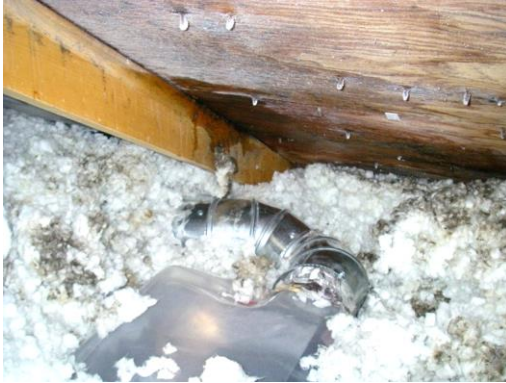
*Figure 1: Locally stained and wet sheathing due to condensation (frost) of humid air which is leaking from a poorly sealed bathroom exhaust duct*

Often this type of damage is attributed to rain water ingress through the roof assembly, inadequate ventilation of the attic space, and condensation associated with airborne moisture from air leakage, duct leakage, or re-entrainment of humid exhaust air into the attic space as shown in Figure 1 and Figure 2. However, despite recent improvements in ceiling airtightness, reduced duct leakage, and code compliant attic ventilation rates, issues of fungal growth and mold on roof sheathing are still common throughout coastal areas of the Pacific Northwest.

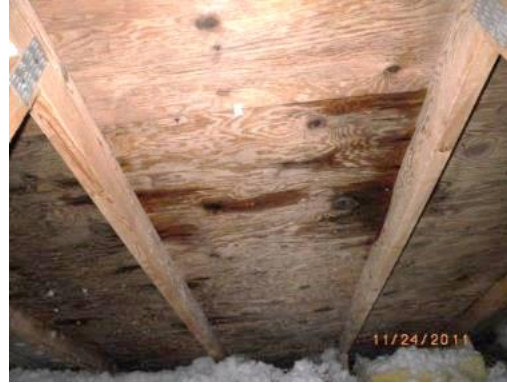
*Figure 2: Visibly wet roof sheathing caused by rainwater ingress through the shingles and underlay*

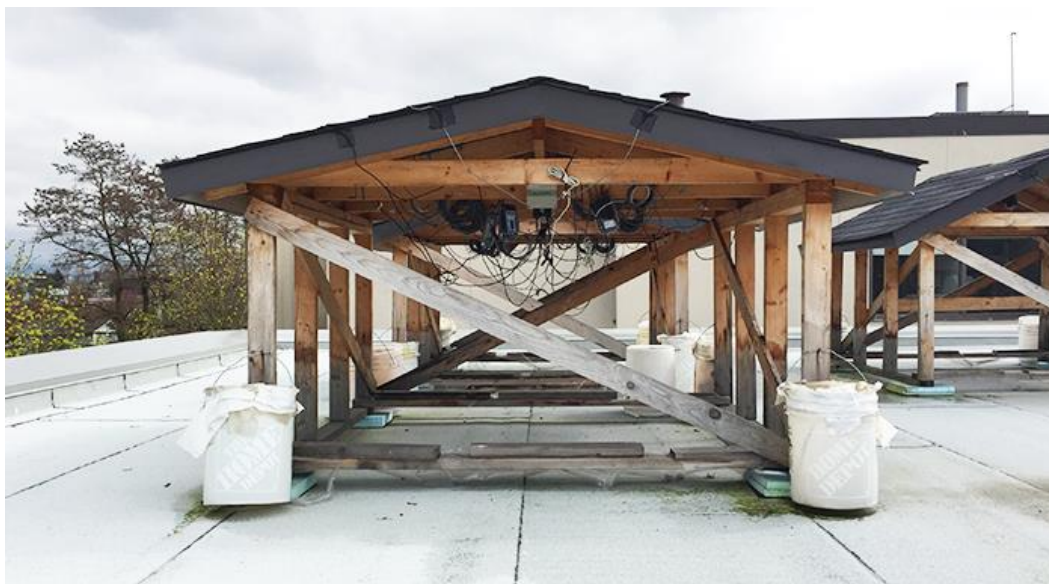
*Figure 3: Roof hut decoupled from interior conditions by unrestricted ventilation to the underside of the roof sheathing. Monitoring equipment was installed to measure performance characteristics including sheathing moisture content at various depths, roof surface temperature, sheathing temperature, and ambient temperature and relative humidity.*

To identify and confirm this moisture source, a long-term monitoring study was conducted by RDH to evaluate wetting and drying of attic roof sheathing, and the impact on observed fungal growth. The study used monitoring of controlled test huts to investigate the field performance of different roof slopes and underlayments. This controlled test hut approach allowed for the evaluation of the field performance of these assemblies under unrestricted ventilation conditions while eliminating many of the conventional wetting mechanisms, such as air-leakage.<sup>1</sup>

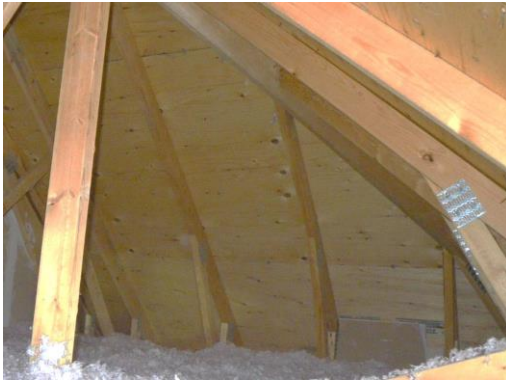
Figure 5: South facing attic roof sheathing for same attic as shown in Figure 14 showing negligible fungal growth

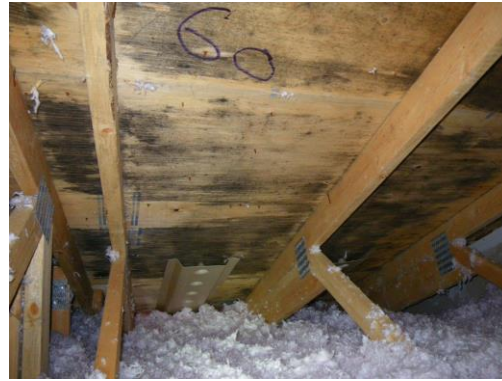
Figure 6: North facing attic roof sheathing for same attic as Figure 13 showing significant fungal growth

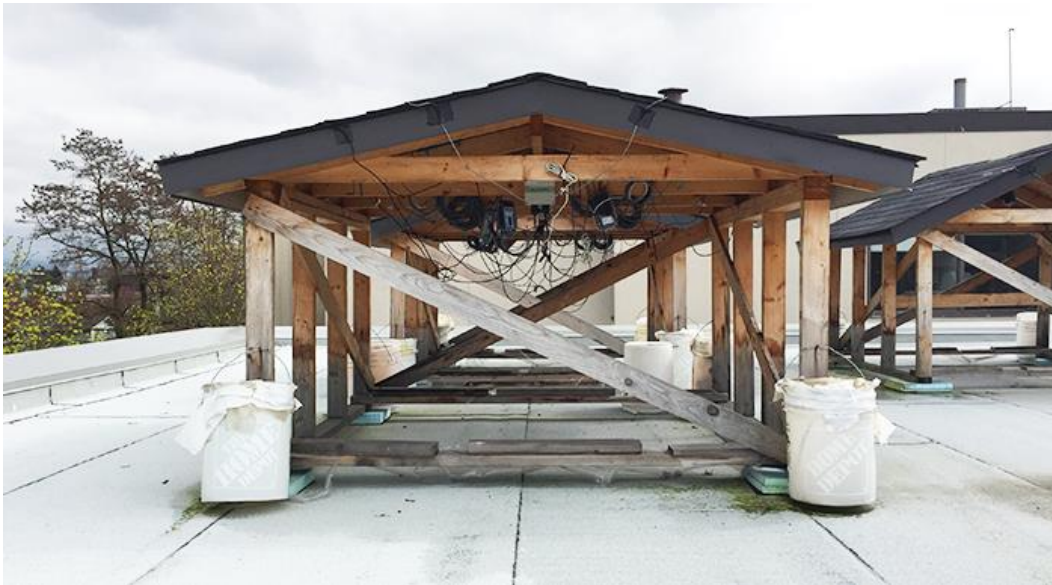
*Figure 11: Roof hut decoupled from interior conditions by unrestricted ventilation to the underside of the roof sheathing. Monitoring equipment was installed to measure performance characteristics including sheathing moisture content at various depths, roof surface temperature, sheathing temperature, and ambient temperature and relative humidity.*

study was conducted to evaluate wetting and drying of attic roof sheathing, and the impact on observed fungal growth. The study used monitoring of controlled test huts to investigate the field performance of different roof slopes and underlayments. This controlled test hut approach allowed for the evaluation of the field performance of these assemblies under unrestricted ventilation conditions while eliminating many of the conventional wetting mechanisms, such as air-leakage.<sup>6</sup>

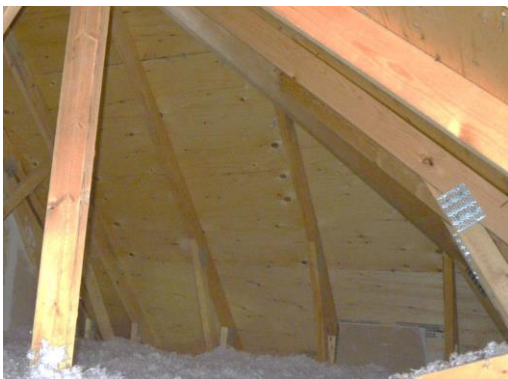
Figure 13: South facing attic roof sheathing for same attic as shown in Figure 14 showing negligible fungal growth

Absorption of solar radiation on the surface a roof can significantly increase the sheathing temperature above ambient air temperatures and cause the roof sheathing the dry. The amount of solar radiation absorbed is dependent on the exposure of the roof to sun, and consequently, roofs of different slopes will experience difference amount of drying. More importantly, however, roofs with different cardinal orientations will also experience significant different amounts of solar heat gains. The difference in performance resulting from the difference in the amount of solar heat gain absorbed by north and south facing roofs is shown in Figure 13 and Figure 14.

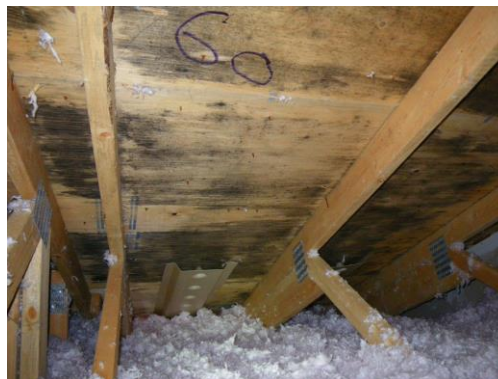
Figure 14: North facing attic roof sheathing for same attic as Figure 13 showing significant fungal growth
