2008 Stormwater Management Facility Monitoring Report SUMMARY

■
Sustainable Stormwater
Management Program

■
December 2008

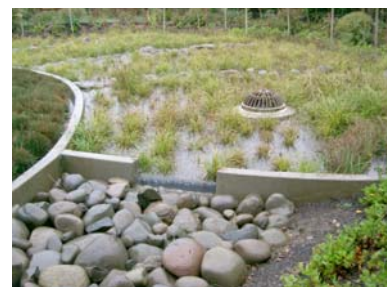
Glencoe Rain Garden

An evaluation of both flow tests and actual storm events indicate a strong ability to limit peak flows. During flow tests of the most intense design storm (the 25-yr, 6-hr), the lowest peak flow reduction was 80%. This would greatly lower or eliminate basement sewer backup risk in the combined sewer area under most circumstances, and velocities in open channel systems would be greatly reduced.

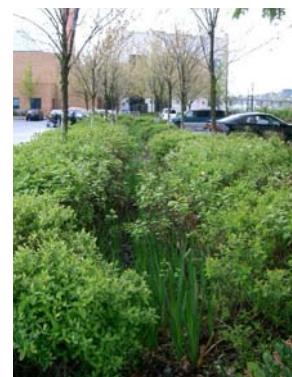
*OMSI North Parking
Lot Swales*

Despite being over 16 years old, the OMSI swales are still performing very well. A test was performed at the OMSI swales in 1995, and though a minimum infiltration rate was not mentioned for this test, the average rate was reported to be 8 inches per hour. The average rate for the test in 2005 was 13 inches per hour – indicating that infiltration capacity has been maintained and actually increased over time. This reinforces the idea that mature vegetation with woody root structures can open and maintain pathways within the soil and consequently improve infiltration.

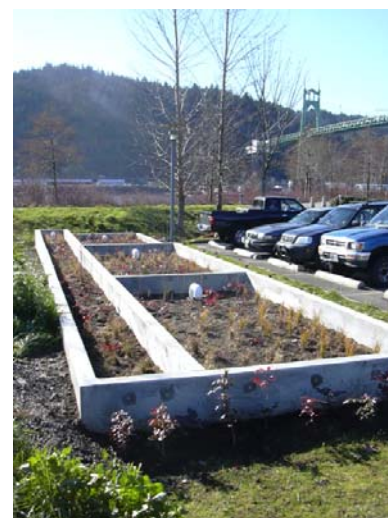
WPCL Test Planters

The Water Pollution Control Laboratory (WPCL) test planters were constructed to compare various planter design elements side-by-side. Four planters were constructed, each with 120 square feet of surface area (sized to manage up to 2,000 square feet of impervious area). Each bay is configured differently to compare: 1) geometry (long and narrow versus short and wide); 2) soil mixture (sandy loam with varying amounts of amendments); and 3) ways to protect the underdrain system from sedimentation (filter fabric or a gravel blanket).

All the WPCL planters have been able to reduce peak flow by at least 91%.

Planters tested for volume retention of the CSO design storm (time compressed, 2.2 inches in 6 hours) have retained between 14% and 47% of inflow volume. Geometry appears to make a significant difference. The long, skinny planter has an average retention 16% lower than the shorter, wider planter. This is likely due to the greater wall length to surface area ratio. The greater wall length provides a greater chance for water to leak down the side, avoiding most of the soil volume. This is accentuated in the summer when the soil dries and shrinks back from the walls (and when most testing has been done). This provides a gap along the wall for water to leak down.

The two soils have performed similarly well, indicating that their differences – proportions of sandy loam, digested paper fiber, and coconut coir – are not substantial.

Filter fabric has shown a 10% greater retention when compared to the pea gravel separator lens, indicating that the filter fabric is more of a barrier to water movement and creates more retention. If filter fabric is used, it is important to ensure the facility soil will not clog the fabric.

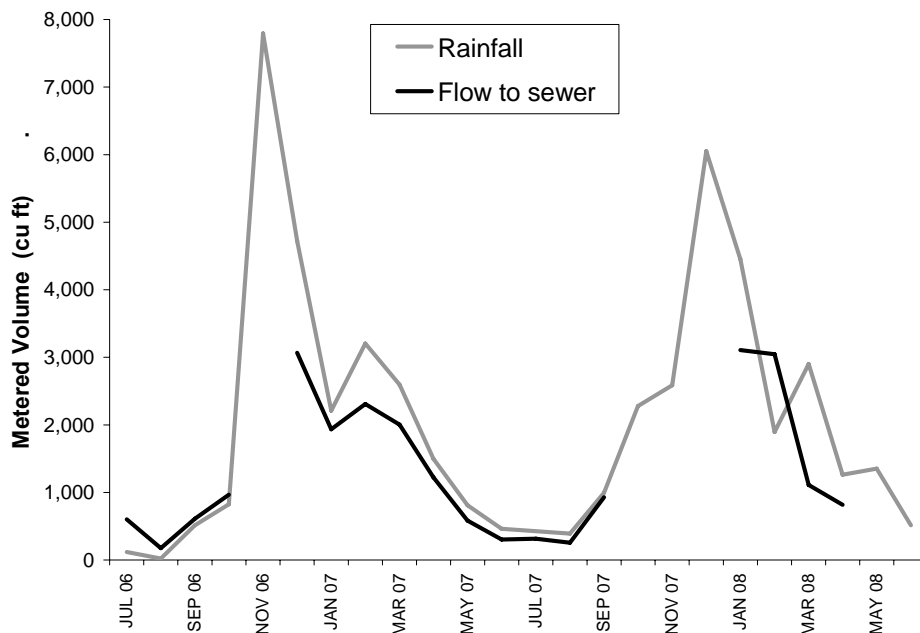
Inflow and outflow volumes for the ReBuilding Center Planters

The ReBuilding Center Planters were installed during a re-development project and manage runoff from 8,000 square feet of roof. Outflow from the planters has been continuously monitored for two years, and the planters have retained 21% of annual rainfall to date. During the largest (depth) rain events, the equipment can become surcharged which makes data unusable.

Trends have been consistent over the first two years of monitoring.
