2008 Stormwater Management Facility Monitoring Report SUMMARY

■
Sustainable Stormwater
Management Program

■
December 2008

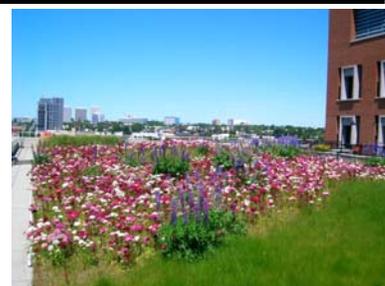
*Multnomah County
Green Roof*

The Multnomah County Green Roof uses a lightweight and highly porous soil media with few fines. This type of soil media is often used to ensure that saturated soil weight does not exceed the structural capacity of the roof. However, it is possible for the media to be too porous and allow water to drain through too rapidly. Though the Multnomah County Green Roof is the thickest at 6 inches, it retains the least volume. This is due to the substantial irrigation applied to keep the roof green during the summer. The irrigation combined with a porous soil media leads to substantial daily irrigation runoff which greatly reduces overall retention.

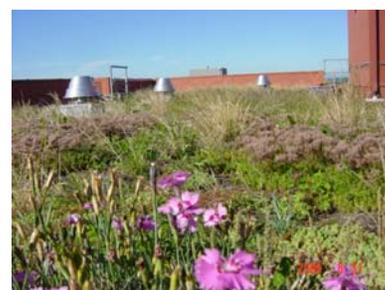
Hamilton Apartment Ecoroof

Annual and seasonal retention for Hamilton West, the roof with the longest monitoring record, has been variable. Differences in yearly rainfall totals and patterns make year-to-year comparisons difficult. For instance, 2004 and 2005 had very high annual retentions (62% and 63%) but 2004 was a very low rainfall year and both years had large amounts of summer rainfall (when high evapotranspiration rates lead to quick recharge of storage capacity). 2006 on the other hand, was very wet with most rainfall occurring during the fall and winter months. As a result, annual retention dropped significantly (47%). Other variables like daily temperatures and wind speed also impact performance.

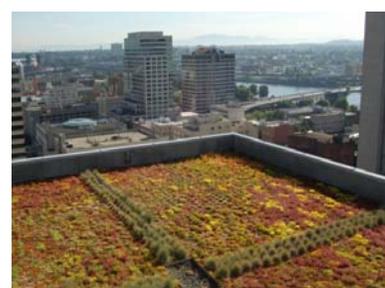
The Portland Building Ecoroof has the highest annual and winter retentions. However, with only 15 months of data, performance will need to be verified in the coming years. Hamilton West has performed consistently well during six-and-a-half years of monitoring, suggesting that it's reasonable to expect long-term stormwater retention of over 50%. The Multnomah County Green Roof is heavily irrigated during the summer. This has resulted in daily runoff when no rain is falling. This irrigation runoff accumulates during the summer months to erase any annual stormwater benefit. It is hoped that irrigation modifications and soil maturity will improve performance in the future.

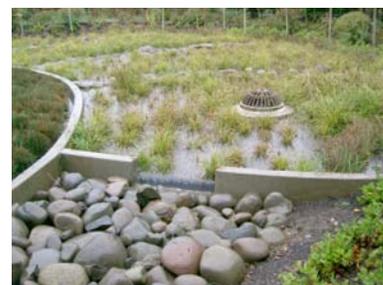
Glencoe Rain Garden

An evaluation of both flow tests and actual storm events indicate a strong ability to limit peak flows. During flow tests of the most intense design storm (the 25-yr, 6-hr), the lowest peak flow reduction was 80%. This would greatly lower or eliminate basement sewer backup risk in the combined sewer area under most circumstances, and velocities in open channel systems would be greatly reduced.

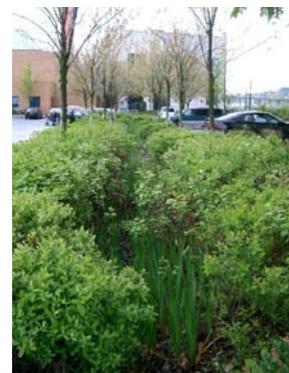
*OMSI North Parking
Lot Swales*

Despite being over 16 years old, the OMSI swales are still performing very well. A test was performed at the OMSI swales in 1995, and though a minimum infiltration rate was not mentioned for this test, the average rate was reported to be 8 inches per hour. The average rate for the test in 2005 was 13 inches per hour – indicating that infiltration capacity has been maintained and actually increased over time. This reinforces the idea that mature vegetation with woody root structures can open and maintain pathways within the soil and consequently improve infiltration.

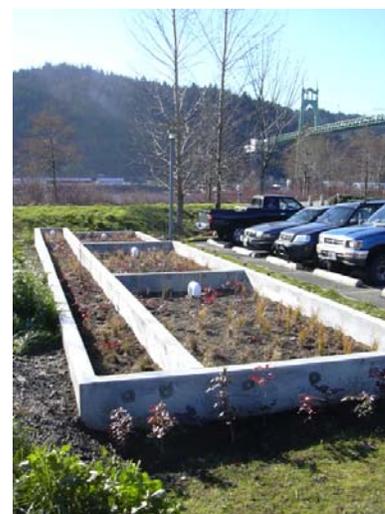
WPCL Test Planters

The Water Pollution Control Laboratory (WPCL) test planters were constructed to compare various planter design elements side-by-side. Four planters were constructed, each with 120 square feet of surface area (sized to manage up to 2,000 square feet of impervious area). Each bay is configured differently to compare: 1) geometry (long and narrow versus short and wide); 2) soil mixture (sandy loam with varying amounts of amendments); and 3) ways to protect the underdrain system from sedimentation (filter fabric or a gravel blanket).

All the WPCL planters have been able to reduce peak flow by at least 91%.

Planters tested for volume retention of the CSO design storm (time compressed, 2.2 inches in 6 hours) have retained between 14% and 47% of inflow volume. Geometry appears to make a significant difference. The long, skinny planter has an average retention 16% lower than the shorter, wider planter. This is likely due to the greater wall length to surface area ratio. The greater wall length provides a greater chance for water to leak down the side, avoiding most of the soil volume. This is accentuated in the summer when the soil dries and shrinks back from the walls (and when most testing has been done). This provides a gap along the wall for water to leak down.

The two soils have performed similarly well, indicating that their differences – proportions of sandy loam, digested paper fiber, and coconut coir – are not substantial.

Filter fabric has shown a 10% greater retention when compared to the pea gravel separator lens, indicating that the filter fabric is more of a barrier to water movement and creates more retention. If filter fabric is used, it is important to ensure the facility soil will not clog the fabric.
