**Owens Corning
3750 NW Yeon Avenue
Portland, Oregon 97210**

PROJECT SUMMARY

Overview of Stormwater System

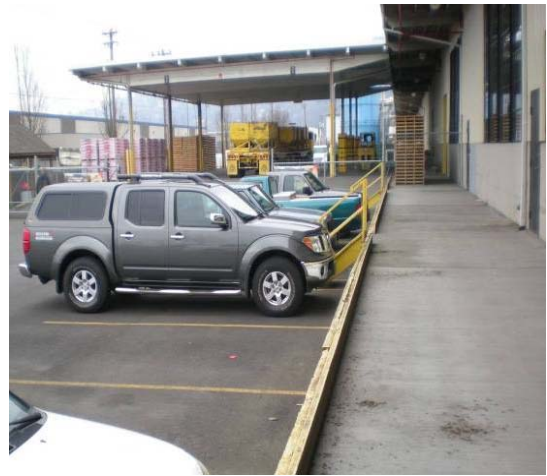
Loading dock before construction

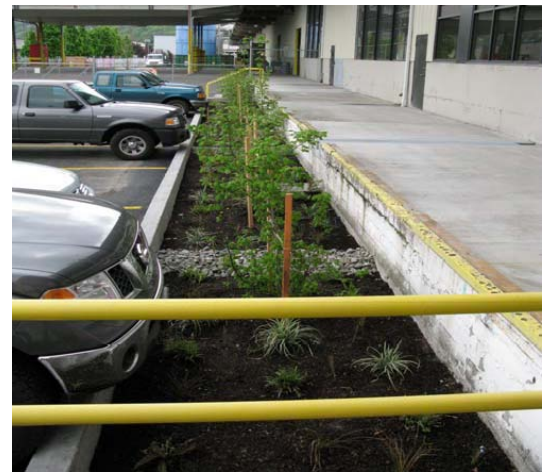
Loading dock after construction

Vegetated Infiltration Planters: The planter at the loading dock collects runoff from three disconnected downspouts. Runoff from two of the disconnected downspouts flows through runnels cut into the loading dock to carry the runoff into the facility. The third downspout flows directly into the facility. The facility is 6 feet wide and 90 feet long.

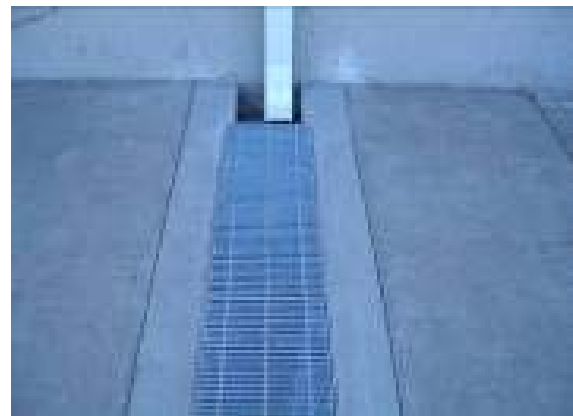
Runnel on loading dock

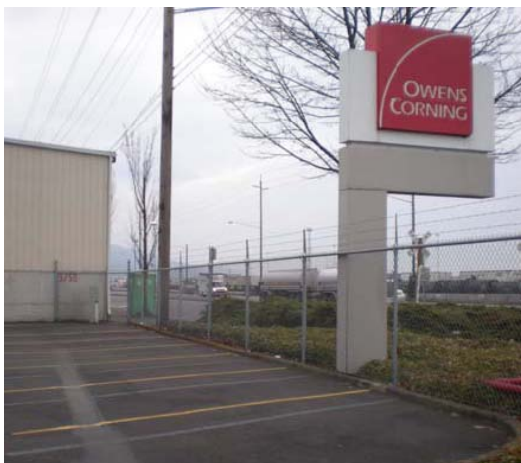
North facility before construction

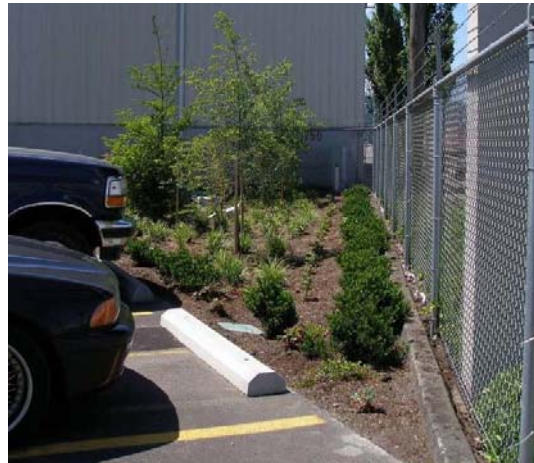
North facility after construction

The corner of the parking lot was excavated to create the north facility. Two downspouts were disconnected, and stormwater flows directly into these vegetated swales.

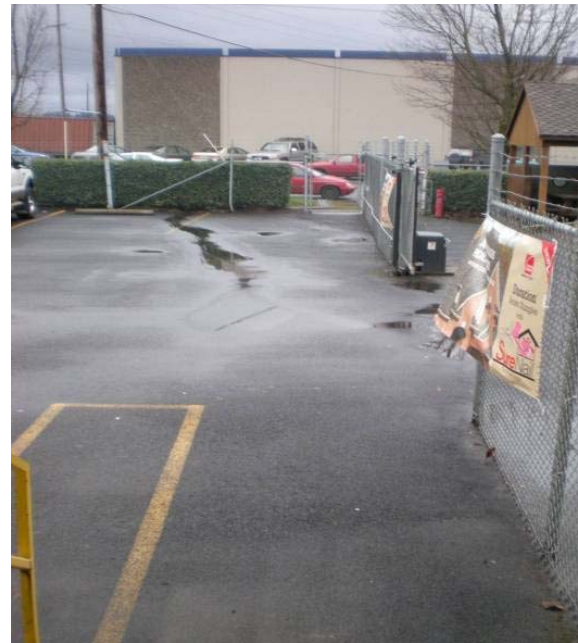
East facility before construction

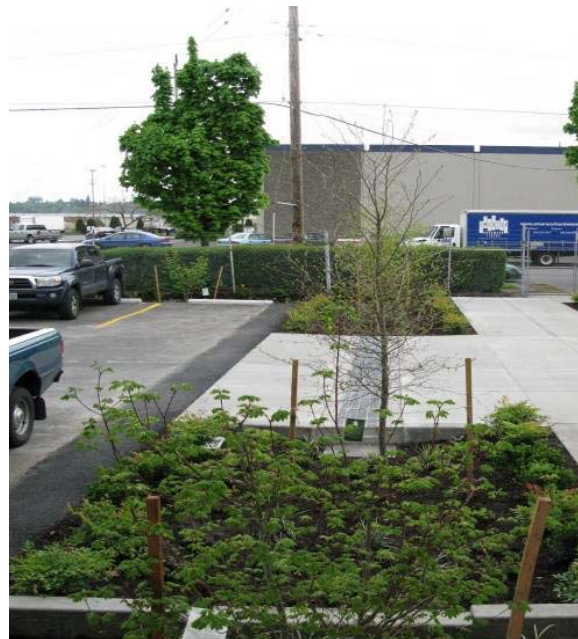
East facility after construction

The east facility runs parallel to a fence and a gate. Runoff from the parking lot and roof enters the vegetated swale by flowing between the wheel stops. The facility is 100 feet long and 8 feet wide.
