DaVinci Living Water Garden Project

2508 NE Everett Street, Portland

Project Summary

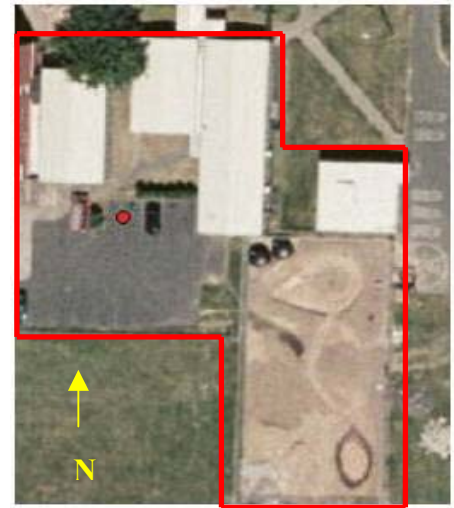
Excavation of the project in 2002. Note the outlines of the stormwater features (SE corner) and the catchment areas (adjacent classrooms and parking lot).

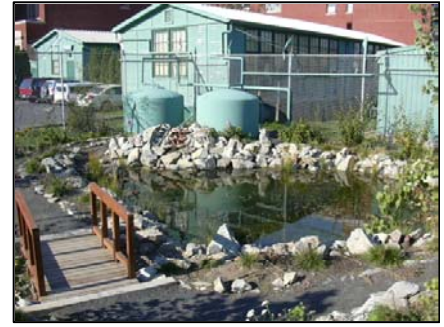
View of the permanent pond, cisterns, and classroom buildings; November 2003

- Two aboveground cisterns store 5,000 gallons of stormwater. They supply the pond and the majority of summer irrigation needs in the Water Garden.
- The lined pond provides stormwater storage year-round.
- Flowforms² aerate and revitalize recirculating pond water. They also provide a pleasant audible and visual element.
- Artistic elements include student-made ceramic tiles and animals, art displays attached to the fence, two commemorative benches, and a “cob” (adobe-like) gazebo.

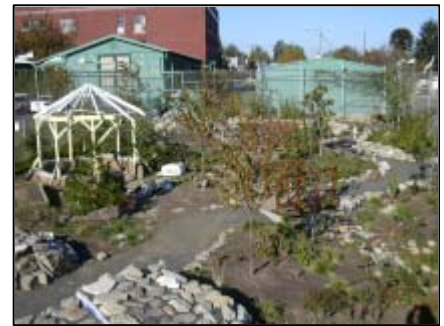
Looking north across the water garden; the edge of the amphitheatre and the gazebo are in the foreground; November 2003.

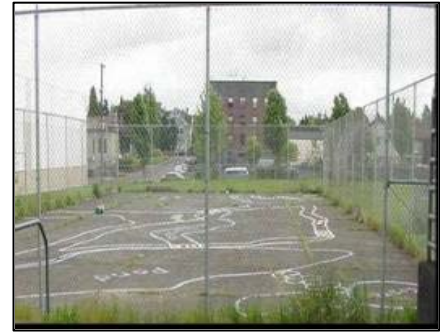
View of the tennis court, marked with features of the future Water Garden; 2001

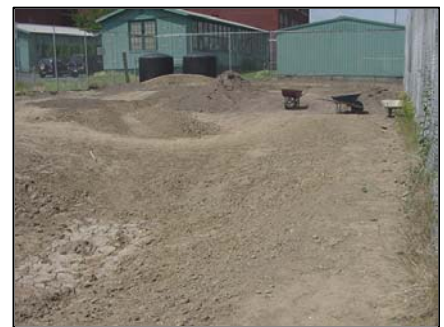
Hand excavation of the features; 2002

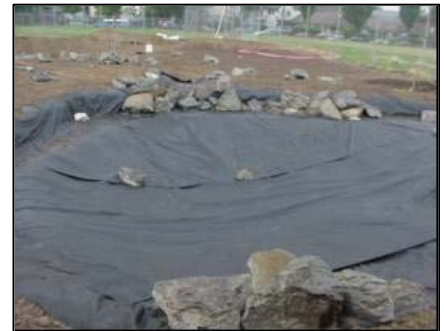
Laying the liner for the permanent pond; 2002

- The pond has a volume of approximately 29,000 gallons (3,000 cu. ft.); some capacity is created during the drier months when water losses occur through evaporation and plant uptake.
- The pond measures roughly 35 ft. by 40 ft. and is 3 ft. deep in the center. It is lined with an 8mm waterproof membrane.
- The pond is supplied with runoff from 2,460 sq. ft. of roof as well as overflow from the cisterns.
- A small pump recirculates and aerates water through the flowforms.
- Overflow drains to the main swale.

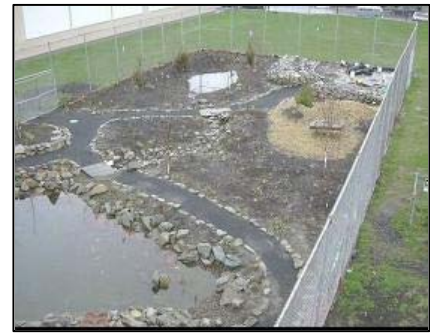
Just after construction - note landscape infiltration basin in background; January 2003

- The basin is 18 ft. by 33 ft., with 4:1 side slopes and a ponding depth of 18 to 20 in.
- The infiltration basin, located in the southeast corner of the water garden, receives overflow from the pond as well as runoff from the parking lot.

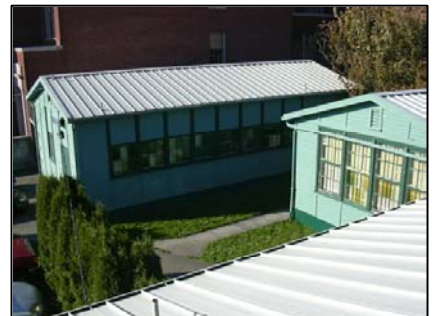
Classrooms that drain to the Water Garden

Approximately 5,300 sq. ft. of roof area (from four portable classrooms) was disconnected and re-plumbed to drain to the cisterns and pond via external ABS piping (3 and 4 in. in diameter).

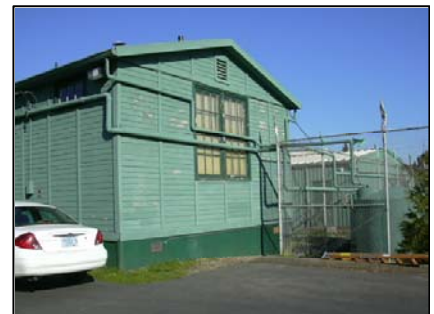
Classroom from which runoff for the three classrooms drains to the cisterns - note aerial pipes

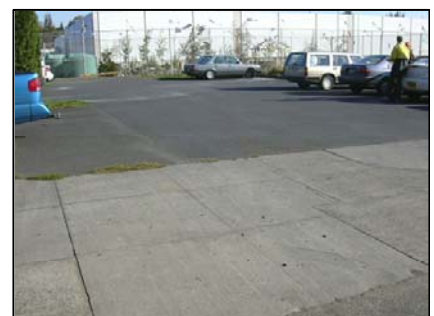
Parking lot area that drains to the Water Garden - note garden fence in background

- Runoff from approximately 4,600 sq. ft. of parking lot drains to the swale, which terminates in the main swale.
- It is 20 ft. long and 5 ft. wide. It is not lined.

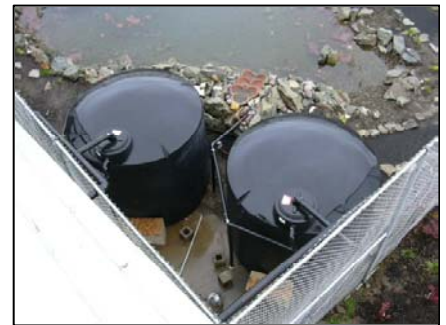
Looking down on the cisterns, flow forms, and pond

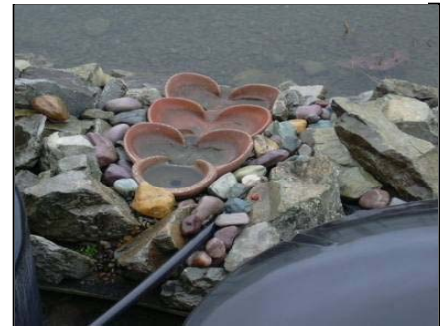
The flow forms

² A flowform is a series of sculpted bowl-like forms creating a cascade effect that cleans and oxygenates flowing water. More details can be found on the internet.

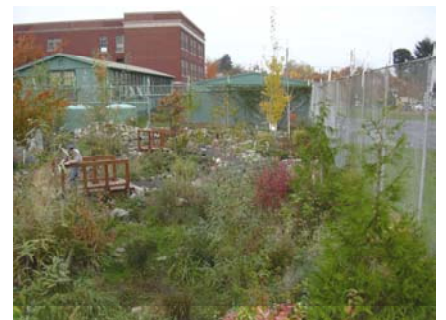
Looking north from within the landscape infiltration basin;
November 2004

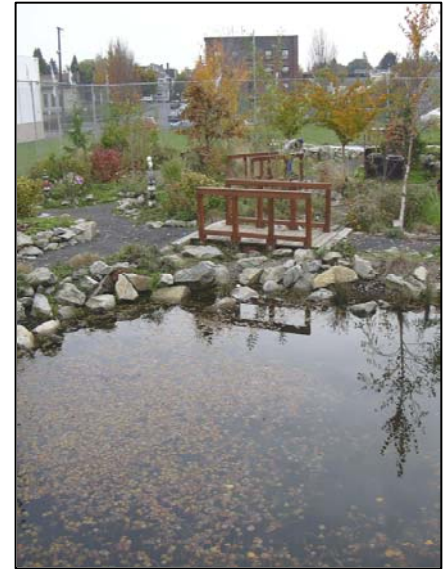
View south from the cisterns;
October 2004
