# NE Siskiyou Green Street Project

NE Siskiyou Street between NE 35<sup>th</sup> Pl. and NE 36<sup>th</sup> Ave., Portland, Oregon

## Project Summary

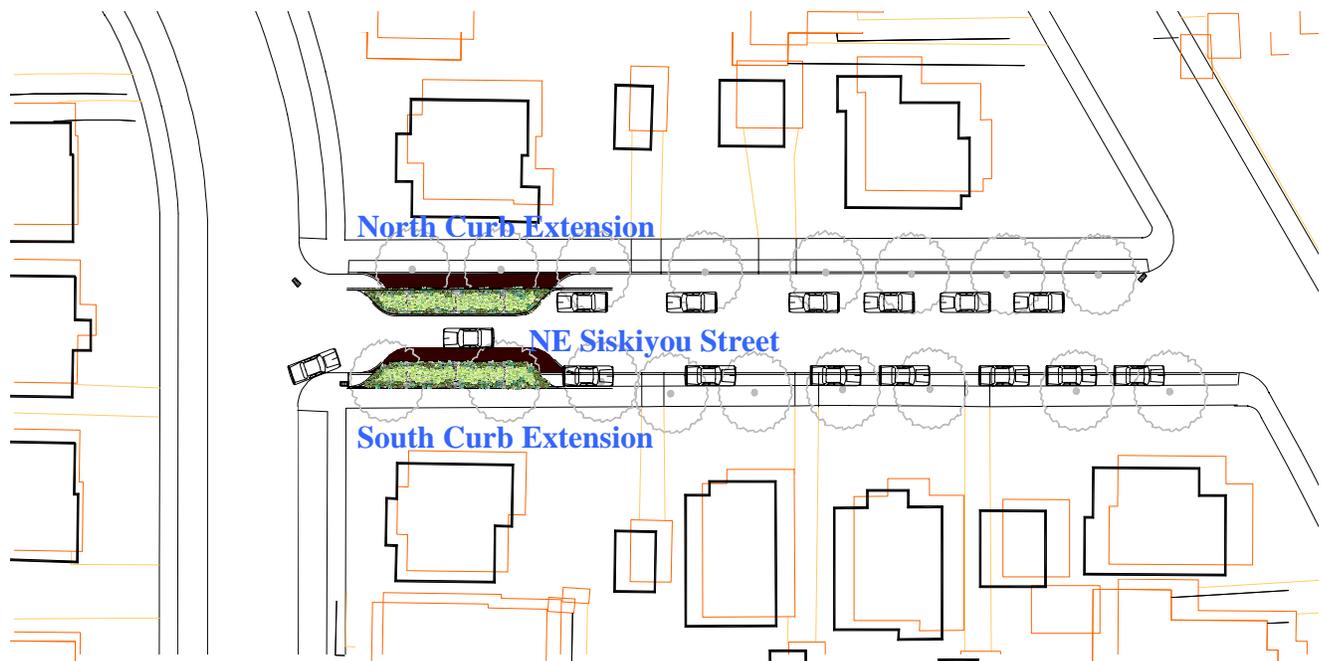
NE Siskiyou Green Street Plan View

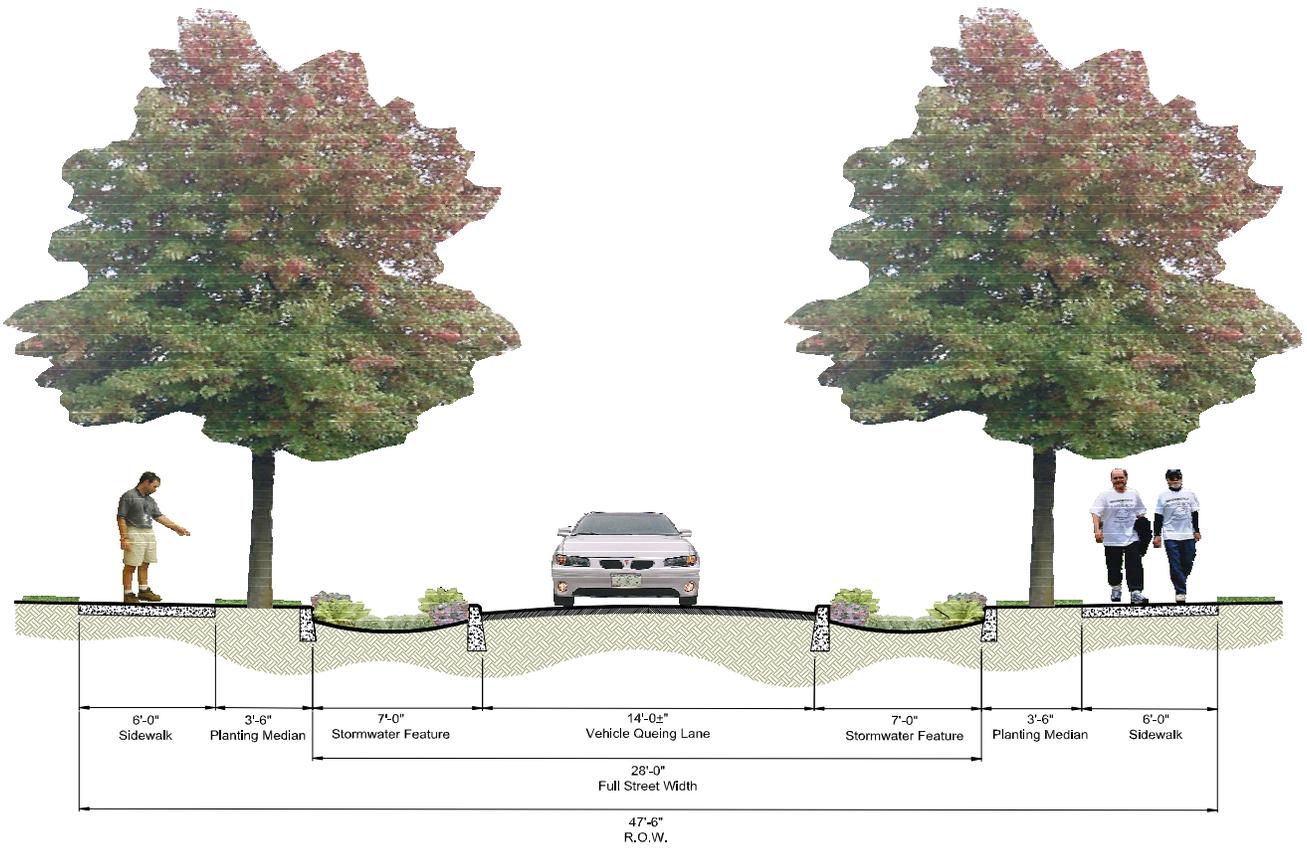
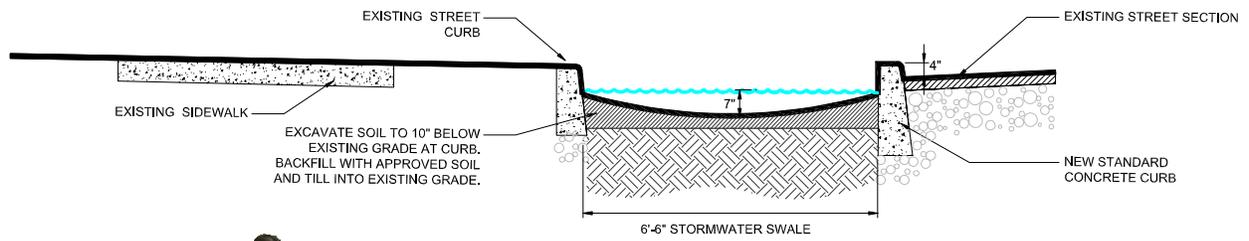
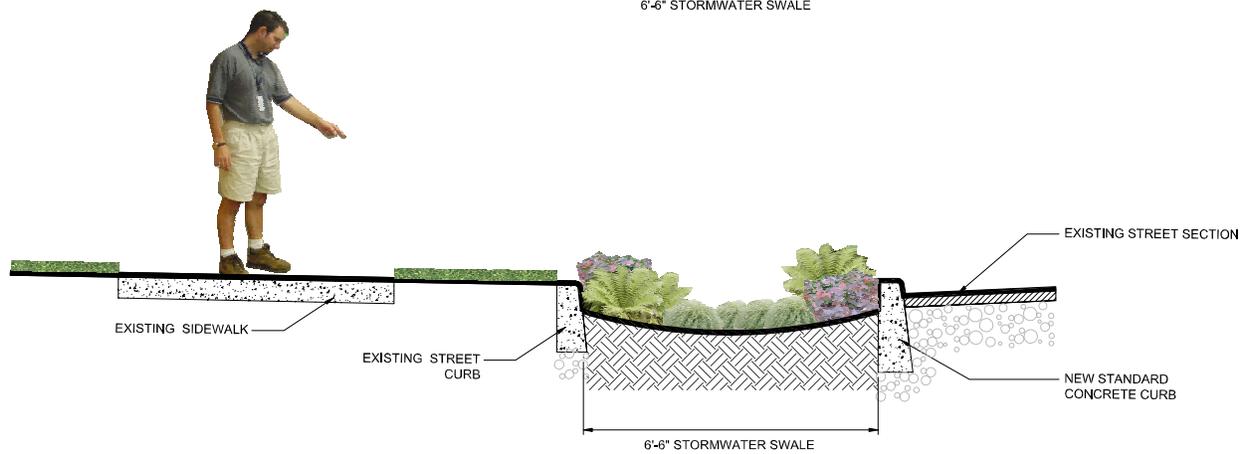
NE Siskiyou Green Street (Cross Section)

- Length: 60 feet; width: 7 feet
- Total area: 275 square feet
- Depth at curb: 6 inches
- Depth at center: 12 inches
- Maximum ponding depth: 7 inches at center

The facilities were excavated throughout to 14 inches below grade and backfilled with a 3-way mix of sand, topsoil, and compost. The mix was tilled into the native soil and spread to create a shallow parabolic cross section (see illustration).

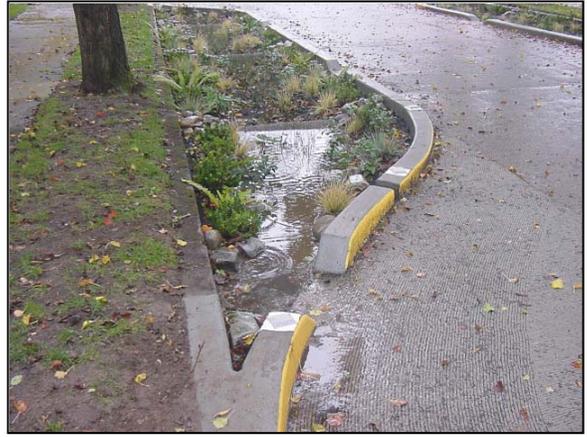
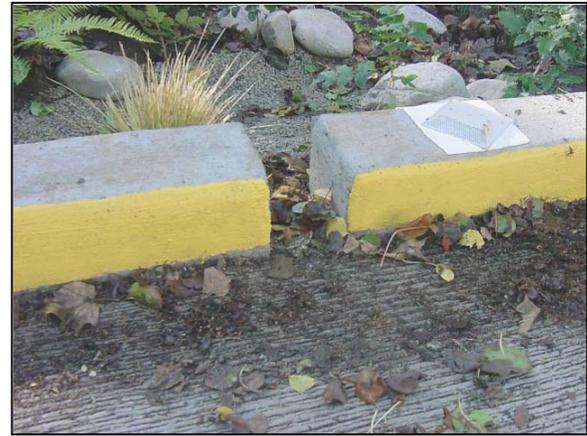
Curb cuts: inflow point (top), side inlet (bottom)

*Overflow:* Overflow exits through a curb cut at the west end of the facility, draining to the combined sewer via the street gutter and the existing street inlet. No modifications were made to the inlet.

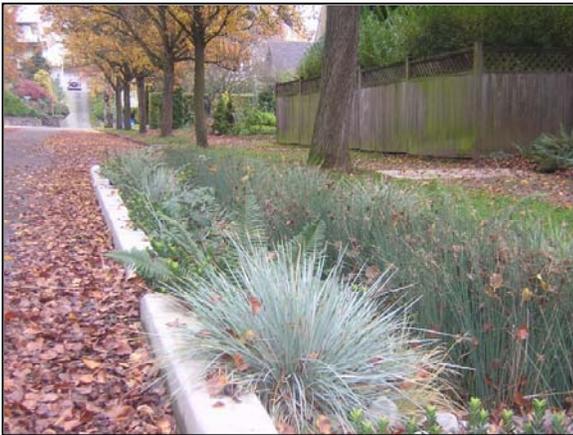
The south planter; fall 2004

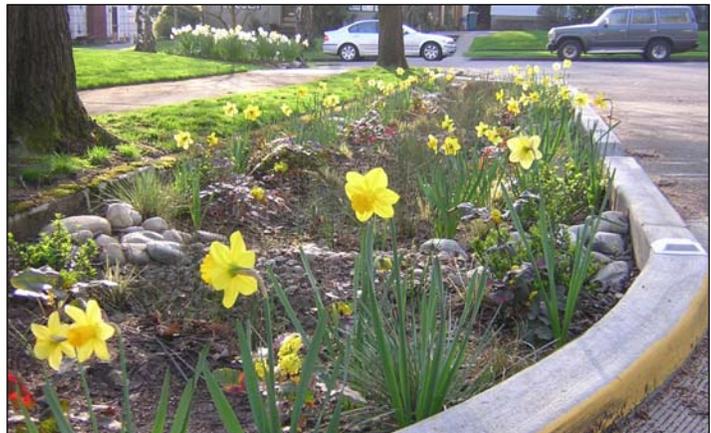
South curb extension. Spring 2004
