N VANCOUVER AVENUE: COLUMBIA SLOUGH BRIDGE NO. 001696

LEVEL II MITIGATION DOCUMENTATION

PORTLAND, MULTNOMAH COUNTY, OREGON

REPORT NO. 2438

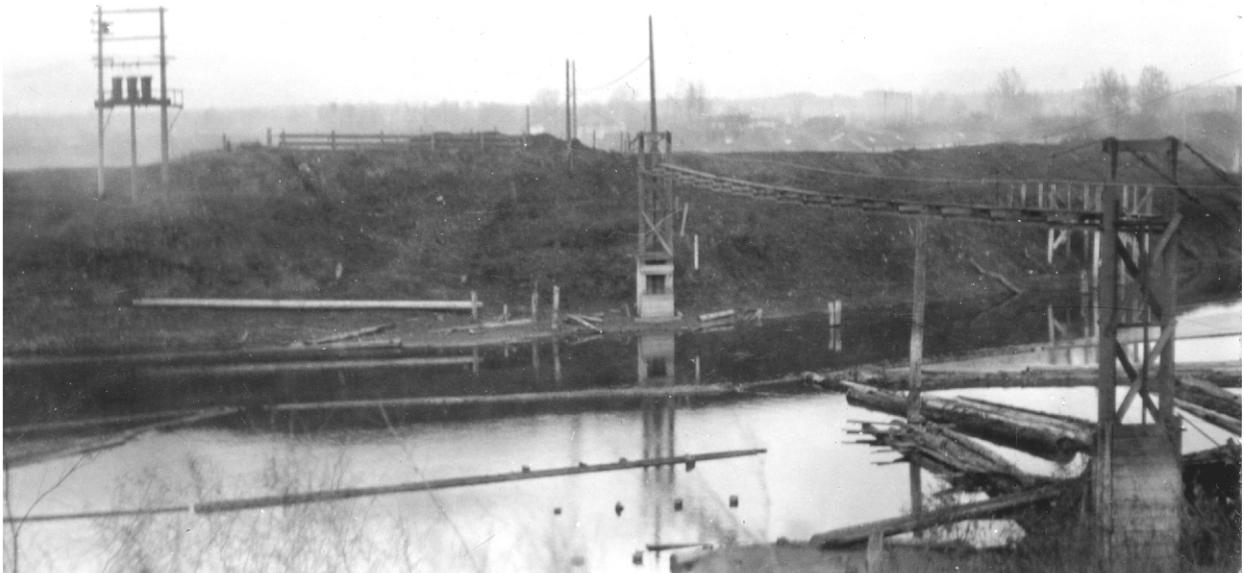
Figure 4. This historical view of the Columbia Slough Levee shows the bridge construction location. Timber stubs in the water are likely the remnants of a prior bridge. The view is towards the north. (Courtesy Oregon Department of Transportation.)

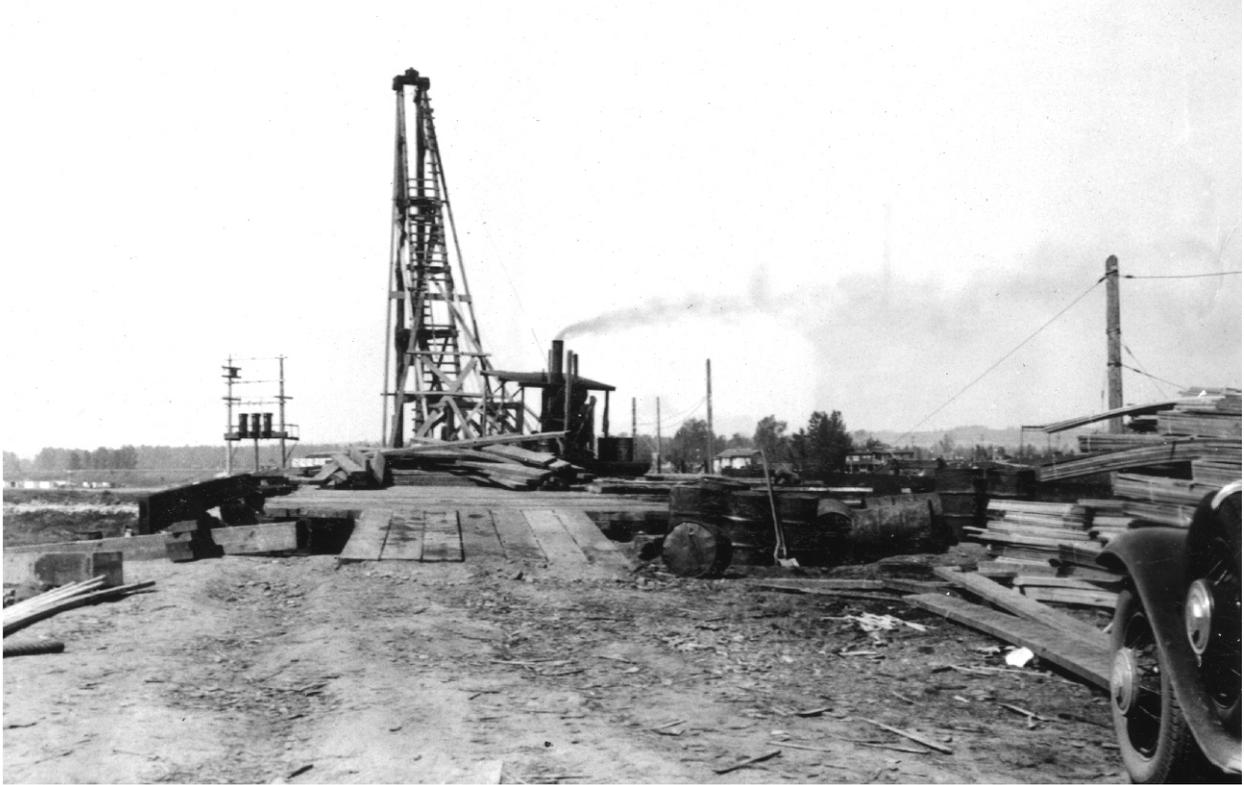
Figure 5. A 1935 view from the southern approach showing the bridge construction in process. The view is towards the north. (Courtesy Oregon Department of Transportation.)

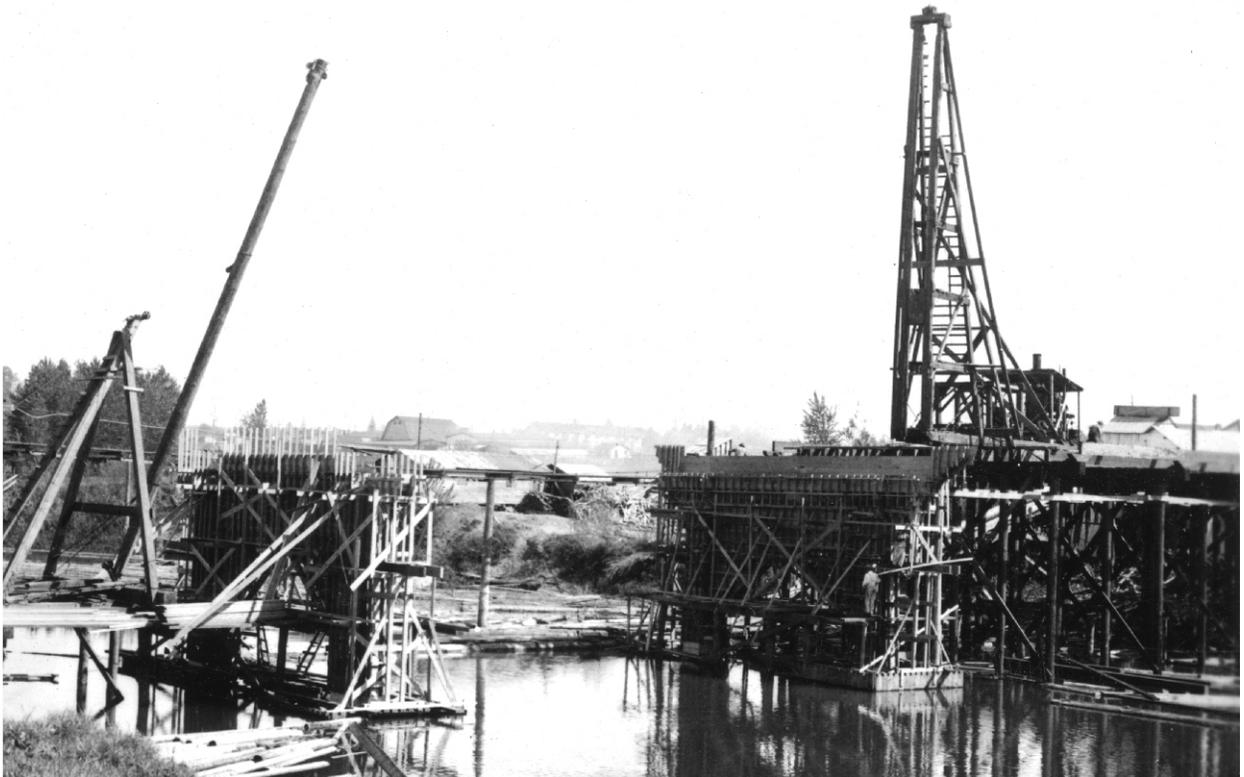
Figure 6. The concrete pile bents for the new bridge were under construction in 1935. The view is towards the southeast. (Courtesy Oregon Department of Transportation.)

support the 75-foot center span of steel I-beams and rest on concrete footings. The concrete bents are also accentuated through the use of pilasters on the piers and scrolled brackets on the outer bracing. Sidewalks, the road deck, central vertical piers, and sections of the guardrails are composed of concrete. The concrete roadway is 7.5 inches thick on the steel span, and 6 inches thick on the timber spans. Opposing cantilevered concrete pedestrian walkways extend beyond each side of the structure, supported by either riveted steel, concrete, or wood brackets, depending on location. Decoratively scrolled wood corbels support the exterior sidewalk stringers atop each wood bent. Some of these corbels are replacements, as made apparent by the appearance of pressure-treated wood with prick marks.
