Bureau of Environmental Services • City of Portland

2010 Stormwater Management Facility Monitoring Report SUMMARY

Sustainable Stormwater Management Program

December 2010

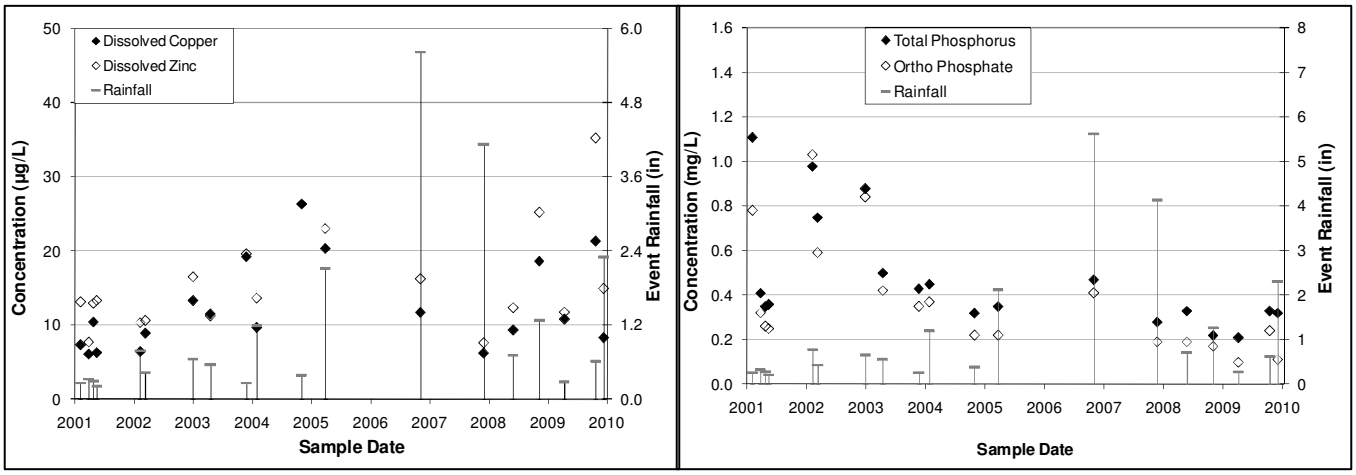
Zinc and copper levels in the runoff are highly variable. Potential metal sources include the soil media, corrosion of roofing materials – flashing, railings, etc. – and metals present in rainfall [Sullivan, 2005]. Ecoroof zinc levels were substantially lower than conventional roof runoff samples collected from the building penthouse (8.9 – 39.3 µg/L ecoroof versus 67.2 – 239 µg/L conventional), but ecoroof copper levels were notably higher (6.8 – 20.6 µg/L ecoroof versus 0.61 – 3.9 µg/L conventional). This would suggest the ecoroof can capture zinc from conventional roof sources like galvanized metals, but that copper in the ecoroof soil media can leach out and raise effluent levels. All events had concentrations well below human health guidelines, but even low levels (down to 3 µg/L) of dissolved copper may adversely impact salmonids and other aquatic life [Hecht et al, 2007]. Efforts to reduce copper export should be investigated in the future.

Phosphorus concentrations appear to be decreasing over time but are still high when compared to in water benchmarks (0.13-0.16 mg/L) established in some Portland watersheds. There was little or no phosphorus or nitrogen found in conventional roof runoff at the site.

Trends for copper, zinc, and phosphorus from Hamilton West runoff samples

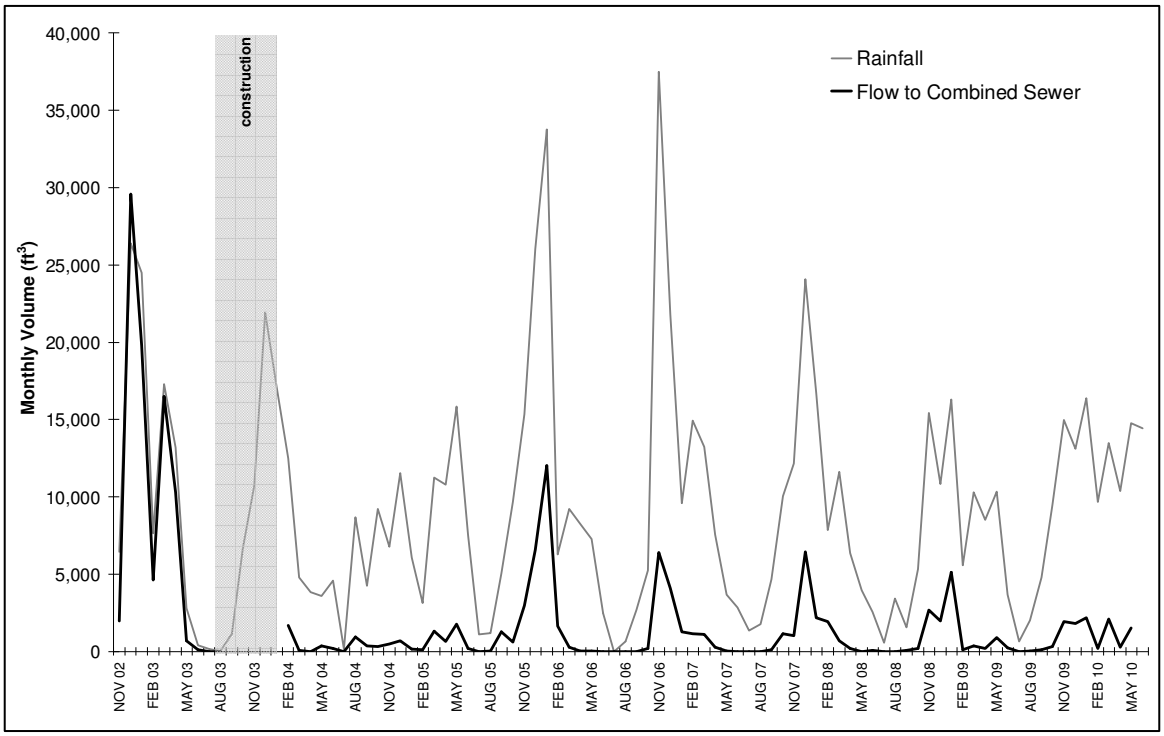
Infiltration facilities have also shown a sizeable reduction in the flow volume entering the city's drainage channels and sewer system. For one facility monitored continuously for six years, annual runoff has been reduced by 85%. Flow tests simulating CSO design storms have shown retentions ranging from 25% to 100%, with an average of 73%, while flow tests simulating the Water Quality Design Storm have shown retentions ranging from 61% to 100%, with an average of 93%.

Inflow volumes to the combined sewer before and after construction of the Glencoe Rain Garden

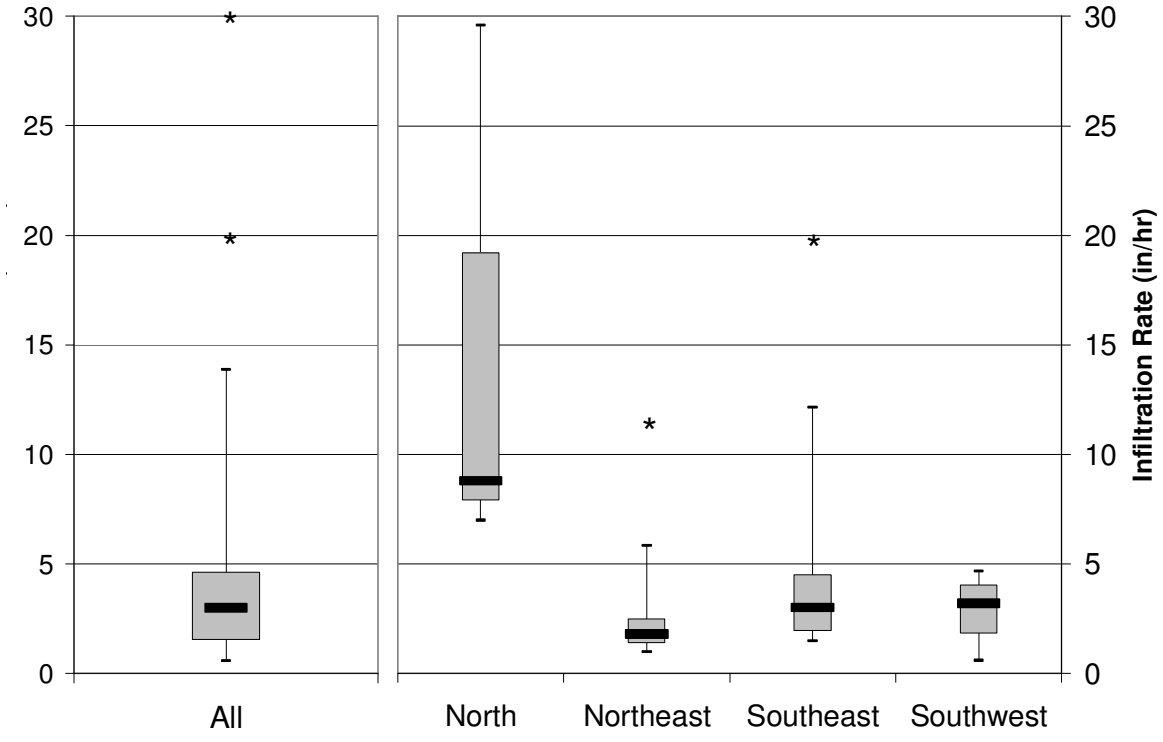
Infiltration Rates for All Facilities (left) and Facilities Separated by Region of the City (right)

The median infiltration rate for all facilities tested was 3 inches per hour, and this median was similar in all parts of the city but the north which had noticeably higher rates. While the west side median rate is very similar to the median for all facilities tested, the range of values was lower – between 0.5 and 4.5 inches per hour. Rates on the east side typically ranged from 1 to 13 inches per hour. This is expected because the west side soils are typically finer grained and are more likely to have a confining layer of low permeability beneath them.

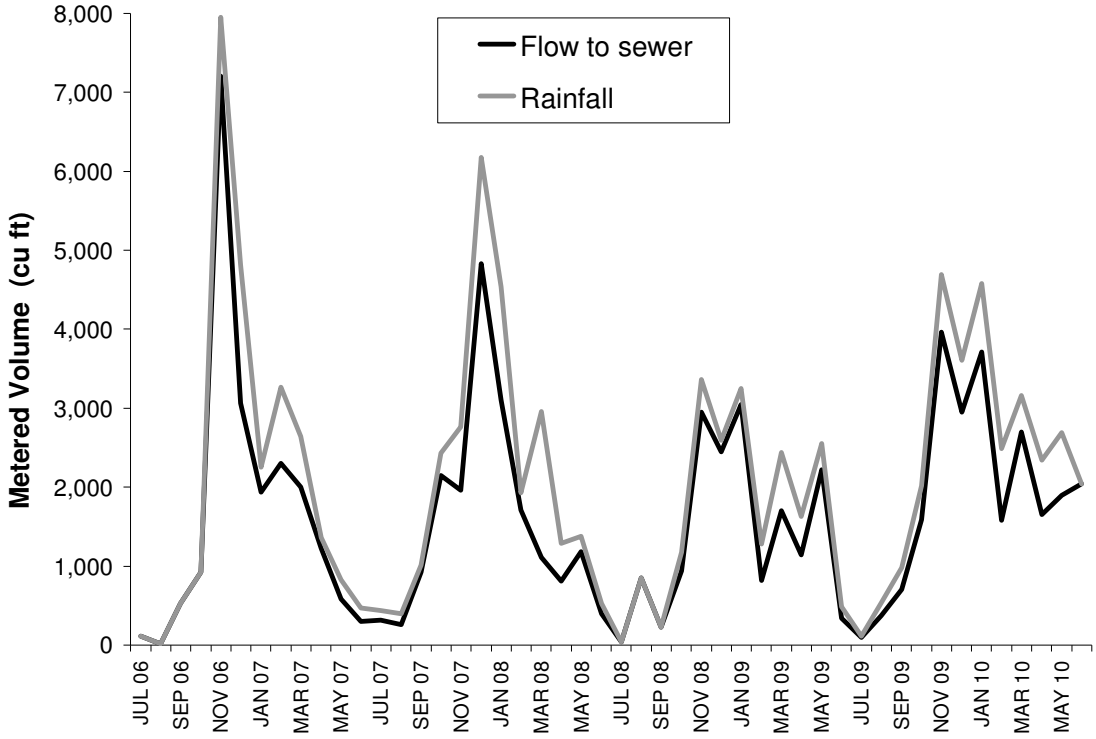
The ReBuilding Center Planters have been monitored continuously over the past four years, and have retained 21% of the total rainfall volume. Results are mildly conservative because during the largest rain events, the equipment becomes surcharged when the drywell overflow backs up. During such events, 0% retention is assumed.

Monthly Inflow and Outflow Volumes for the ReBuilding Center Planters

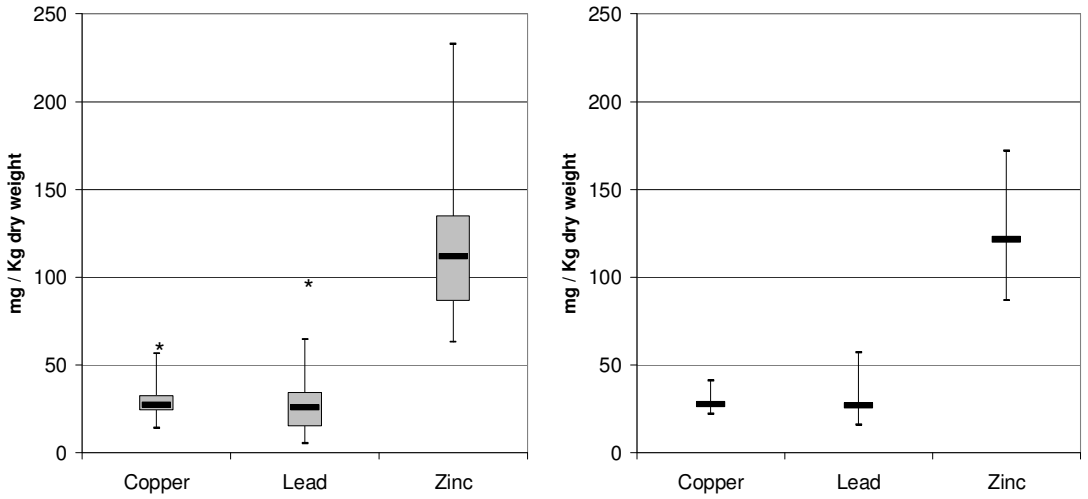
Comparison of Surface Soil Metal Content for Facilities (left) and Controls (right)

The range of metal concentrations for the limited number of control samples (n=4), are generally similar to the concentration found in the facility samples (n=35). As more control samples become available, it will be possible to determine if this trend continues.

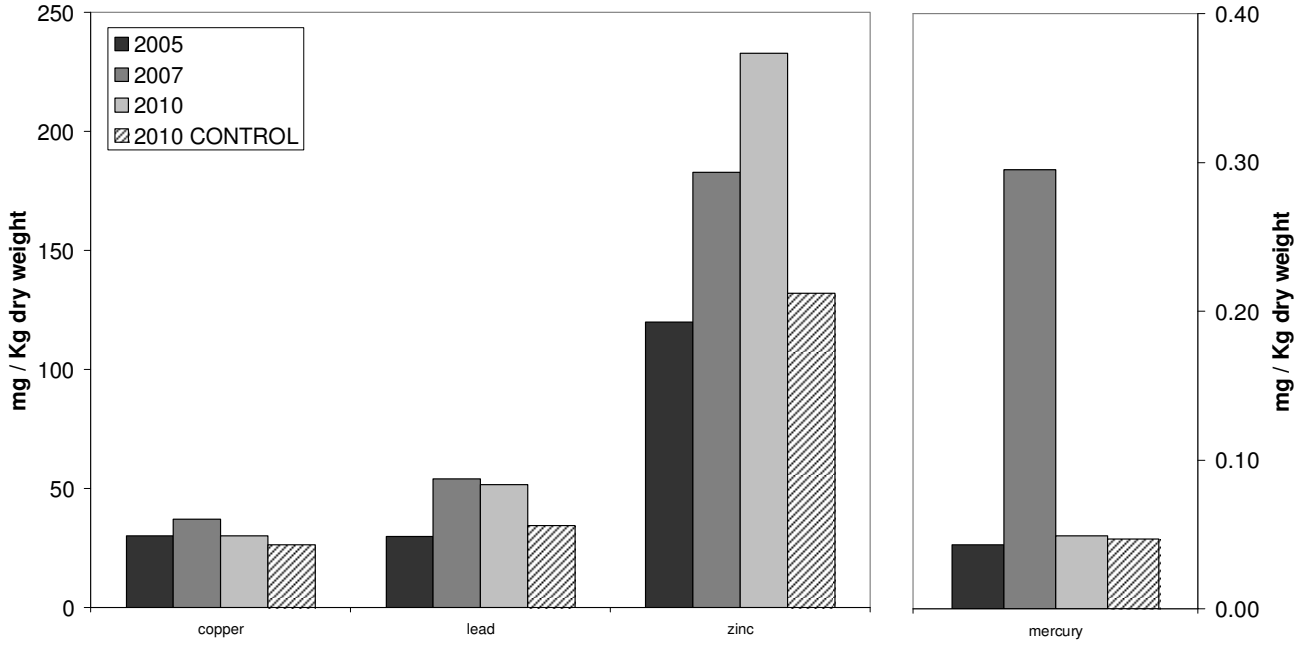
There are no strong trends for metals, but one facility with three samples, 12th & Montgomery, has shown increasing zinc levels in the surface sample (0 to 6 inches), which are also elevated over control samples from outside the stormwater facility. Results may also be impacted by the level and frequency of maintenance, with greater attention to sediment removal likely resulting in lower concentration levels. The 12th & Montgomery facility was routinely maintained, but sediment did slowly accumulate in the facility. That accumulating sediment may be the source for the increasing zinc levels in the surface sample, though other metals did not increase.

Surface Soil Metal Levels at SW 12th & Montgomery

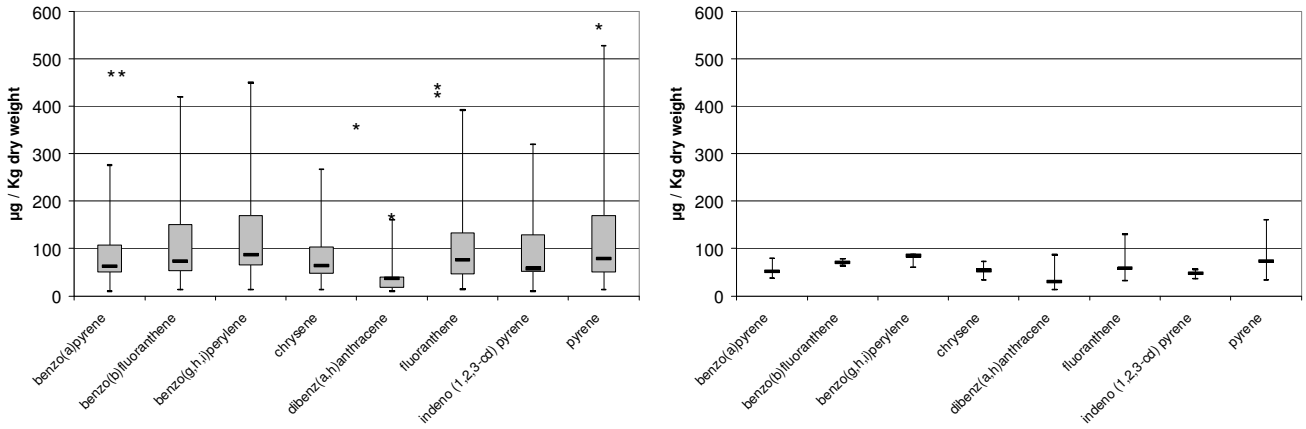
PAHs were found in all stormwater facilities, but typically at concentrations well below human health guidelines. More samples are needed to determine any potential trends in concentrations. There appears to be no strong correlation between PAH concentrations and surrounding land use or facility age.

Control samples were taken in 2010 outside the stormwater facilities for comparison. Control sample PAH levels were generally consistent with stormwater facility sample levels. This suggests that PAHs are prevalent in urban soils and not specifically associated with the soil in stormwater facilities. All PAH levels will be closely watched in the future to determine how levels are changing over time.

Comparison of Surface Soil PAH Content for Facilities (left) and Controls (right)

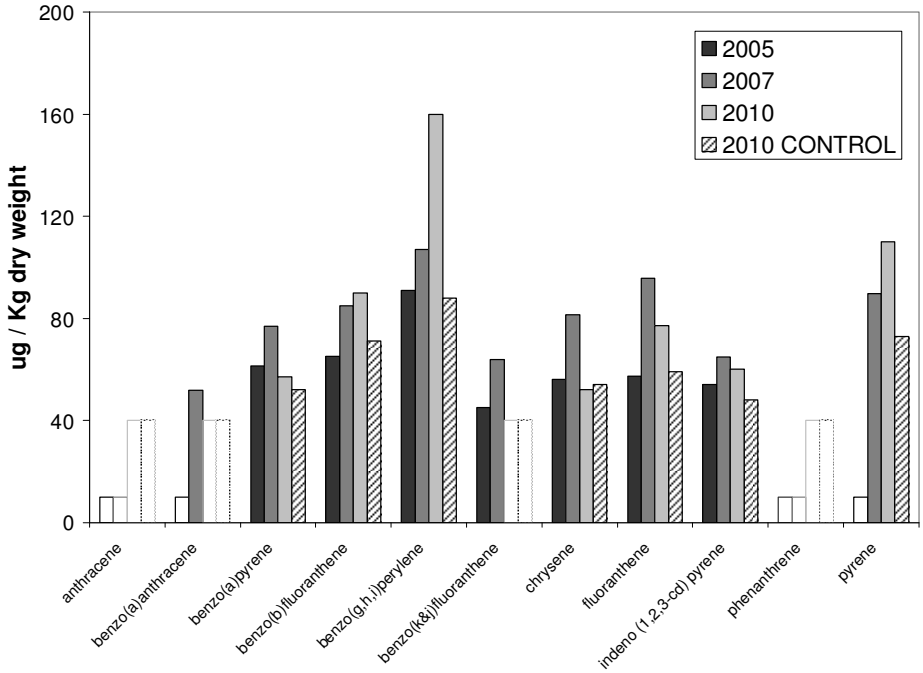
Surface Soil PAH Levels at SW 12th & Montgomery
