# Oregon Natural Resources Council

5825 N. Greeley Avenue, Portland

# **Project Summary**

<b>Project Type:</b>	Commercial stormwater retrofit – demonstration project
Technologies:	Porous paver system; landscape infiltration basin; simple downspout disconnections (to splash blocks).
Major Benefits:	<ul> <li>Runoff from more than 13,000 sq. ft. of impervious surface (roof and pavement) has been removed from the combined sewer.</li> <li>The stormwater facilities remove more than 300,000 gallons of runoff from the sewer in a typical rain year, with corresponding reductions in runoff pollutants.</li> <li>The project added 4,700 sq. ft. of native landscaping, improving the aesthetic appeal of the property and benefiting the urban environment.</li> </ul>
Cost:	\$82,946 (unit cost of \$6.00 per sq. ft. of impervious area managed). The total cost includes some components that were not essential to the stormwater management goals (e.g. a rain harvesting system and a bridge). Environmental Services provided a \$30,000 grant.

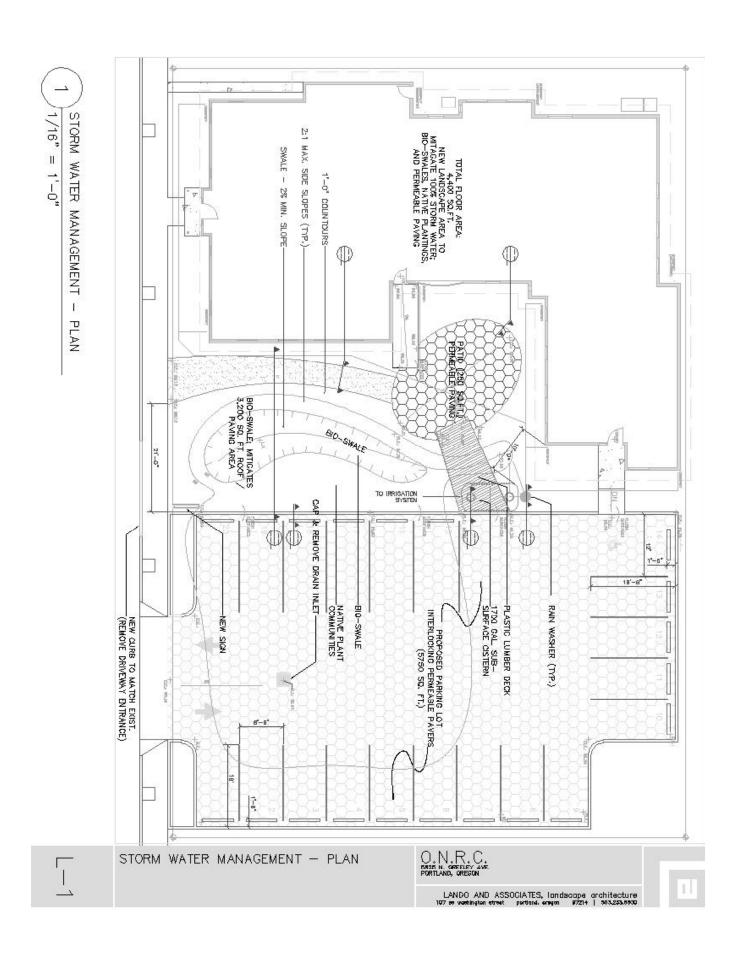
Newly planted infiltration basin after rain; January 2003

The City expressed initial concern about the lack of a piped emergency overflow for the landscape infiltration basin. ONRC then doubled the capacity of the basin and demonstrated that if it ever reaches capacity it will overflow to the pervious parking lot without threatening any structures. City inspectors confirmed that the paver system was installed consistent with the manufacturer's guidelines – the City did not have standards for paver systems at the time of the project.

<u>Good design</u> – The landscape infiltration basin is an integral part of the surrounding near the building's entrance. The project demonstrates that stormwater management features can be integrated into attractive landscape areas rather than being designed as "facilities" relegated to peripheral areas.
