# Portland Parks & Recreation (PP&R)

### Eastside Field Office

#### Project Summary

<b>Project Type:</b>	Commercial/residential stormwater retrofit - demonstration project
<b>Technologies:</b>	Landscape swales, landscape infiltration basin, vegetated filter, and downspout disconnections
<b>Major Benefits:</b>	<ul style="list-style-type: none"> <li>Runoff from 14,000 sq. ft. of impervious roof and parking lot surface has been removed from the combined sewer.</li> <li>The stormwater facilities remove more than 314,000 gallons of runoff from the sewer in a typical rain year, with corresponding reductions in runoff pollutants.</li> <li>More than 6,200 sq. ft. of native landscaping was added, improving the urban environment and the aesthetic appeal of the property.</li> </ul>
<b>Cost:</b>	\$55,183 (unit cost of \$ 3.94 per sq. ft. of impervious area managed). Environmental Services granted \$30,000 for the project through the Willamette Stormwater Control Program <sup>1</sup> .
<b>Constructed:</b>	Summer 2002

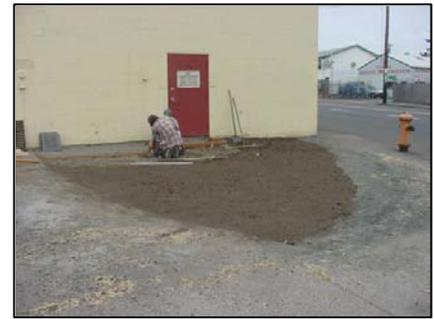
Prior to planting - landscape infiltration area on the NE corner of the property; 2002

- There are 4 shallow landscape depressions that capture and infiltrate runoff. They are typically 6 inches deep.
- The areas occupy a total of 1,500 sq. ft. of landscape.
- The three shallow landscape areas along the east side of the property together manage runoff from 750 sq. ft. of office roof and approximately 1,000 sq. ft. of adjacent asphalt.

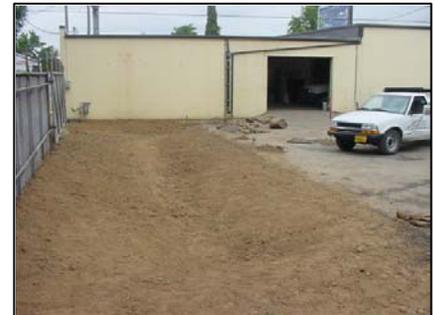
Graded landscape infiltration basin - west side of property; 2002

- The basin is 45 ft. long, 14 ft. wide, and 3 ft. deep.
- It is located behind the office along the west side of the property. A 5-ft. buffer separates the facility from the property line.

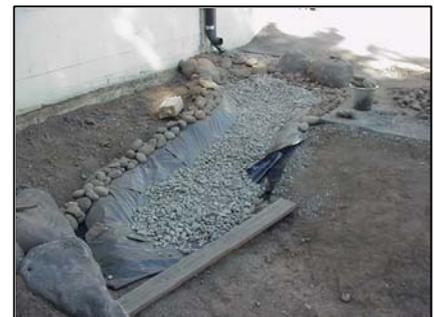
Construction of lined swale draining runoff from warehouse downspout to infiltration basin; 2002

- Fifty lineal ft. of ABS pipe (4 in. diameter) was installed along the ceiling of the warehouse. The new pipe collects runoff from the warehouse roof and conveys it to the south wall of the building.
- Runoff is piped through the south wall of the building and down the exterior, discharging to the landscape infiltration basin.

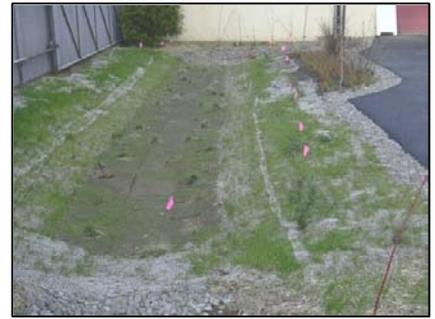
The landscape infiltration basin on the west side of the property just after planting; 2002

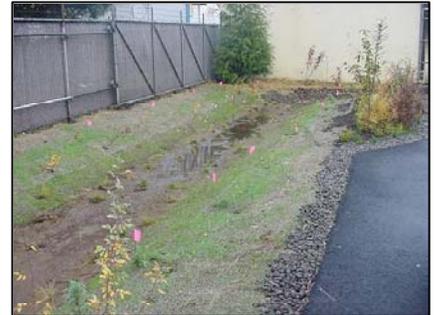
Another shot of the basin just after planting - note that the side of the basin next to the pavement was designed as a filter strip for pavement runoff

The east side of the main landscape infiltration basin was designed as an evenly-sloped filter strip with the purpose of filtering and slowing runoff (as sheet flow) from the parking lot. The area has not functioned as designed: runoff from the parking lot concentrates into a couple of flow paths rather than spreading throughout the strip.

Vegetated Filter Strip– The vegetated filter strip along the edge of the parking lot (west side of property) was designed to slow and filter sheet-flow entering the landscape infiltration basin from the adjacent parking lot. In practice the runoff concentrates into one or two flow paths; the result illustrates the challenges associated with achieving the grades required for filter strips in similar situations.

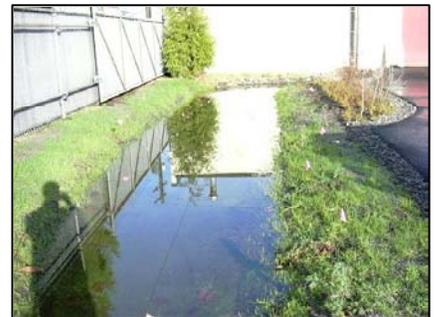
The basin after rain; 2003

In 2004 the PP&R staff observed that the landscape facilities are less frequently ponded with runoff – monitoring is needed to confirm if infiltration rates have improved.

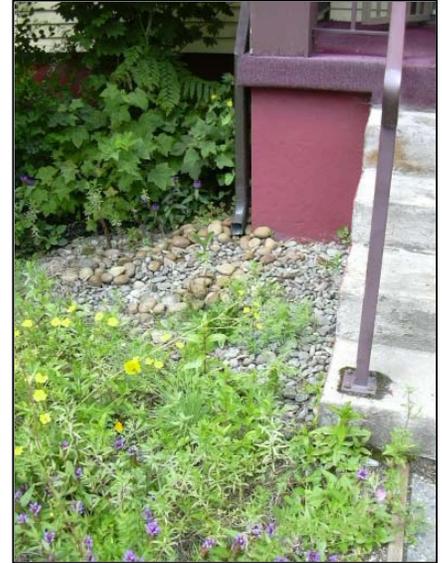
Disconnected downspout on the front of the office building; spring 2004

- Three simple downspout disconnections drain 1,500 sq. ft. of office roof.
- Simple residential-type drain rock helps convey roof runoff to 3 shallow landscape infiltration areas, one behind the office and 2 in front.

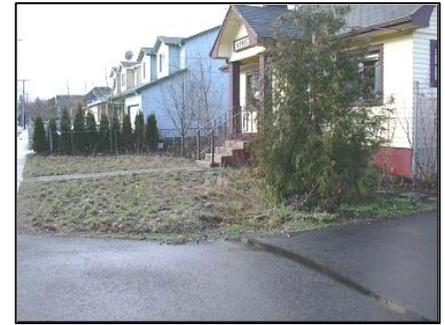
Recently planted landscape infiltration area in front of the office building - note flow path on asphalt driveway.
