Portland Bureau of Transportation

Split Speed Bump Report

January 1998

Kathy Mulder, PE, City of Portland, Oregon, Traffic Calming Program

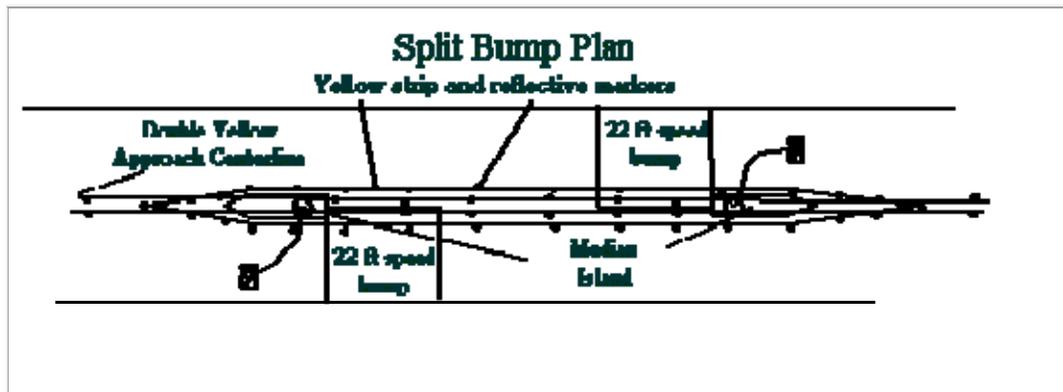
The device was placed approximately 200 feet west of the all-way stop. The first part of the testing was for safety. Concerns of whether automobile drivers would violate the device and chicane between the bumps were raised. Twenty-four hour time lapse video equipment was placed to record driving patterns over the bump.

The 24 hour time-lapse video showed that drivers did not swerve into the oncoming lane to avoid the speed bump half in their lane. The temporary concrete medians and signs placed in advance of each bump half seemed to keep drivers in their own lane and over the speed bump. Dense centerline striping and raised reflective pavement markings gave an illusion that a median continued the entire distance between the bump halves. Subsequent 24 hour time-lapse video showed no indication of confusion on the part of the drivers, nor any violations of drivers trying to avoid the device at any time.

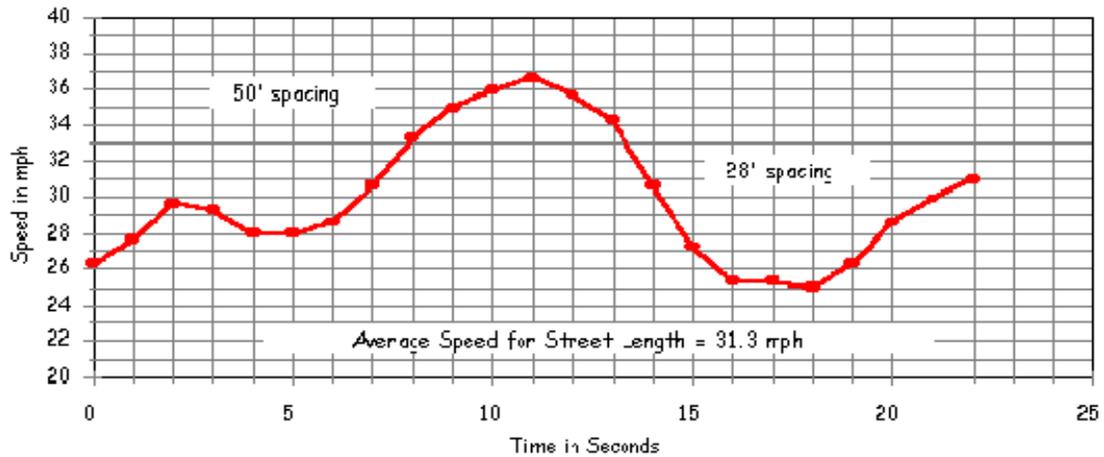
Engine 41 Eastbound - Average

SE Market Speed Bump Test

Emergency vehicles ran timed tests through both of the new split bumps to determine the time lost by each vehicle. A truck and an engine were supplied for the test. These are the vehicles that had the greatest delay per device during the original testing of the other traffic calming devices.

Both vehicles were able to travel the length of the street at speeds between 29 and 31 mph. The vehicle speeds through the 50 foot off-set spacing were 26 mph to 30 mph. Between the 28 foot off-set spacing, speeds were 20 mph to 26 mph. It was found that the actual time lost was no more than 1 to 2 seconds for the largest of the vehicles.

In reviewing the data for the test, it was noted that the slowest speeds, and therefore the most time lost, were at the off-set speed bump with the 28' spacing. The speed for the off-set speed bump with the 50' spacing never went below 25 mph.

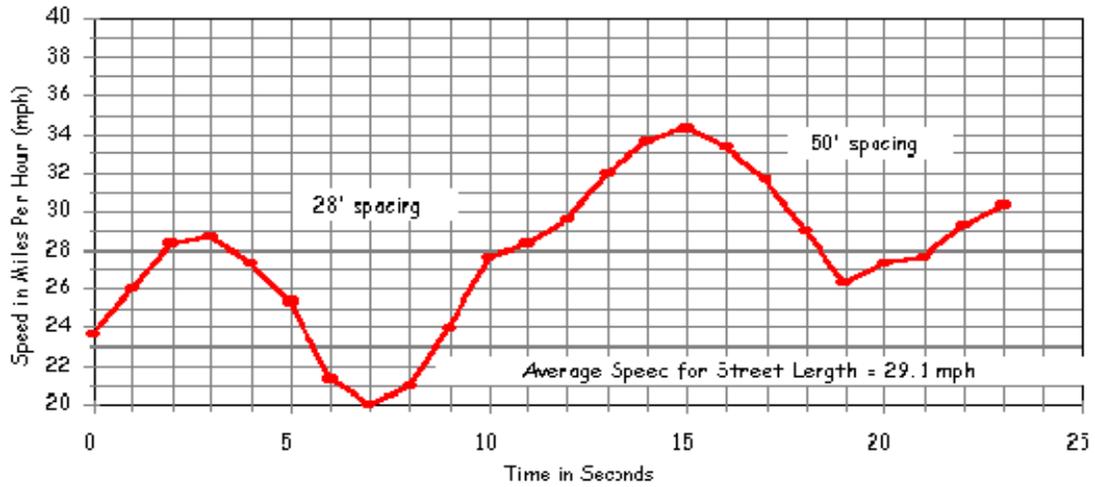
Engine 41 Westbound - Average

SE Market Speed Bump Test

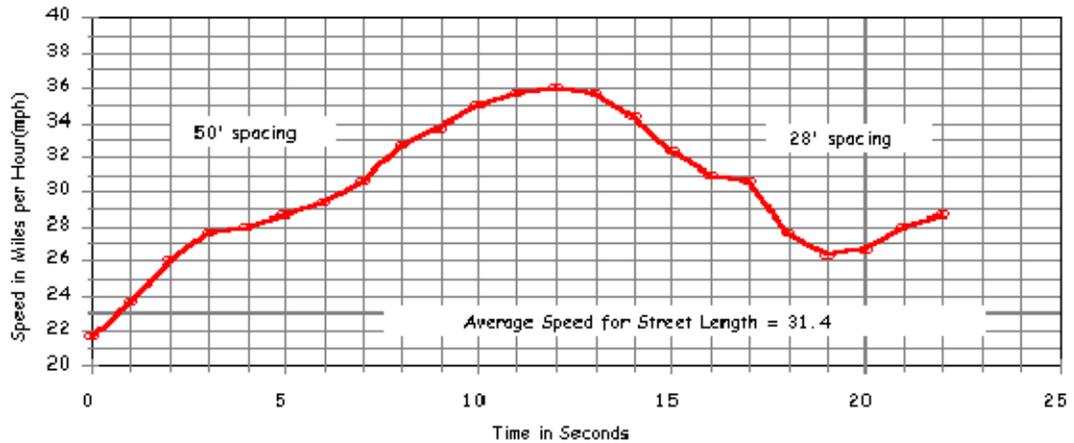
Truck 41 Eastbound - Average

SE Market Speed Bump Test
