Re: Infiltration test at 1037-1041 SE 111<sup>th</sup> Avenue, Portland, OR

**Field Investigation:**

**Infiltration Testing:**

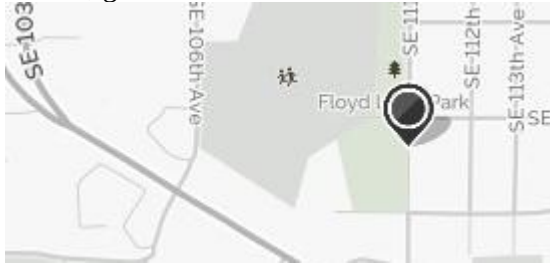
Rapid Soil Solutions (RSS) has performed one (4) infiltration test for future storm water and partition approval. Figure 1 below shows the project site location. Soils found on site match those in by DOGMI. RSS course grained flood deposits of sands, gravels and rounded cobbles.
