# Killingsworth Station

1455 NE Killingsworth  
Portland Oregon

## Project Objective

## Project Description

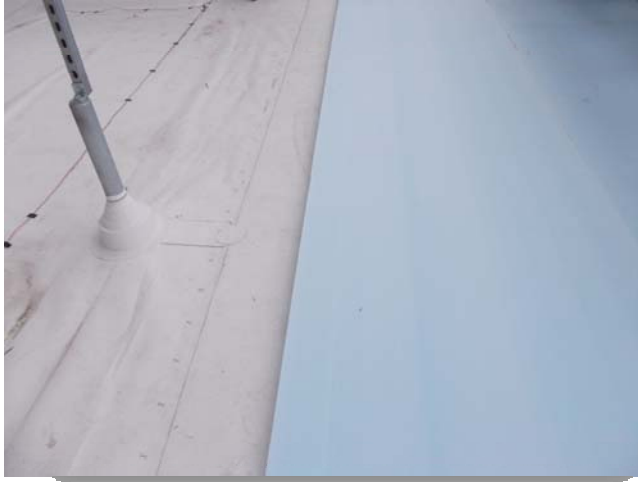
TPO membranes are single-ply roof membranes constructed from ethylene propylene rubber. They are designed to combine the durability of EPDM rubber with the proven performance of hot-air weldable

seams. They have been tested as having excellent resistance to ozone, are algae-resistant, environmentally friendly and safe to install. The material's manufacturers are so confident in properly welded seams that the material is sometimes advertised as a monolithic (seamless) roof. Seam strengths are reportedly 3 to 4 times those of EPDM's adhesive and tape seams.

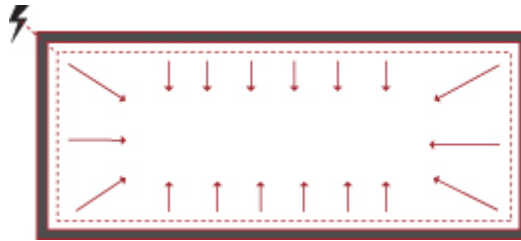
A. Small electrical pulses are directed onto the membrane. The electricity is searching for a ground connection.

An electric field is created by applying water on the membrane surface and using the water as a conductive medium. A breach in the membrane creates a vector (ground fault connection), which can then be measured by a certified ILD® technician.

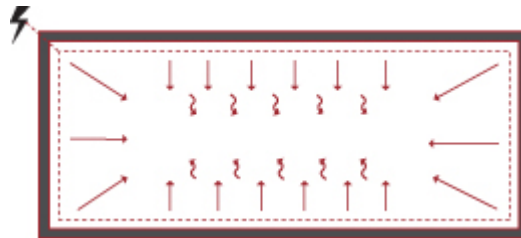
B. If the membrane is watertight, the electricity is isolated and does not find a ground connection.

The EFVM® technician reads the electric flow traveling across the membrane, mapping the “vectors” with pin point accuracy.

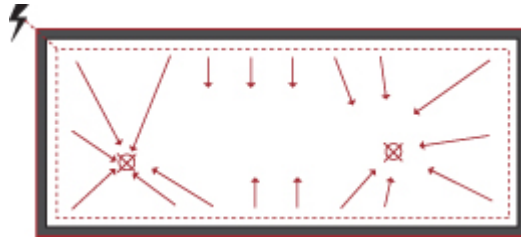
C. If the membrane is not watertight, the electricity makes a ground connection and is pulled toward positive poles.

Once EFVM® testing is complete; customers receive CAD drawings, picture documentation and a written report detailing the location and nature of all breaches and defects.

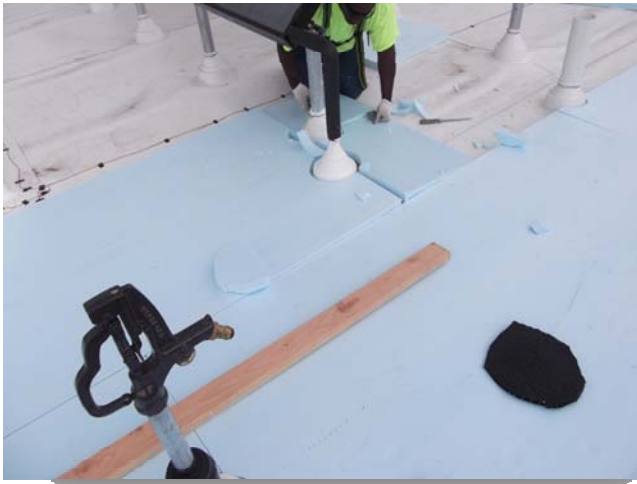
- *Dow Styrofoam*
- <http://building.dow.com/na/en/products/insulation/deckmate.htm>

2" of Dow Styrofoam Brand Square Edge Insulation with an insulate value of approximately R-5 per inch and a compressive strength of 25 psi.

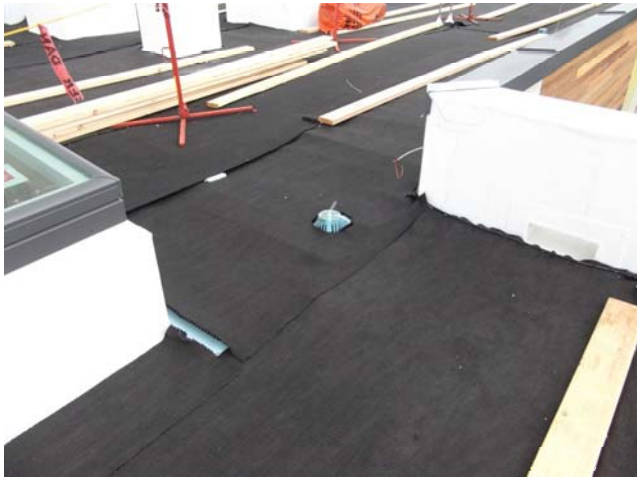
- *Carlisle Miradrain 9800*
- <http://www.carlisle-ccw.com>

CCW MiraDRAIN 9800 is a high-performance, high-strength drainage composite consisting of a three-dimensional, high-impact polystyrene core, and a superior, heavy weight nonwoven filter fabric. The filter fabric is bonded to the individual dimples of the molded polystyrene core to minimize fabric

intrusion into the flow channels caused by backfill pressure. The fabric provides unmatched filtration, preventing small particles of soil from clogging the drainage channel while allowing subgrade moisture to pass freely.

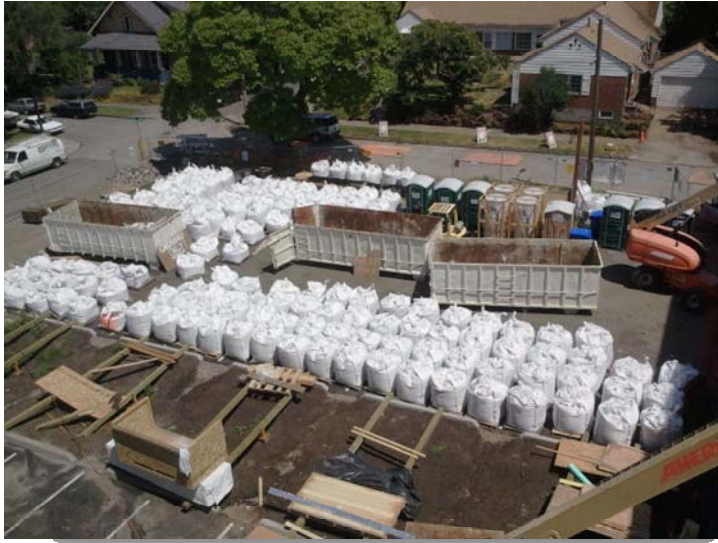
*Pro-Gro Max Lite Extensive*

- **4" ProGro Extensive**
- <http://pro-gromixes.com>

<b>Tested Weight Volume %</b>	<b>Weight per cubic foot</b>	<b>Water Retention weight <u>per cubic foot</u></b>	<b>Water Retention,</b>
Dry Weight (dry)	9.0 pounds per cubic foot.	0.0 pounds (dry)	0.0 %
Field Moisture Capacity (FMC)	39.0 pounds per cubic foot.	30.0 pounds	47.6%
Saturated Bulk Density (SBD)	50.7 pounds per cubic foot.	41.7 pounds	68%

Conclusion – At Field Moisture Capacity, 4 inches of media will hold 10 pounds of water or 1.2 gallons.  
At Saturated Bulk Density, 4 inches of media will hold 13.9 pounds of water or 1.7 gallons.

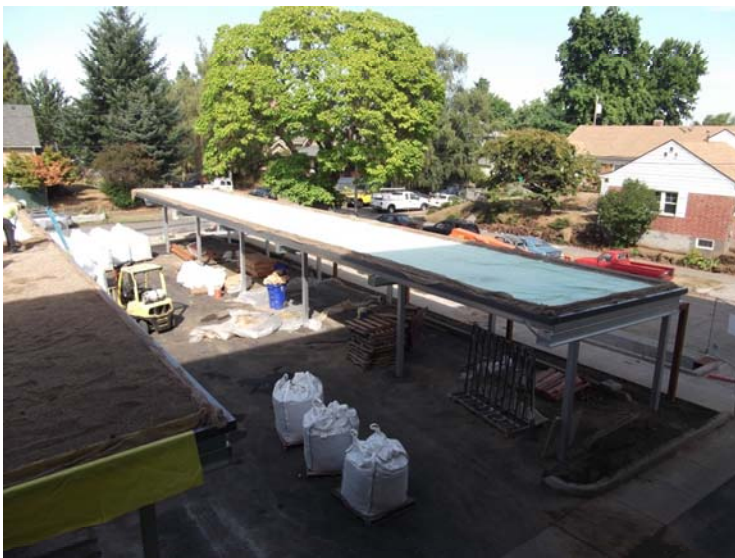
- The pre-manufactured carport metal roof panels were not of heavy enough gauge to allow for the installation of the

installation of the roof. The corrugated metal panels could not support a person walking directly on the panels without deflection, and water leaking through the metal panel joints onto park cars was a concern. To resolve the concern a cementitious Durarock tile backing board was installed with a

vapor barrier, over the vapor barrier a moisture retention blanket was installed under the 4 inch soil section.
