Holman Pocket Park and Green Street Bike Boulevard Project

NE Holman St. at NE 13th Ave.

Project Summary	
Project Type	Neighborhood Bikeway with green streets and stormwater retrofit in adjacent public park
Technology	Infiltration planter, infiltration basin, landscape filter strip, green streets, ecoroof, street trees
Benefits	<ul style="list-style-type: none"> -The 6 facilities (excluding the ecoroof), totaling 1,113 ft², manage runoff from 16,100 ft² of concrete and asphalt. -Most of the flow captured infiltrates, treating for water quality before going to a sump. -The re-design decreased the impervious surface in the area. -Neighborhood destination, meeting space and public education
Notable Features	<ul style="list-style-type: none"> -Seat walls were added to allow for better community gathering opportunities. -The underlying soils have an infiltration rate of 18" per hour. -Multiple types of stormwater management facilities -Holman Street adjacent to the park was closed to car traffic, allowing for the narrowing of travel lanes, creating more pervious landscape area.

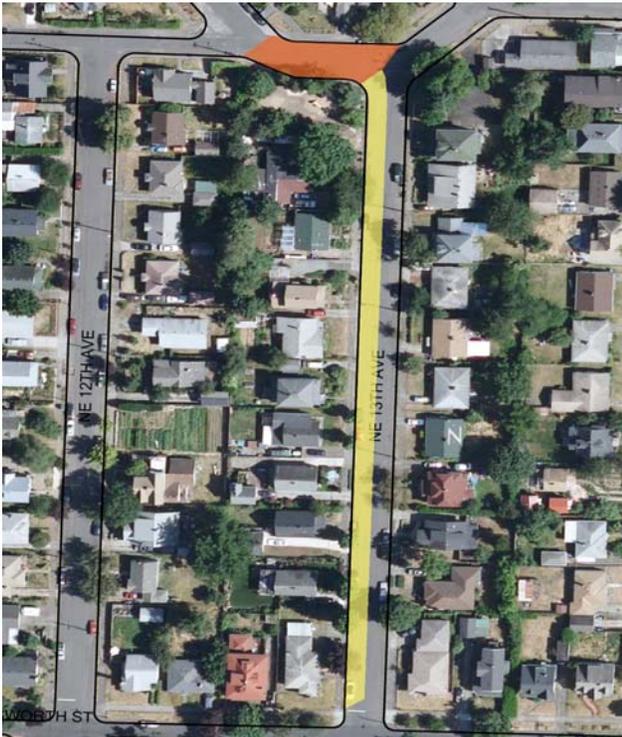
Holman ROW stormwater facility catchment areas extend from NE Holman St. in the north to NE Ainsworth St. in the south. The yellow catchment area is managed by green street facilities in the ROW adjacent to the park, while the orange catchment area is managed by landscape facilities in the ROW to the north.

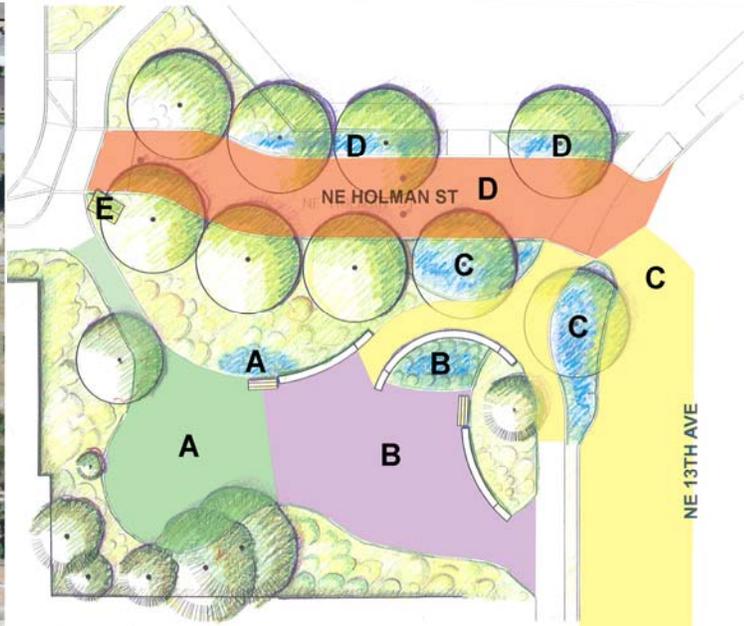
Plan shows both Holman Park and Holman ROW stormwater management facilities. There are 4 major catchment areas, shown in different colors. Each catchment is labeled A-D to correspond with the facility type into which it flows. The facility types are as follows: A) infiltration basin, B) infiltration planter, C) green streets, D) landscape filter strips, E) ecoroof. The ecoroof accepts rain that falls on it.

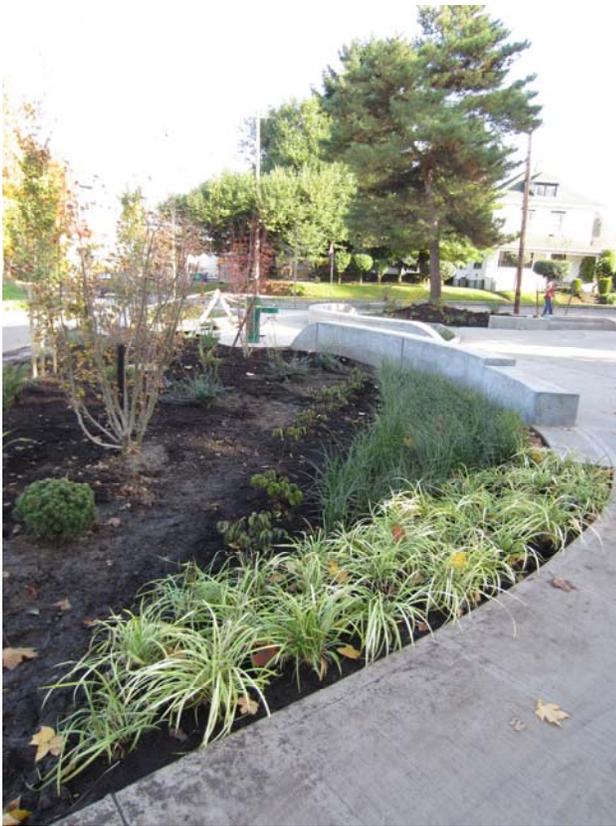
The infiltration basin accepts runoff from the plaza inside Holman Park. It has a 3:1 slope on all sides and a ponding depth of 6". In an overflow situation, water spills into the landscape area north of the facility.

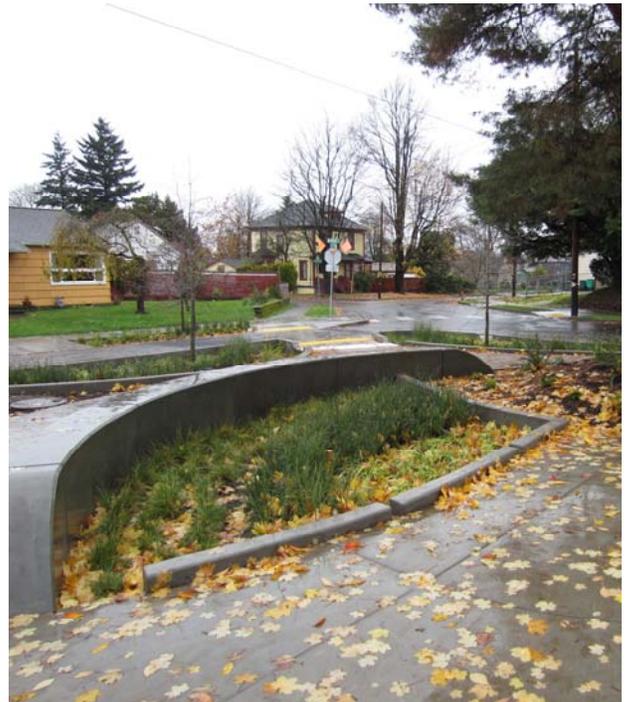
The infiltration planter also accepts runoff from the plaza inside Holman Park. It has a flat bottom and a ponding depth of 6". The site has extremely high infiltration rates. An emergency overflow pipe was installed, but has been left capped.

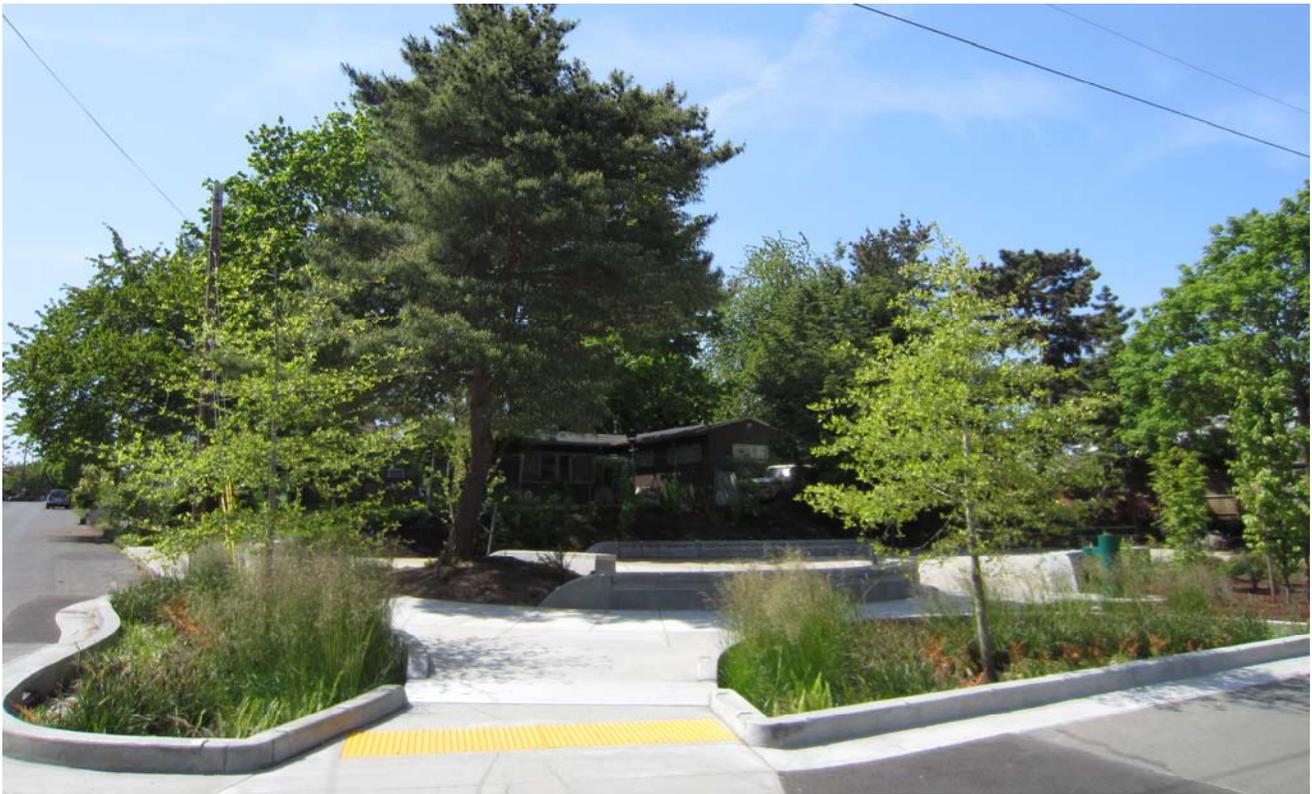
Two green streets in the ROW adjacent to the park accept runoff from the street. They are flat bottom infiltration facilities with a ponding depth of 6". Water enters the first facility (left), ponds to 6", then enters the second facility (right) by way of a trench grate. An emergency overflow beehive inlet in the second facility directs water to a sedimentation manhole and sump.

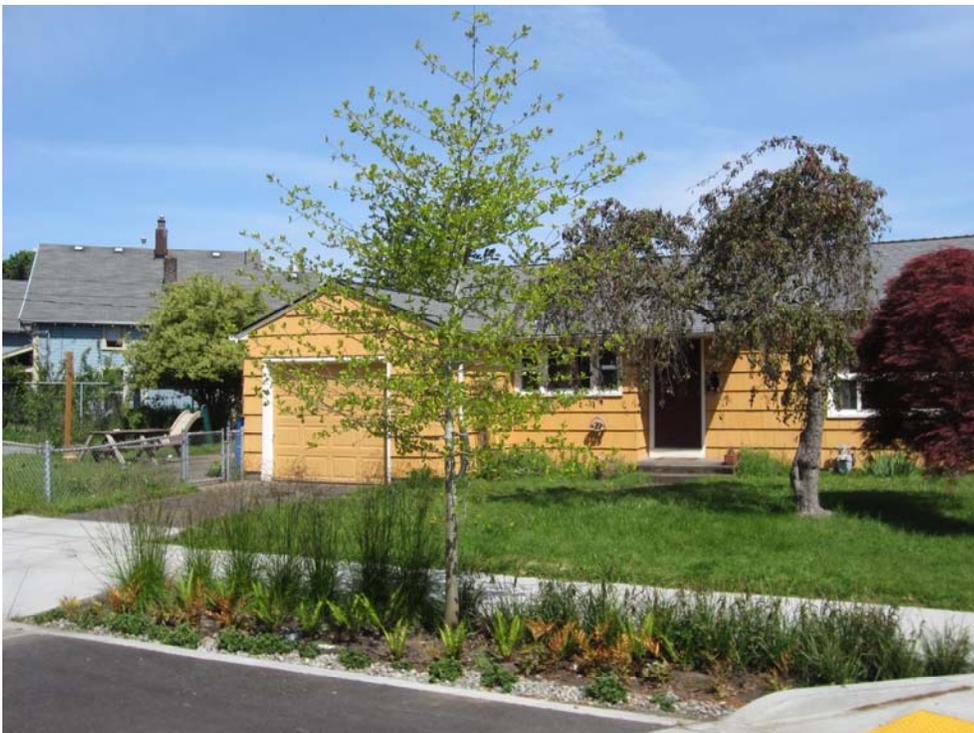
Two filter strips were constructed in the ROW north of the park. They are flat bottom infiltration facilities with a 3" ponding depth. Water enters from the street over the flush curb. The emergency overflow runs back into the street and to a catch basin east of the site where the water previously drained.

The landscape filter strips were filled with too much soil in anticipation of settling. The soil did not settle, and the ponding volume was greatly reduced. To regain volume, some soil was removed and a layer of river rock was added to the finished surface of the soil in certain areas.

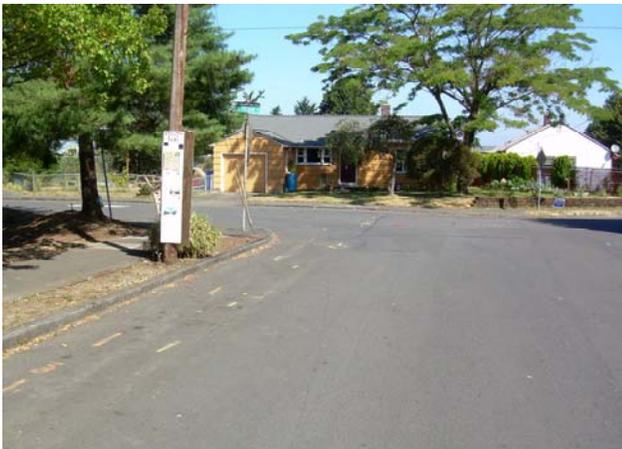
NE corner of the park before construction

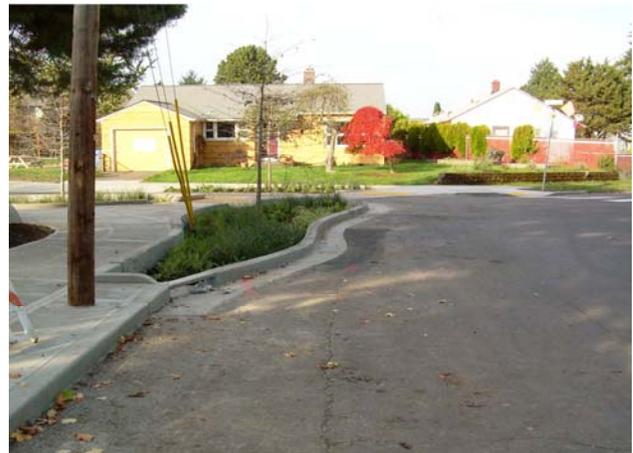
NE corner of the park after construction

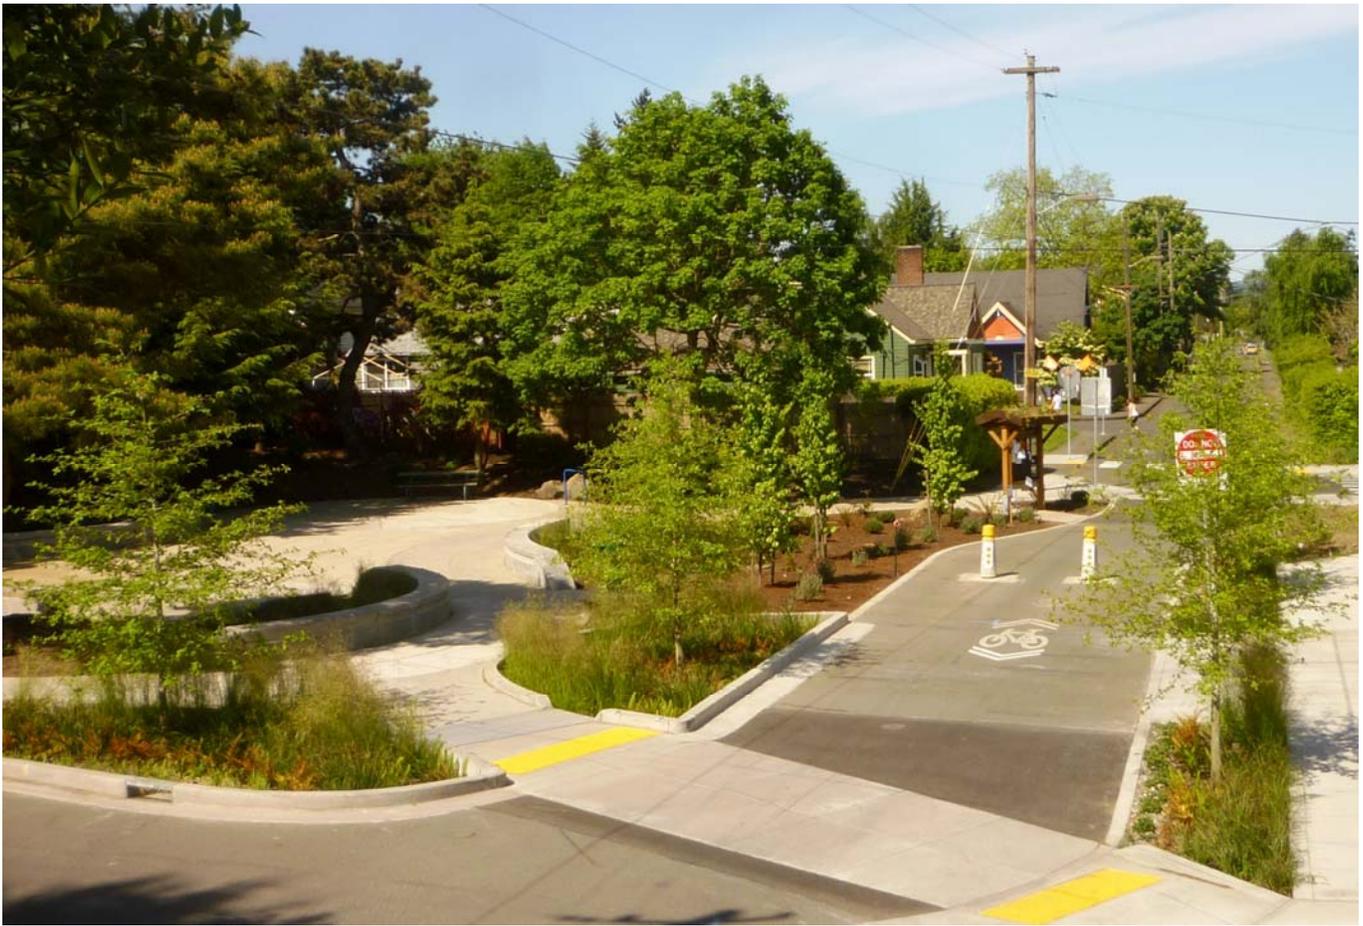
Overview of park and ROW work looking west after construction

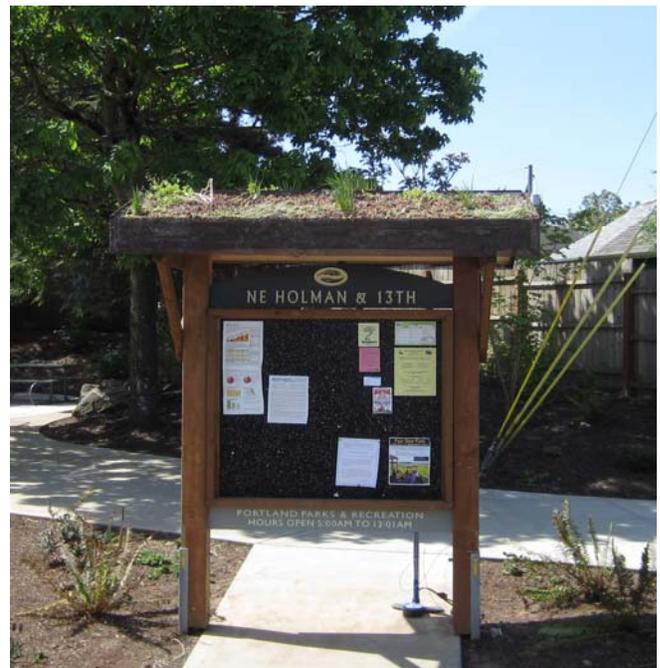
A kiosk for neighborhood news was added. Community members added an ecoroof to the structure in May 2012.
