Page 19 L.L.C.

(Previously the United Salad Co. Garage)
939 SE Alder St.

Project Summary

Overview of the Stormwater System

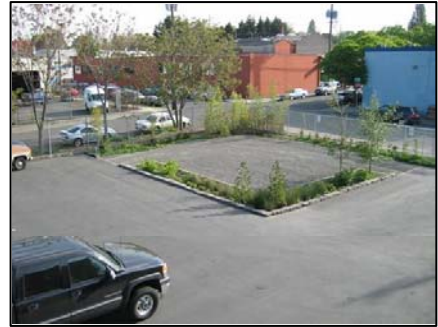
Overview of the retrofitted parking lot

The existing 10,000 sq. ft. asphalt parking lot was replaced with a smaller, re-graded asphalt parking lot, a gravel courtyard, a landscape infiltration basin, and perimeter landscape areas.

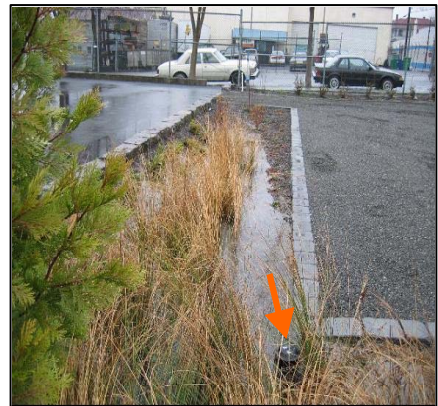
L-shaped infiltration basin with emergency overflow (see arrow) and gravel courtyard

- The L-shaped infiltration basin has a total length of 60 ft.. It is 11 ft. wide and it has 2:1 side slopes. Although it is 6 in. deep (ponding depth) at the standpipe, the average depth is just 3 in. – the basin is very shallow at its ends.
- Evenly-spaced curbstones border the basin along the edge of the parking lot. In addition to serving as attractive tire stops, the spaces between the stones allow runoff to enter the basin.
- During large storm events runoff ponds on adjacent asphalt areas prior to overflowing via the standpipe.

The overflow inlet (standpipe) is approximately 6 in. above the basin floor. The standpipe is located at the elbow of the L-shaped landscape basin. The standpipe is a modification to the old parking lot catch basin, which was removed and re-plumbed to the location of the standpipe.

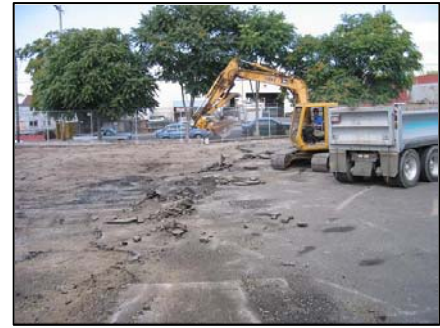
Removal of parking lot asphalt during project construction, summer 2002

The new 7,000 sq. ft. parking lot slopes toward the landscape infiltration basin. The job required much more than simply re-grading the surface with additional layers of asphalt; the asphalt contractor recommended complete removal of the old asphalt surface, including the gravel sub-grade, in order to ensure the integrity of the new asphalt surface. About two-thirds of the surface was excavated to an average depth of one foot; in some areas excavation was as deep as 3 ft. below grade.

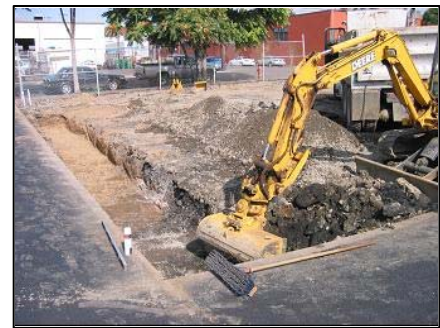
L-shaped basin under construction, 2002

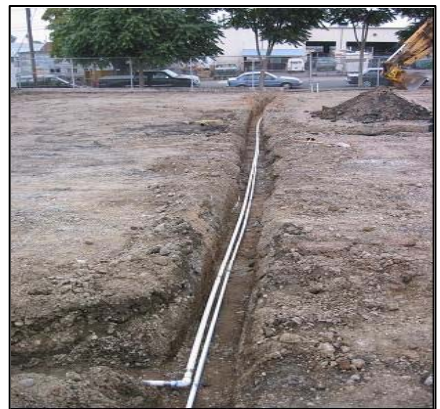
New subsurface irrigation pipe for hose bib, looking north.

Four temporary soaker hoses were installed to irrigate the new plantings during the 2-year establishment period. A new hose bib at the north end of the landscape infiltration basin supplies the hoses. Water service for the bib required a new water line from the building. The pipe work included the installation of a backflow prevention device.

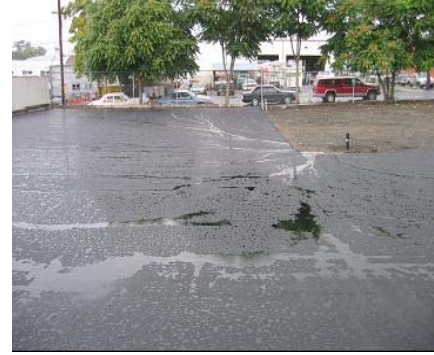
Repaved asphalt parking lot, graded to drain into infiltration basin; 2002

The new asphalt layer is 3 in. thick, on average, to accommodate commercial trucks.

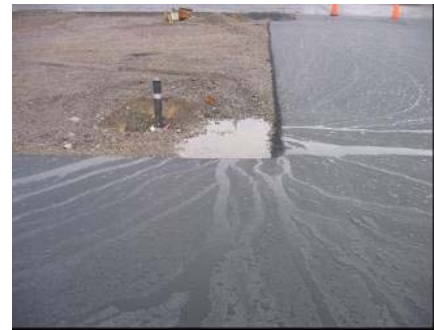
Flow paths draining to the location of the landscape infiltration basin (yet to be built); 2002

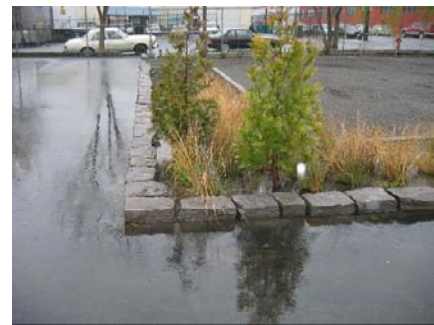
Landscape infiltration basin in a rain event; 2003

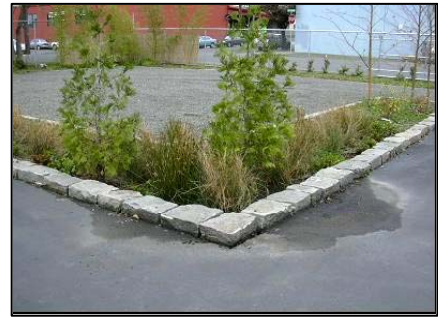
Landscape infiltration basin after a storm, 2003. Note damp pavement where runoff recently ponded on asphalt surface.

Stormwater Capacity - The internal volume of the landscape infiltration basin is smaller than typical for its size (footprint) – it has an average depth of just 3 inches. However, additional capacity is provided by the parking lot surface: runoff fills the landscape infiltration basin and then temporarily ponds in the parking area before overflowing to the sewer system.
