Page 19 L.L.C.

(Previously the United Salad Co. Garage)
939 SE Alder St.

Project Summary

Overview of the Stormwater System

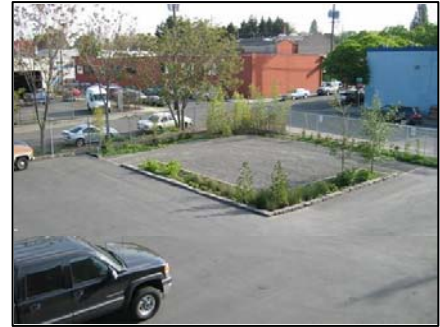
Overview of the retrofitted parking lot

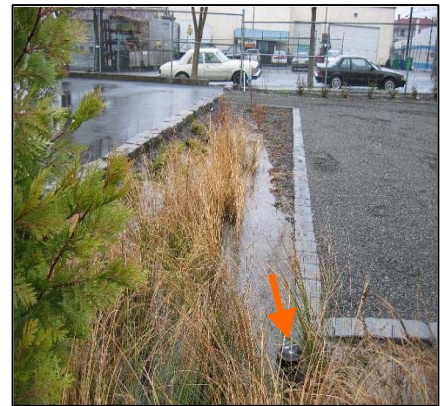
L-shaped infiltration basin with emergency overflow (see arrow) and gravel courtyard

- The L-shaped infiltration basin has a total length of 60 ft.. It is 11 ft. wide and it has 2:1 side slopes. Although it is 6 in. deep (ponding depth) at the standpipe, the average depth is just 3 in. – the basin is very shallow at its ends.
- Evenly-spaced curbstones border the basin along the edge of the parking lot. In addition to serving as attractive tire stops, the spaces between the stones allow runoff to enter the basin.
- During large storm events runoff ponds on adjacent asphalt areas prior to overflowing via the standpipe.

The overflow inlet (standpipe) is approximately 6 in. above the basin floor. The standpipe is located at the elbow of the L-shaped landscape basin. The standpipe is a modification to the old parking lot catch basin, which was removed and re-plumbed to the location of the standpipe.

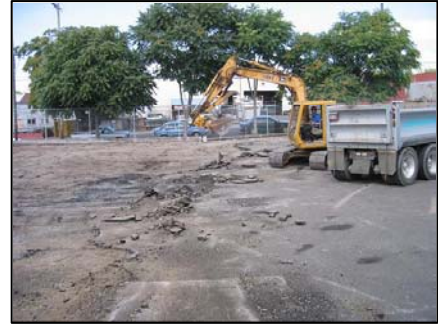
Removal of parking lot asphalt during project construction, summer 2002

The new 7,000 sq. ft. parking lot slopes toward the landscape infiltration basin. The job required much more than simply re-grading the surface with additional layers of asphalt; the asphalt contractor recommended complete removal of the old asphalt surface, including the gravel sub-grade, in order to ensure the integrity of the new asphalt surface. About two-thirds of the surface was excavated to an average depth of one foot; in some areas excavation was as deep as 3 ft. below grade.

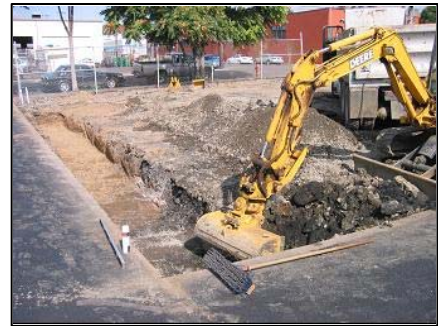
L-shaped basin under construction, 2002

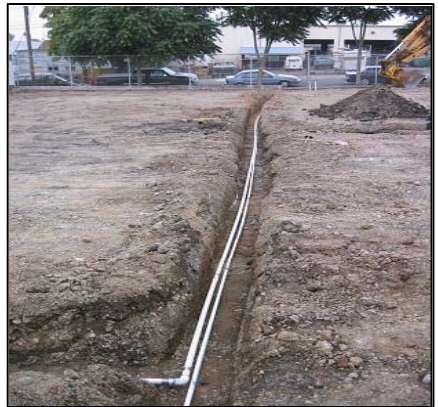
New subsurface irrigation pipe for hose bib, looking north.

Four temporary soaker hoses were installed to irrigate the new plantings during the 2-year establishment period. A new hose bib at the north end of the landscape infiltration basin supplies the hoses. Water service for the bib required a new water line from the building. The pipe work included the installation of a backflow prevention device.

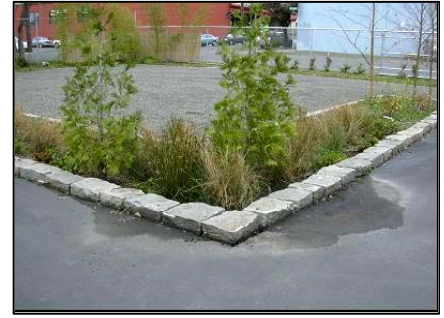
Landscape infiltration basin after a storm, 2003. Note damp pavement where runoff recently ponded on asphalt surface.

Stormwater Capacity - The internal volume of the landscape infiltration basin is smaller than typical for its size (footprint) – it has an average depth of just 3 inches. However, additional capacity is provided by the parking lot surface: runoff fills the landscape infiltration basin and then temporarily ponds in the parking area before overflowing to the sewer system.
