Mississippi Commons
3721-3727 N Mississippi Avenue
Portland, Oregon

PROJECT SUMMARY

Overview of the Stormwater System

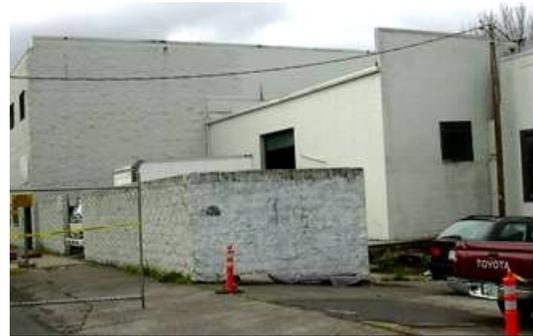
Mississippi Commons Before

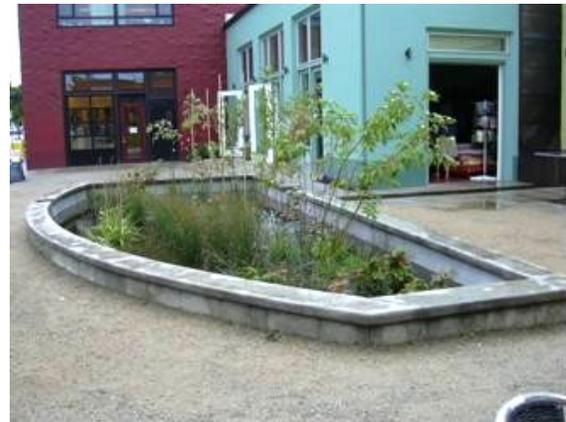
Mississippi Commons After, with Stormwater Infiltration Planter

- The Mississippi Commons redevelopment project converted a collection of buildings from light industry to mixed-use artist space, offices, and retail. Part of the project involved providing complete onsite stormwater management.
- Two downspouts were disconnected from the roof and directed to a two-level, steel-lined basin. The basin empties into a grate-covered trench in the ground, which in turn flows into an infiltration planter. Vegetation, soil, and material in the planter slow and filter the stormwater before it soaks into the ground.
- The infiltration planter is designed as an architectural feature for the building’s public courtyard.
- A third downspout is piped under the concrete and bubbles into the planter by way of a pipe.

- During large storm events, overflow enters a stand pipe within the planter and is directed underground to a drywell on the property. Overflow also spills onto an adjacent pervious gravel courtyard through an opening in the planter wall.

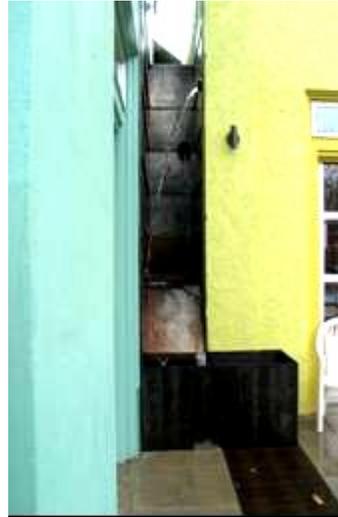
Downspouts disconnected to collection basin and conveyed along a trench to the planter

Creative approach: The steel stormwater basin and conveyance system are a creative and innovative approach to capture and convey runoff from the building roofs.

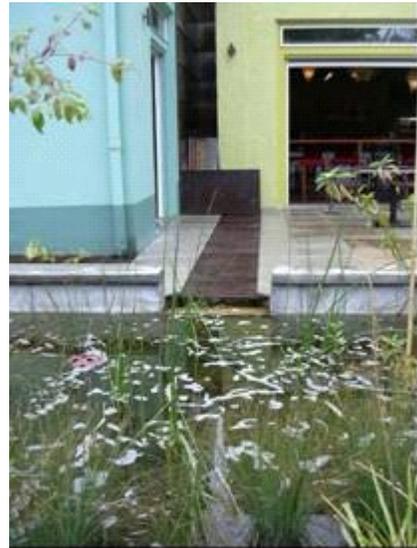
Roof runoff conveyed to the newly vegetated planter

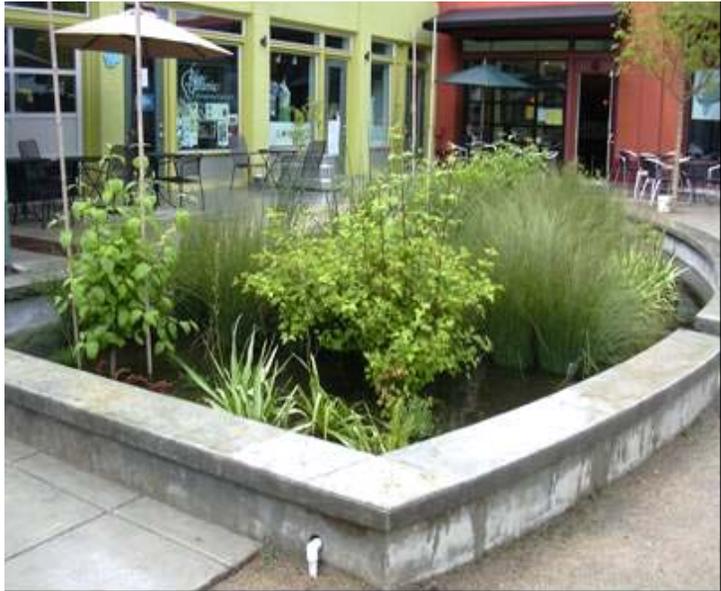
Stormwater Infiltration Planter, looking north

Infiltration planter: The infiltration planter has a 12-inch sub-base of washed $\frac{3}{4}$ -inch gravel, which is separated from approximately 24 inches of soil by a layer of filter fabric.

Landscaping: The largely native vegetation in the infiltration planter includes *Juncus patens*, Grooved rush; *Cornus stolonifera*, Red twig dogwood; *Viburnum trilobum*, American cranberry bush; *Camassia leichtlinii*, Camas lily; *Sisyrinchium*, Yellow-eyed grass, *Scirpus acutus*, hardstem bulrush, and *Carex rupestris*, Curly sedge.

Plant survival: Since this was an early demonstration project, it was not known how some plants would behave in periodic standing water. All species appear to have survived except *Polystichum munitum*, sword fern; and *Fragaria chiloensis* strawberry; the *Mahonia aquilifolium*, Oregon grape, is surviving but is not growing with vigor. Continued visual assessments will determine the long term viability of the existing plants.
