Martin Residence

Project Address: 903 NE Rosa Parks Way

Project Type: Shed and Chicken Coop Roof

Ecoroof Size: 220 SF (Combined)

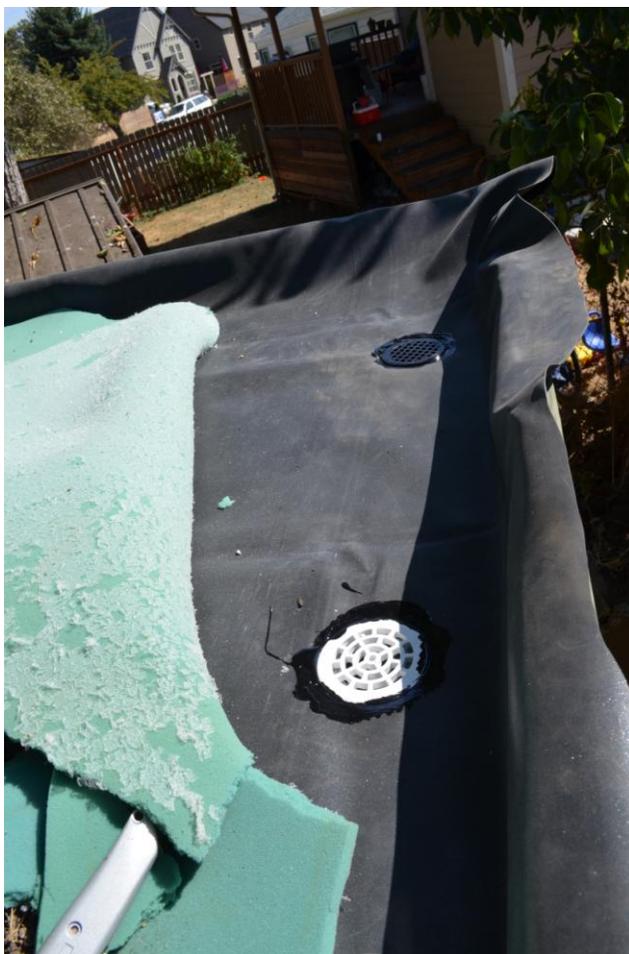
Chicken Coop Drainage

The roof of the chicken coop slopes toward the front where (4) 3" floor drains are located. These drain to a gutter.

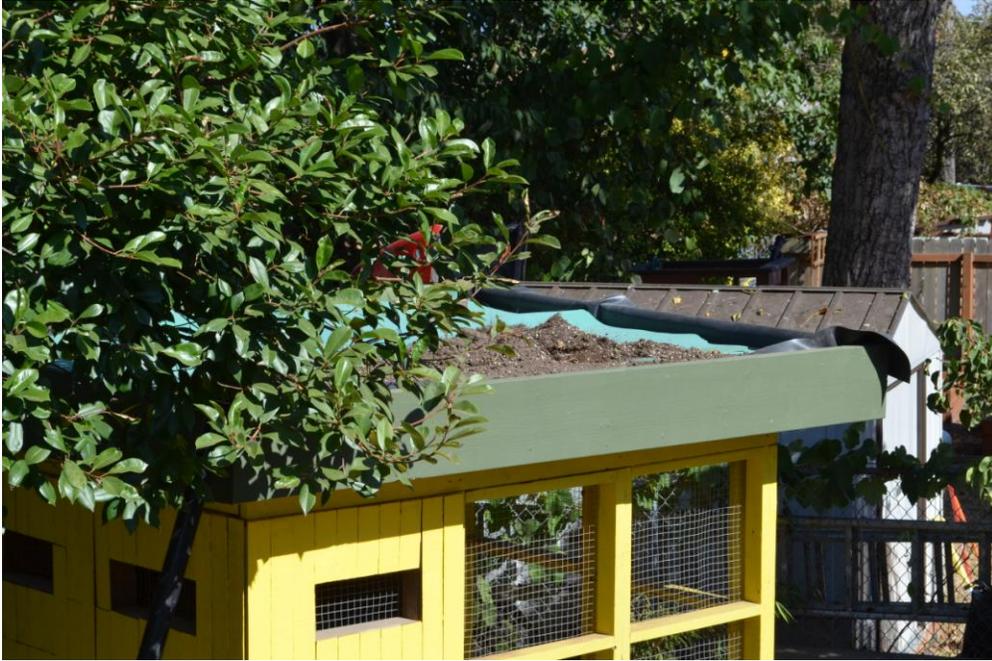
Chicken Coop with waterproofing carpet padding and soil

Roof Description: Both roofs have a similar profile. Plywood sheeting is nailed to the rafters. Because the shed was build a year prior, it had a full asphalt shingle roof. On top of this, filter fabric was placed to protect the waterproofing. Next was a pond liner which serves as waterproofing and root barrier. Above the pond liner, carpet padding adds extra protection. Finally 5-8 inches of soil were placed. The chicken coop roof was the exact same except that it did not have the asphalt shingles to begin with. Tar paper was placed directly on top of the plywood sheeting as a vapor barrier and as a protection for the 40 mil pond liner abover it.

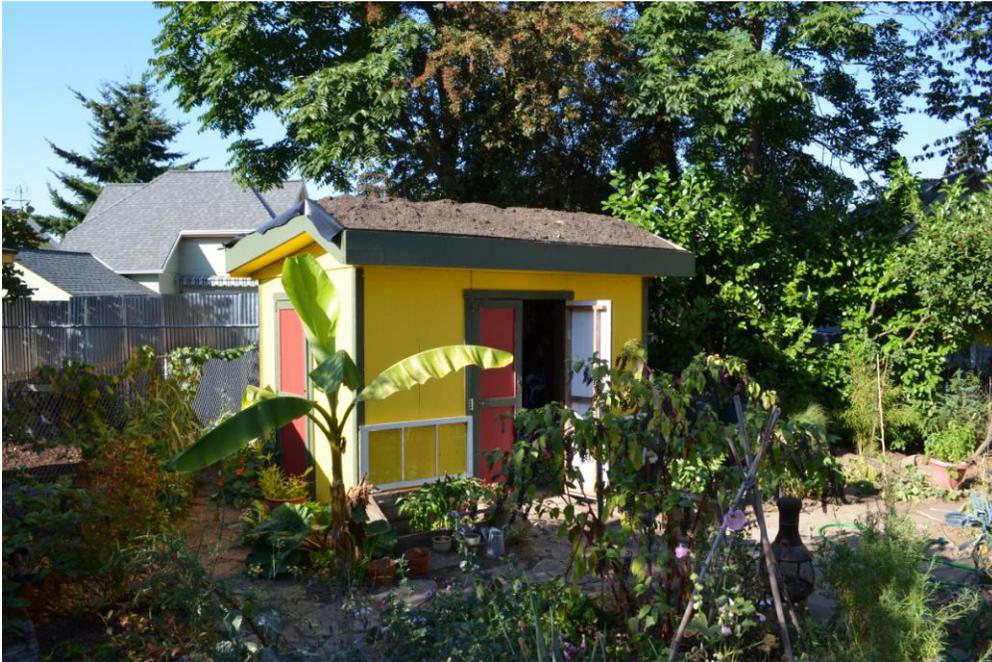
Shed with Soil

2x12 douglas fir edging holds the soil in place. In the front of the shed, slits were cut in the waterproofing at the base of the roof. This allows water to drain down between the roof sheeting and the 2x12. It is captured into a 2" channel and conveyed laterally. At the back of the shed, four notches were cut into the support board to allow water to flow into the gutter. Filter fabric holds the soil in place.

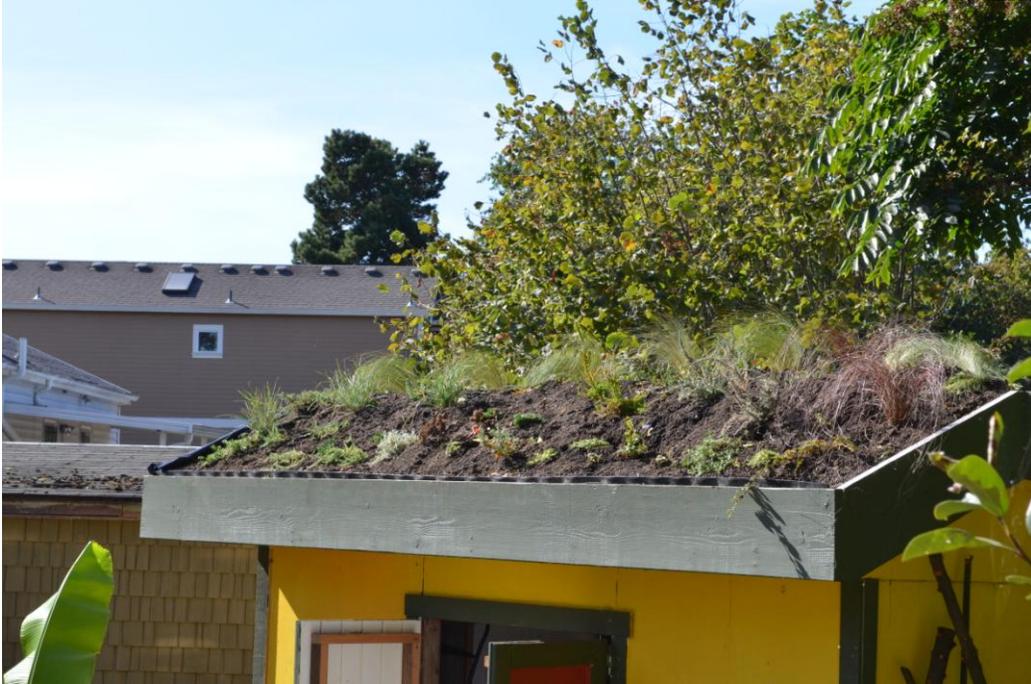
Planted Shed Roof

When the steep portion of the shed was planted, I had to create flat basins around each of the plants to keep the water from running off and not infiltrating into the soil.

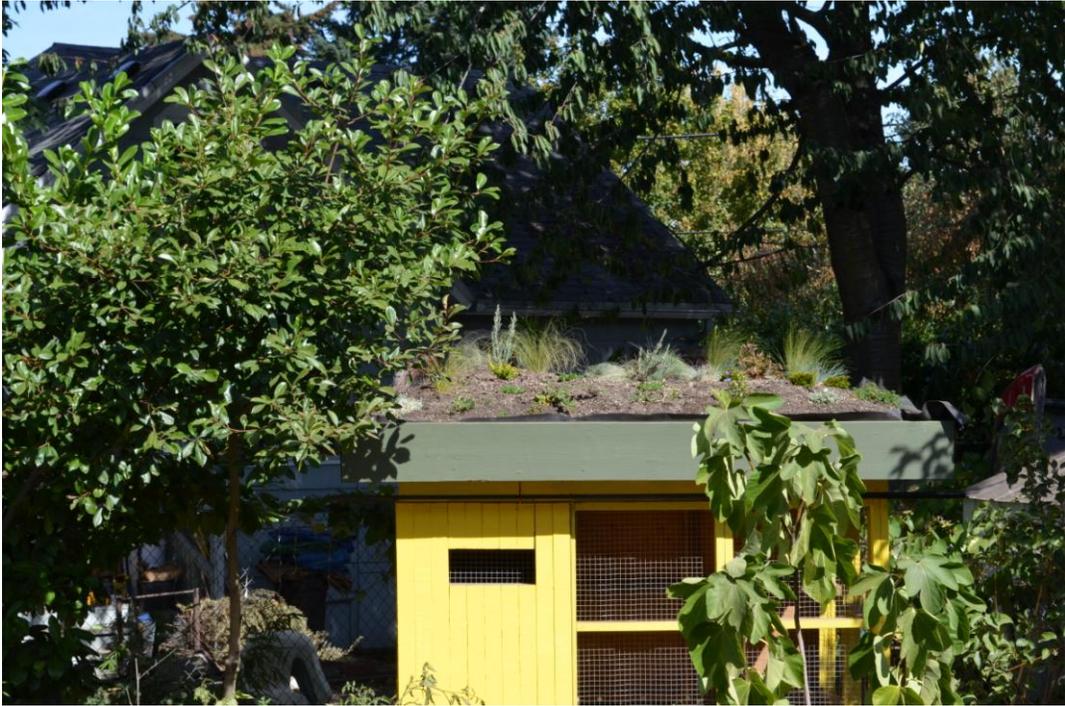
Planted Chicken Coop Roof
