Offset Speed Tables for Reduced Emergency Response Delay

ITE Technical Conference, March 2004, Irvine, California

Scott Batson, PE

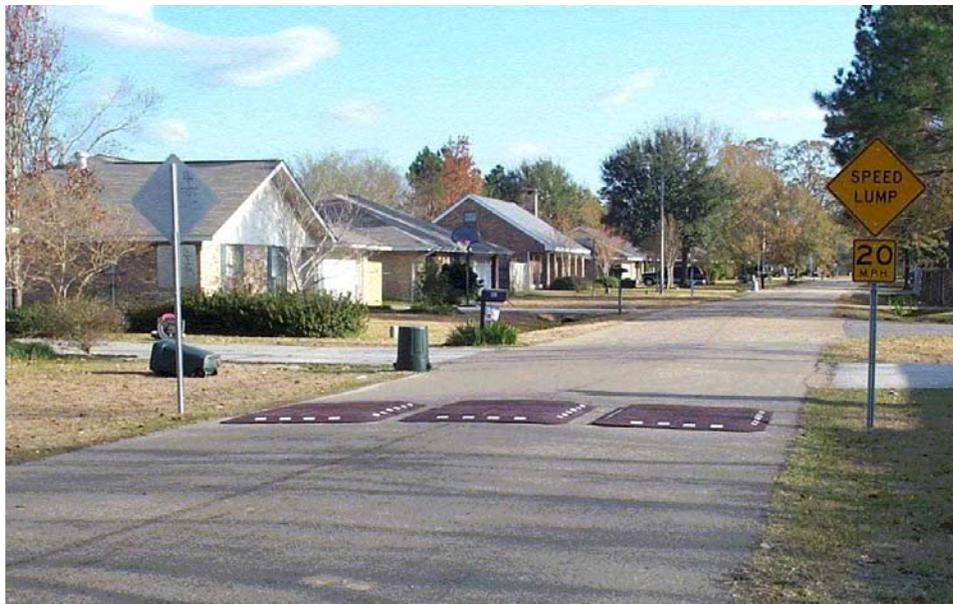
Photo 1. Speed Cushion, Lafayette, LA.

Compounding the issue of track width was the common use of dual rear wheels for heavier vehicles like transit buses and fire trucks. Dual rear wheels in heavy vehicles mean the clear space between the wheels of large vehicles more closely matches the track width of sedans and sport-utility vehicles common in the U.S. Finding a speed cushion wide enough to slow most private vehicles and yet narrow enough to permit fire trucks and transit vehicles to pass easily, without overloading those heavier vehicles' rear axles proved difficult. Also, the use of speed cushions means there are intentional gaps, or channels, between devices in a multi-device installation (see Photo 1).

The UK study also found that 45% of drivers aimed for the gaps when traversing speed cushions and noted concern when gaps coincided with street centerlines.¹² Finally, the use of speed cushions and the need for larger vehicles to straddle the devices meant that conflicts with parked vehicles were possible, eliminating the original benefit to using speed cushions.¹³

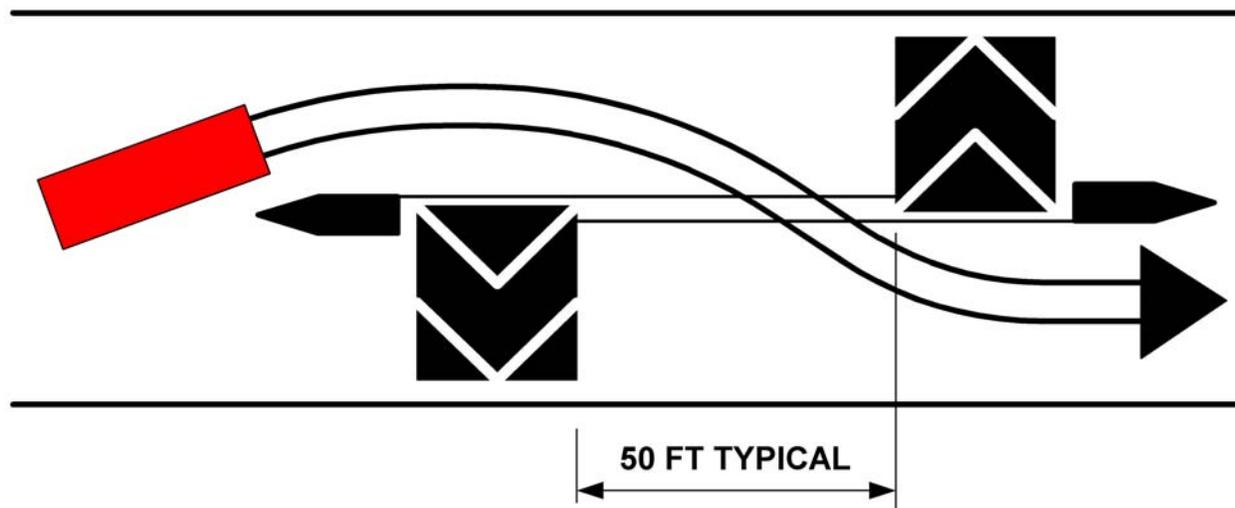
Figure 1. Offset Speed Table with Islands and Emergency Response Path.

In 1997 PDOT began testing an alternative to the speed cushion concept. PDOT'S design used a standard speed table that was constructed across only half of a street. The second half of the speed table was constructed downstream of the first and in the opposing lane. As emergency equipment is able to use any portion of the roadway to accomplish a response, the space between the speed table halves permitted emergency vehicles to cross the street centerline and slalom around them in a serpentine pathway (Figure 1). Constructed with the offset speed tables were median islands on the outside approaches to deter civilian drivers from crossing the centerline. In addition, a double yellow centerline was added approaching each island and quadruple yellow centerline with raised pavement markings were added between the speed table halves. The dense pavement markings between the speed table halves gave an illusion that a median continued the entire distance. The addition of the islands and striping was done to deter drivers from mimicking the pathway emergency vehicles could take.

Tests of the offset speed table with islands were conducted on two public streets, SE Market and SE 17th, in 1998. The testing of the offset speed hump with islands successfully demonstrated fire truck access speeds of 20-30 miles per hour through the pair of speed tables. Response delay was reduced from a maximum of 9.4 seconds for standard speed tables⁶ into the 2-second range.¹⁴ Video of the test site on SE Market showed no indication of confusion on the part of the drivers, nor any violations of drivers trying to avoid the device at any time.¹⁴ The testing also revealed that the offset speed table with median islands has limited application. Street width must be at least 40 feet, curb to curb, to provide for the serpentine path of Emergency Equipment and parking removal is often necessary opposite of each speed table half (see Figure 1). Additionally, where the street is less than 40 feet, transit drivers and other wide vehicle operators

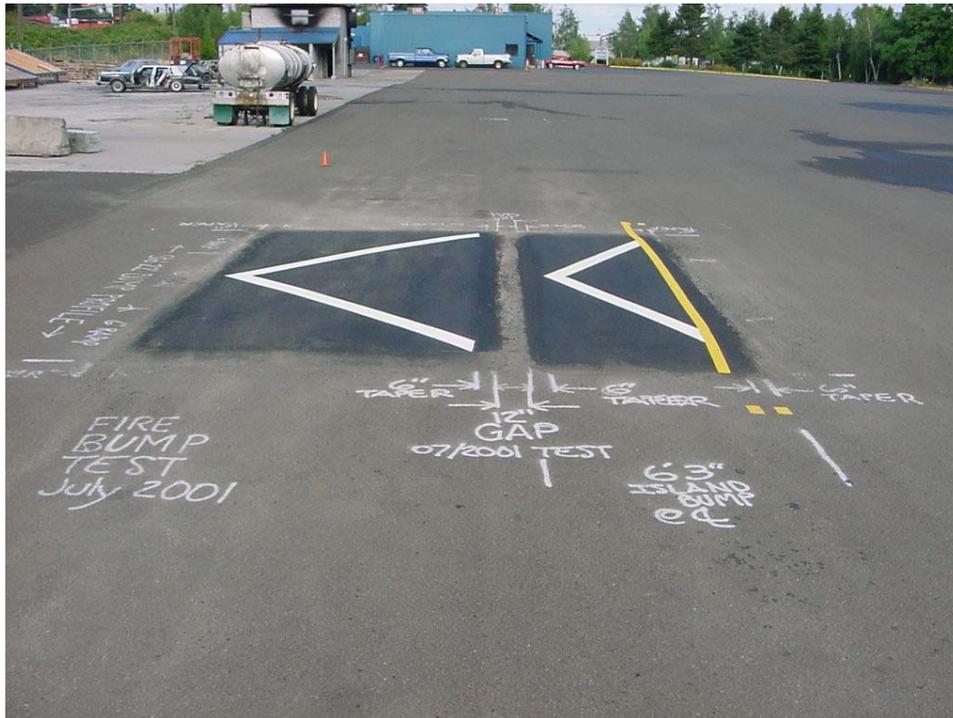
Photo 2. Offset Speed Hump with Channel Test Object – Looking Upstream.

PDOT constructed a prototype device at the Fire Bureau's training facility (Photo 2). This is a controlled area not subject to general traffic and permitted a variety of vehicles to test the device while data was collected. The primary purpose of this test was to determine what benefit the channeled speed table design provided for emergency vehicle response time. This testing also assisted in answering concerns of PDOT over driver control questions as well as refining the design and evaluating constructability issues.

The test device was constructed at Station 2 the week of July 16, 2001. The test object was a standard 22-foot speed table with 6-foot parabolic approach ramps and a 10-foot flat section with a maximum height of 3 inches. A channel was constructed offset from the centerline resulting in a 6-foot 3-inch wide cushion-like object that emergency equipment could straddle. The edge tapers for the channel and centerline edge were constructed with a 1:2 slope. Formal testing, using eight vehicles, was conducted on July 23, 2001. Each vehicle was driven over the device twice with drivers directed to aim for the channel. For the first run drivers were directed to attain 25 mph before crossing the speed table. For the second run the target speed was 30 mph. In past tests the typical speeds of fire trucks and engines crossing a standard 22-foot speed table varied from 14 mph to 21 mph.⁶ The majority of delay at the standard 22-foot speed table is due to the larger fire vehicle's slow acceleration. Attaining typical crossing speeds above 25 mph with the new design would represent a significant reduction in delay for emergency response and was the chosen target speed for a successful test. Each vehicle successfully traversed the test device near or above 25 mph as shown in Table 3.

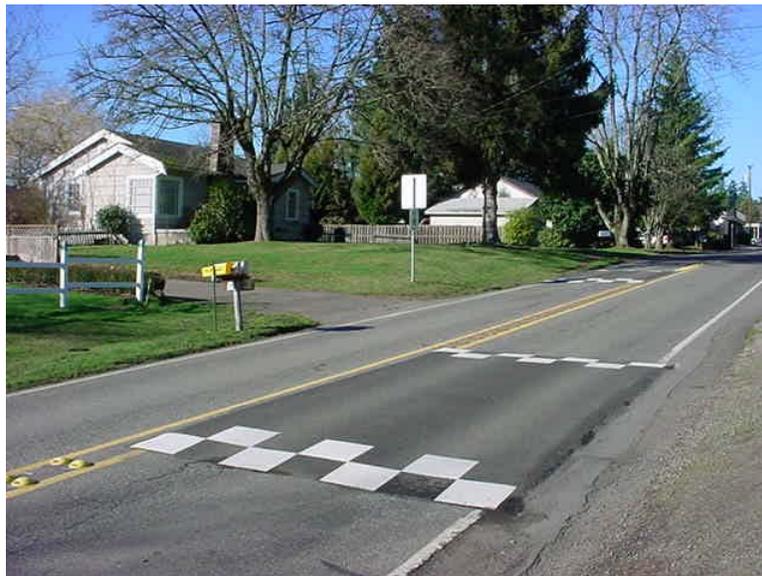
Photo 3. Beaverton Offset Speed Hump – SW 87th Avenue.

The nearby City of Beaverton installed offset speed tables without islands on SW 87th-Birchwood-Laurelwood in the summer of 2003 (Photo 3, next page). Offset speed tables were chosen due to the designation of the street for emergency response. Before construction of the speed tables the 85th percentile speed was measured at 34 mph in a 30-mph zone with 25% of

drivers exceeding the posted speed. After construction the 85th percentile speed reduced to 30 mph with 15% of drivers exceeding the posted speed. Vehicle volume on the street reduced from an average of 5800 vehicles per day (vpd) to 5400 vpd. The offset speed tables were originally constructed with only pavement striping to communicate to drivers to remain on their side of the street due to the weather. Subsequent to construction Beaverton received complaints from local residents about driver circumnavigation of the offset speed tables by crossing the centerline. The City of Beaverton added raised pavement markers with inset reflectors to deter such behavior (see Photo 4) after the weather warmed up in 2004. The City of Beaverton reports that complaints regarding centerline violations are no longer common from local residents.

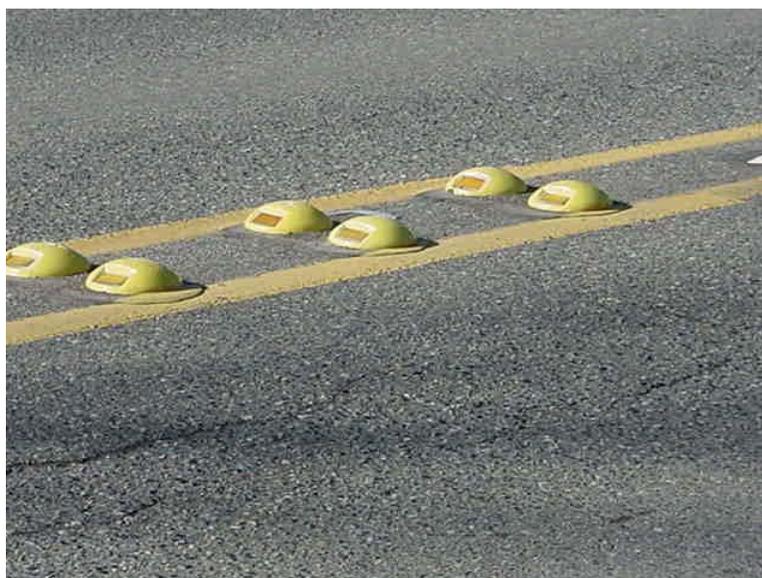
Photo 4. Beaverton Offset Speed Hump Centerline RRPMs.

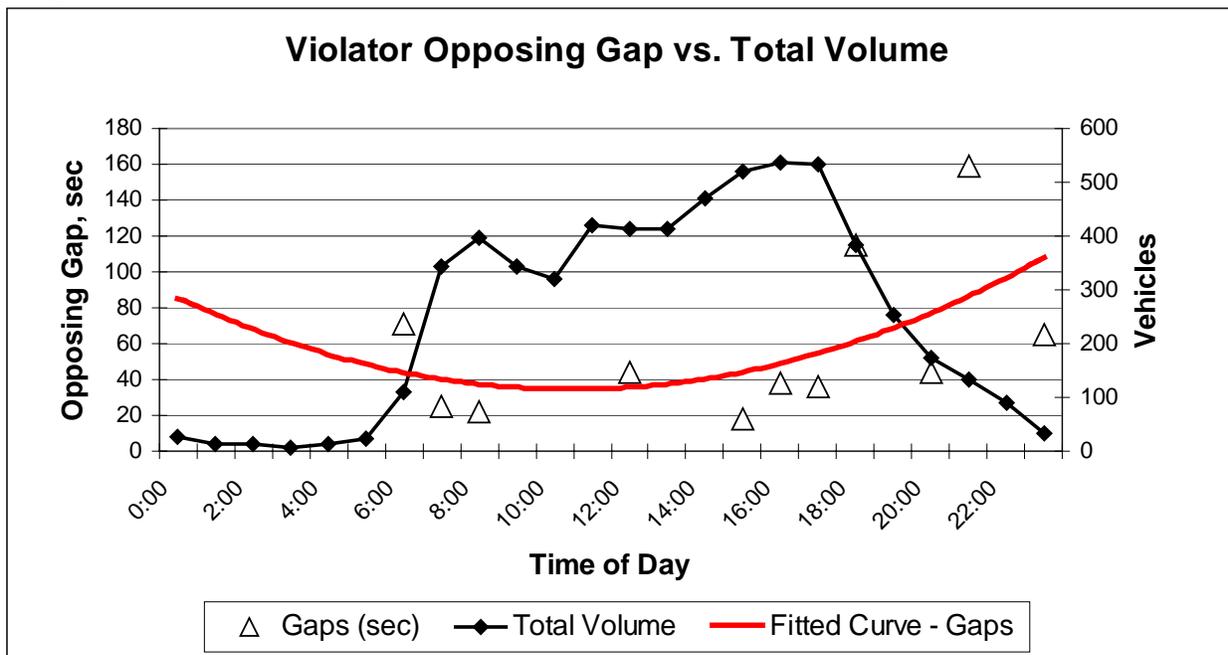
Graph 1. Violations versus Traffic Volume

It is expected that the offset speed table will be self-regulating in regards to centerline violations and such self-regulation is sensitive to opposing traffic volume. As opposing volumes increase fewer drivers likely to violate a double yellow centerline will do so (see graph 1). PDOT collected video at the Beaverton site to determine the frequency of centerline violations. Approximately 13 vehicles in a 24-hour period violated the centerline to some extent, either completely or partially avoiding the offset speed tables. This represents a violation of 0.22% of the total population of drivers. The average length of time a driver was within a portion of the opposing lane (exposure) during such maneuvers was 2.88 seconds with a standard deviation of 1.13 seconds. The opposing headway gap, the length of time before the next opposing vehicle passed the offset speed table after a violation occurred, averaged 22 seconds with a standard deviation of 10.43 seconds. The exposure and opposing headway analyses are conservative in that data corresponding to opposing gaps in excess of 60 seconds (5 of the 13) were discarded.
