Bureau of Environmental Services • City of Portland

# 2006 Stormwater Management Facility Monitoring Report SUMMARY

Sustainable Stormwater Management Program

September 2006

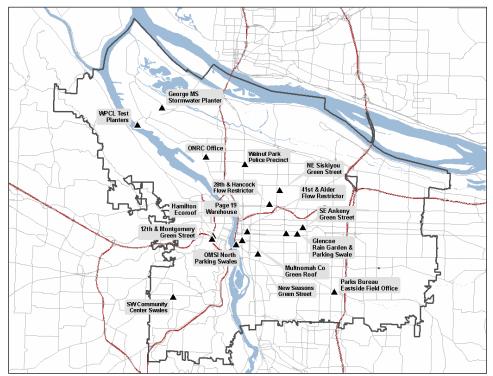
Facilities Evaluated in 2005

Monitoring data collected through December 2005 is included in this report. Evaluated facilities are located throughout the city and represent an effort to include a variety of facility types, configurations, ages, and land uses. General facility types included here are: Ecoroofs, Green Streets, Vegetated Infiltration Basins, Stormwater Planters, and Flow Restrictors.

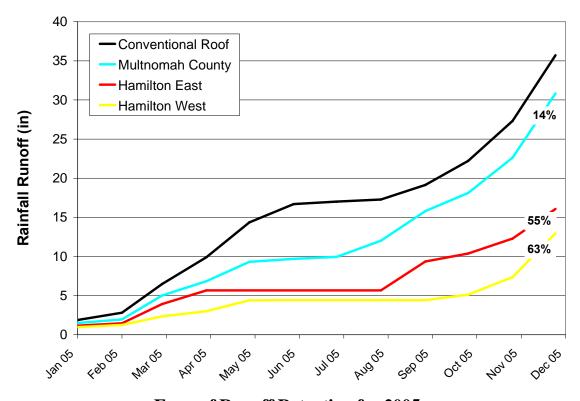
**Ecoroof Runoff Retention for 2005**

It is interesting to note that annual and seasonal retention for both Hamilton West and Hamilton East improved over each of the four years of monitoring. This would suggest that retention performance can improve as the soil and plant complex matures. It will be interesting to see if the younger Multnomah County Green Roof shows a similar trend as it ages.

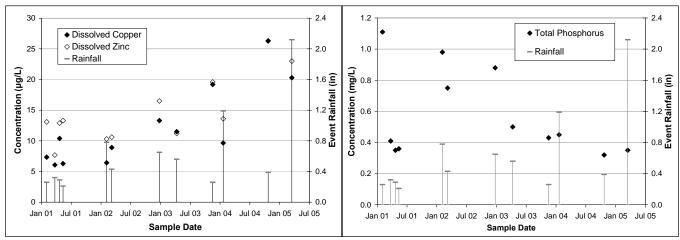
Trends for copper, zinc, and phosphorus from Hamilton West runoff samples

Zinc and copper levels in the runoff appear to be rising over the past four years. Though concentrations of both were well below human health guidelines, many samples contained levels of copper that may adversely impact aquatic life ( $>7 \mu g/L$ ). The soil media, especially from Hamilton West, contains zinc and copper, but the corrosion of roofing materials – flashing, railings, etc. – and metals in rainfall may also contribute.

Phosphorus concentrations appear to be decreasing over time but are still high (0.35 mg/L) when compared to benchmarks established in some Portland watersheds (0.13-0.16 mg/L).

This data represents a small sample of events collected only during winter and spring months. More sampling is necessary to determine: 1) if concentrations are truly significant, 2) how levels compare to concentrations found in rainfall and conventional roof runoff, and 3) the source – soil media, roofing materials, rainfall, etc. Despite the remaining questions, current data does indicate that selection of an appropriate soil medium should include an evaluation of potential water quality impacts.

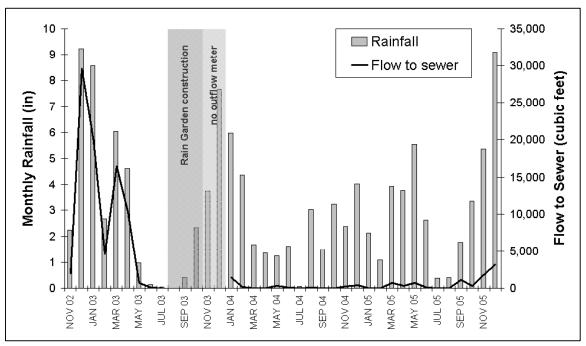
Inflow volumes to the combined sewer before and after construction of the Glencoe Rain Garden (94% reduction)

The Green Street facilities also provide a notable reduction in the flow volume entering the combined sewer. Annual runoff has been reduced by up to 94%, and flow tests simulating CSO design storms have resulted in retentions as high as 80%.

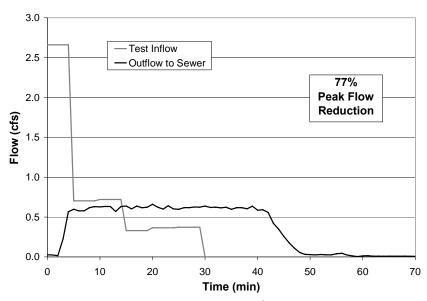
Peak flow reduction for the 41st & Alder hanging trap

A flow test simulating the 25-yr Design Storm was performed at a test installation at the intersection of SE 41<sup>st</sup> & Alder. The restrictor at this location is a hanging trap, and it acts as a centralized control for three inlets. During the test, the unit lowered the peak flow to the combined sewer by 77% – an excellent result that would provide basement sewer backup protection in most circumstances.
