Mississippi Commons
3721-3727 N Mississippi Avenue
Portland, Oregon

PROJECT SUMMARY

Overview of the Stormwater System

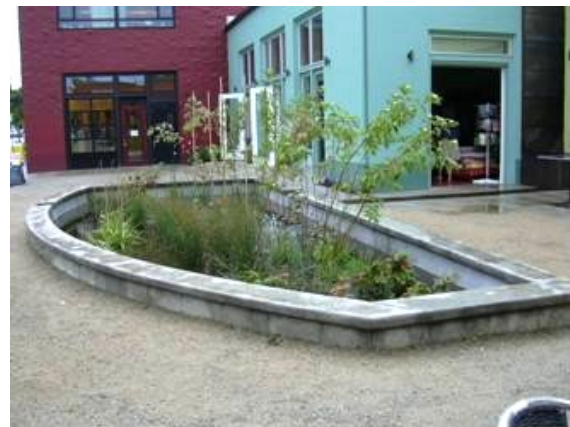
Mississippi Commons After, with Stormwater Infiltration Planter

- The Mississippi Commons redevelopment project converted a collection of buildings from light industry to mixed-use artist space, offices, and retail. Part of the project involved providing complete onsite stormwater management.
- Two downspouts were disconnected from the roof and directed to a two-level, steel-lined basin. The basin empties into a grate-covered trench in the ground, which in turn flows into an infiltration planter. Vegetation, soil, and material in the planter slow and filter the stormwater before it soaks into the ground.
- The infiltration planter is designed as an architectural feature for the building’s public courtyard.
- A third downspout is piped under the concrete and bubbles into the planter by way of a pipe.

- During large storm events, overflow enters a stand pipe within the planter and is directed underground to a drywell on the property. Overflow also spills onto an adjacent pervious gravel courtyard through an opening in the planter wall.

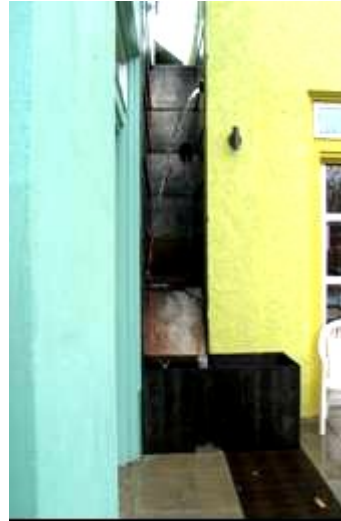
Downspouts disconnected to collection basin and conveyed along a trench to the planter

Creative approach: The steel stormwater basin and conveyance system are a creative and innovative approach to capture and convey runoff from the building roofs.

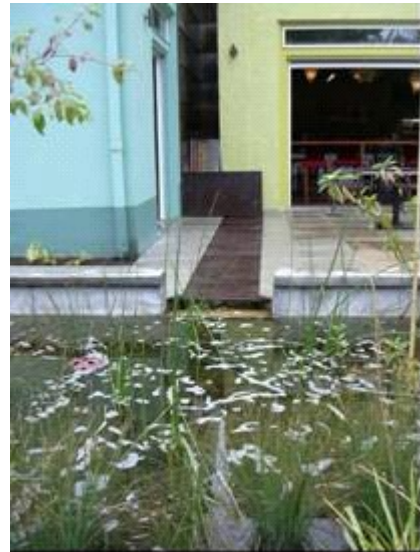
Roof runoff conveyed to the newly vegetated planter

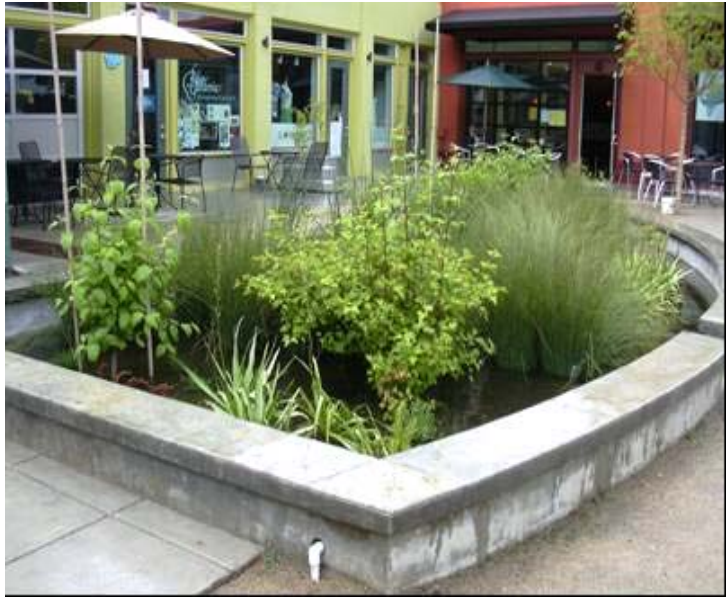
Stormwater Infiltration Planter, looking north

Infiltration planter: The infiltration planter has a 12-inch sub-base of washed $\frac{3}{4}$ -inch gravel, which is separated from approximately 24 inches of soil by a layer of filter fabric.

Landscaping: The largely native vegetation in the infiltration planter includes *Juncus patens*, Grooved rush; *Cornus stolonifera*, Red twig dogwood; *Viburnum trilobum*, American cranberry bush; *Camassia leichtlinii*, Camas lily; *Sisyrinchium*, Yellow-eyed grass, *Scirpus acutus*, hardstem bulrush, and *Carex rupestris*, Curly sedge.
