# Headwaters at Tryon Creek

The Headwaters at Tryon Creek serves as a demonstration in sustainable stormwater management, green development practices, wildlife habitat restoration and water conservation. The development includes LEED Silver rated senior housing, town homes and market-rate apartments along with numerous environmental site enhancements which are highlighted by the first daylighted creek in the City, running the length of the 2.8 acre (1.1 hectare) property. This newly developed community is now a part of the growing ecology of its site.

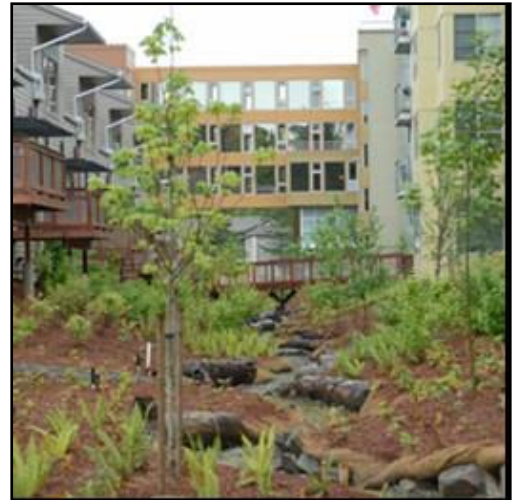
The daylighted tributary stream of Tryon Creek:

- originally ran through a pipe under the site
- is approximately 450 linear feet (135 meters)
- connects an upstream, forested wetland to a downstream rain garden
- is planted with native trees, shrubs, and grasses that restore lost riparian and wetland habitat
- has a 5 foot (1.5 meter) deep gravel lens below the stream bed that helps direct flow below the surface for groundwater recharge.

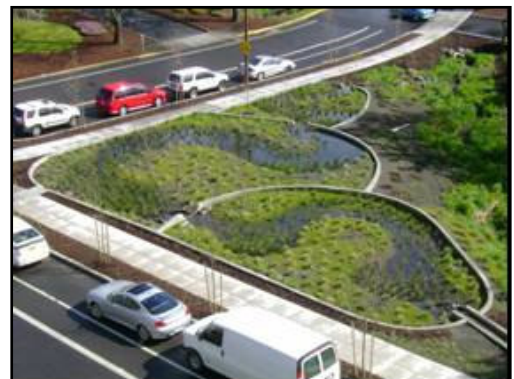
The Rain Garden:

- covers 0.5-acres (0.2-hectares)
- sits on the site of a former traffic triangle and a 200 foot (61 meter) section of street
- allows the long-buried stream to connect with Tryon Creek
- treats storm water from adjacent development and right-of-way, helping to filter pollutants as well as reducing the rate and magnitude of stormwater flows.

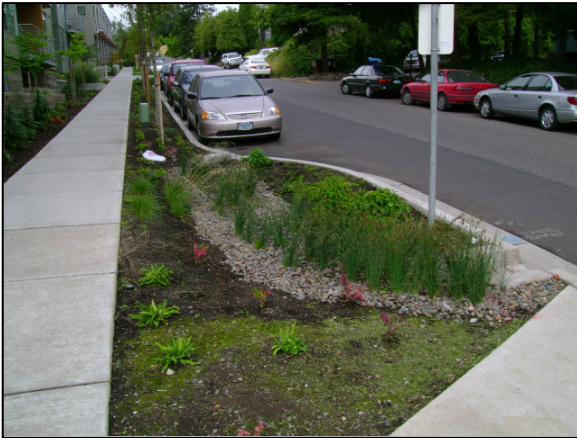
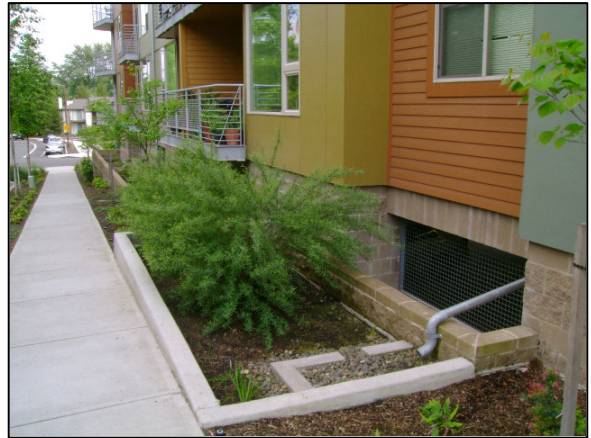
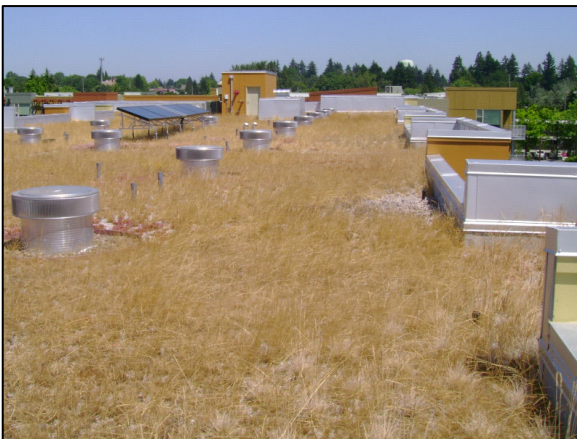
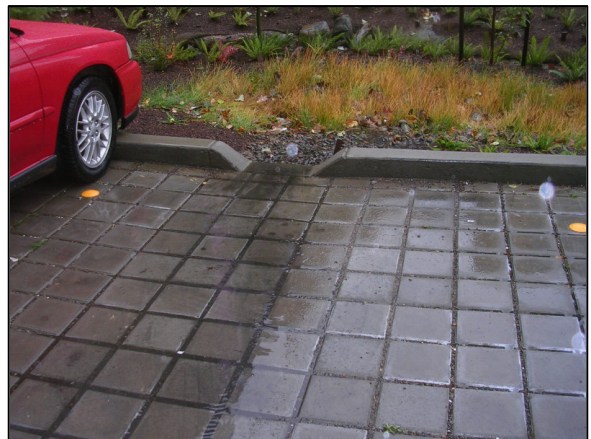
Remaining elements of the site continue to celebrate water while endeavoring to mimic natural processes. These include:

- **green street infiltration planters** that artfully display the conveyance of stormwater, collecting onsite stormwater as well as stormwater from the public right of way.
- **flow-through planters** adjacent to the building capture roof runoff, and individual downspout gardens diffuse and infiltrate the stormwater.
- a 14,000 square foot (1,300 square meter) **ecorooftop** and captures and detains precipitation and provides supportive habitat to the area.
- **pervious pavement** was used in the parking lots.
